Wittner Inspection Services

PROPERTY INSPECTION REPORT FORM

John Doe <i>Name of Client</i>	09/17/2024 <i>Date of Inspection</i>
12345 Anywhere Ct, Anytown, TX 77777 <i>Address of Inspected Property</i>	
Dauson Wittner <i>Name of Inspector</i>	TREC# 24364 <i>TREC License #</i>
<i>Name of Sponsor (if applicable)</i>	<i>TREC License #</i>

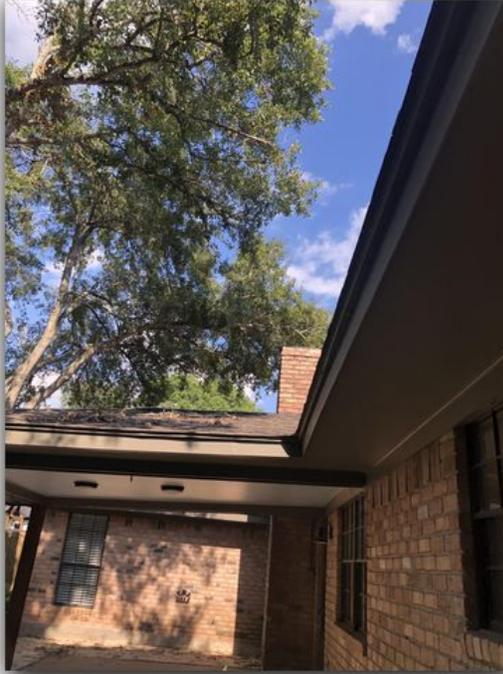
Comments: Slopes away from home. Recommend installing gutters and downspouts to direct water away from the foundation.

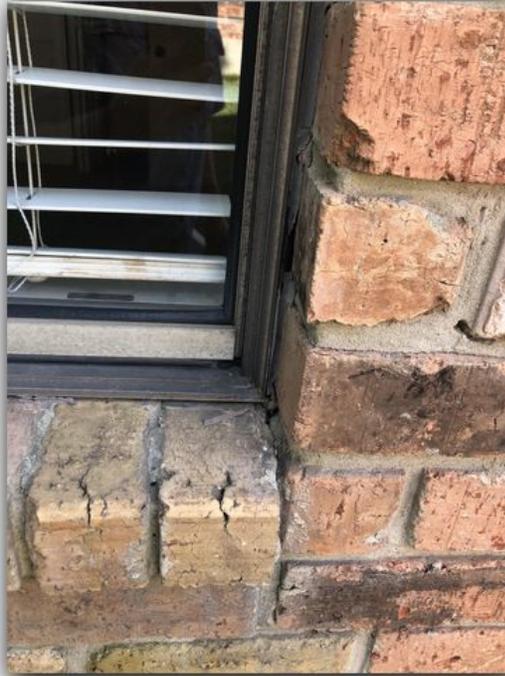
Comments: Multiple exterior window caulking is deteriorated. Recommend caulking windows. Windows hard to open in Front 2nd Bedroom.

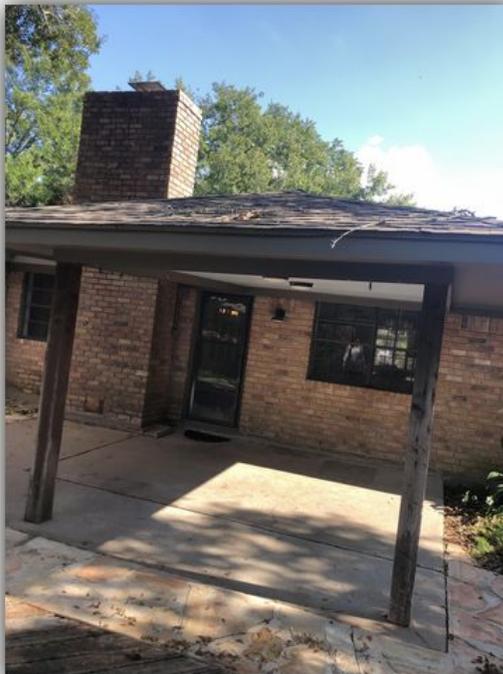
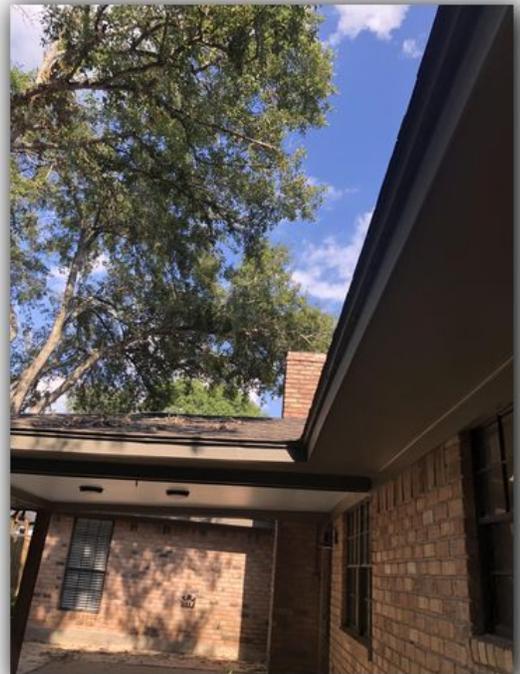
Comments: Does not sit level. Slopes downward with the grading.

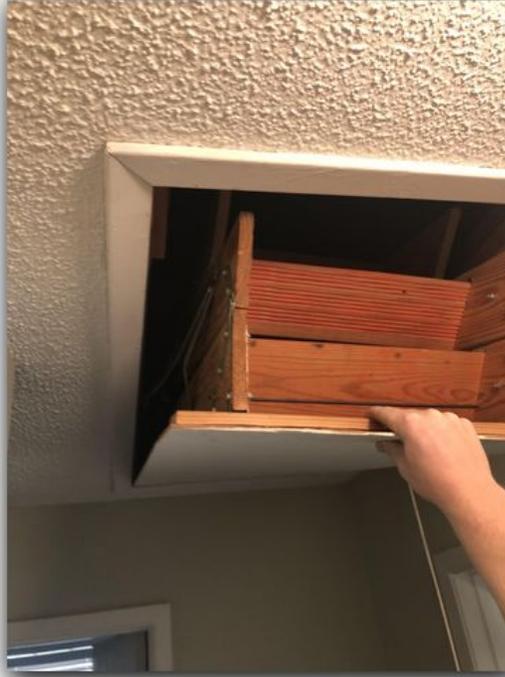
Comments: Could not open attic access hatch in hallway to inspect evaporator unit. Did not test due to high outdoor temperature.

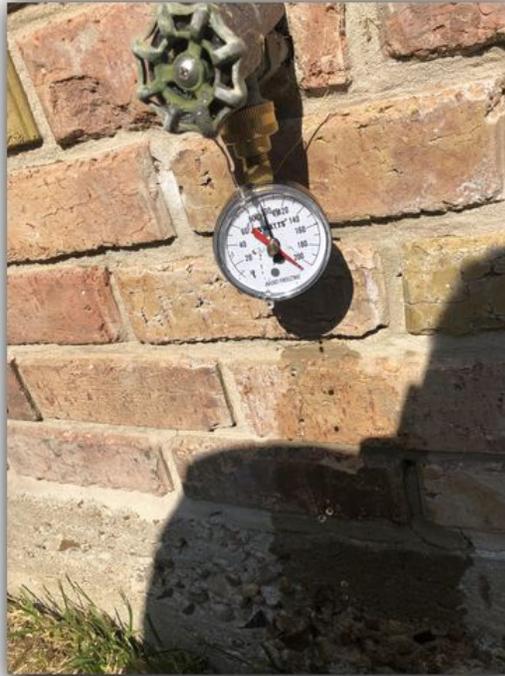
Comments: Water faucet on left side exterior of the residence was leaking out of hose bib handle during testing. Water pressure exceeds 80 psi. Recommend a pressure reducing valve to be installed when the water pressure exceeds 80 psi by a qualified contractor. Washer connection has water around it possibly from disconnecting previous unit. Master bath sink fixture had no water. Tile cracked in hall bath and not enough caulking around bath tub. Hall bath shower fixture loose. Multiple bath sink faucet supply lines flange not properly attached to wall. Kitchen sink spray head leaking when main faucet was turned on.

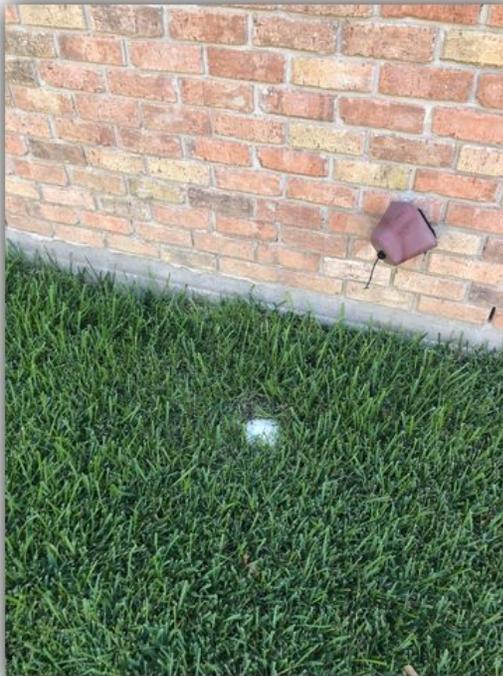
Comments: Clean out located on right side of home.

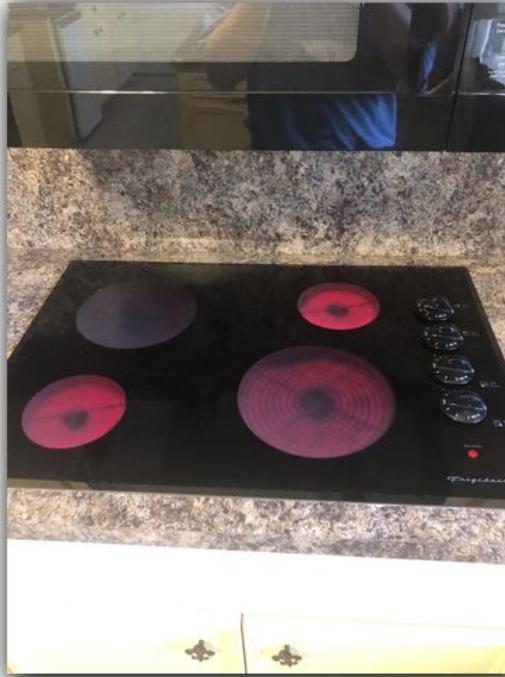
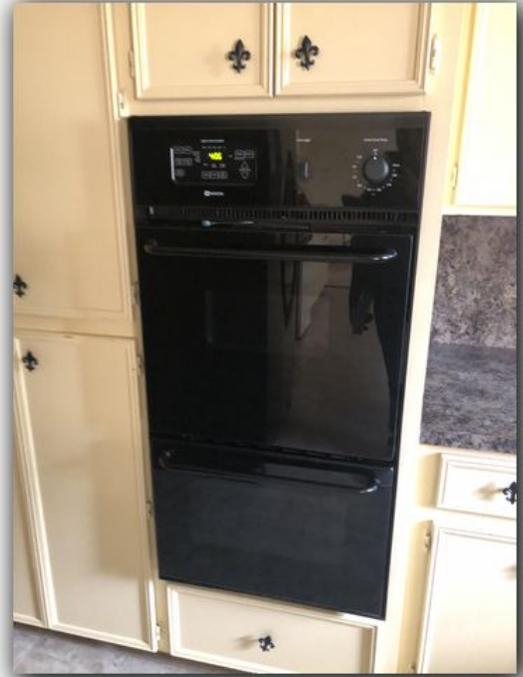
Comments: Cooktop works. Heated upper and lower oven to 350°F. Upper oven measured 330°F. Lower oven measured 363°F. Both within acceptable temperature ranges.
