HUD Engineering Evaluation

123 Sample Inspection, Sample, TX, 77303

PROPERTY INSPECTION REPORT

1234 Main Street
Magnolia TX 77354

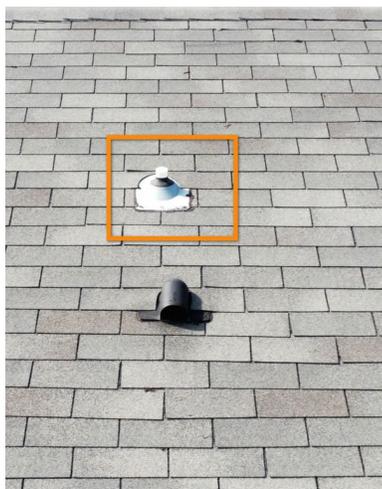
Back

Stack vents should terminate at least 6-inches above the roof. Recommend installation of a riser and/or a new boot, as necessary.

Recommendation: Contact a qualified plumbing contractor.

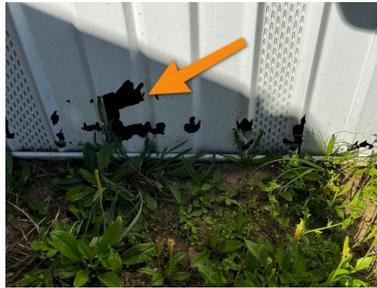
Right

1: Damaged skirting

The skirting was damaged around the home at various areas.

Recommendation: Contact a qualified general contractor.

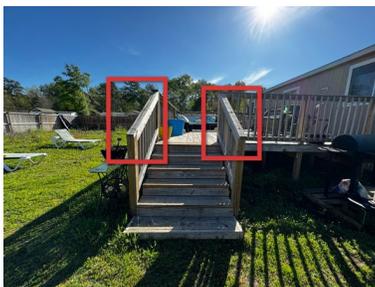
Back

Non-graspable handrails is a safety hazard. Handrails should be no wider than 2-1/4" so that a person can easily hold onto them.

Recommendation: Contact a qualified general contractor.

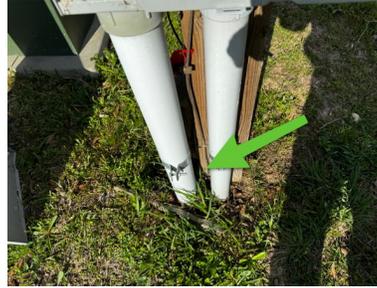
Ground rod, not visible

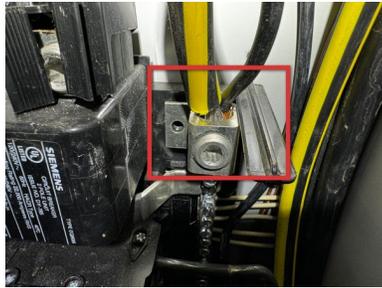
Electrical panel in laundry room

⚠️ Safety Hazard

The neutral service conductor was double lugged with a ground wire. The ground wire should be on a separate lug. The present condition can result in a loose connection and become a fire hazard.

Recommendation: Contact a qualified electrical contractor.

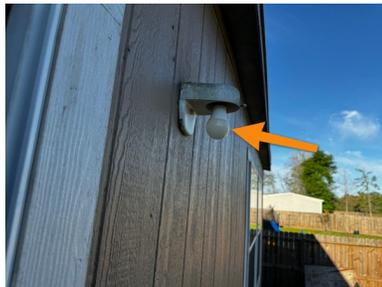
Back

1: Fixture - light inoperable / bulb needs replacement

One or more lighting fixtures failed to illuminate (fixtures did not turn on when nearby switches were activated). It is advised to further evaluate by replacing bulbs and/or consulting with the property owner. If changing bulbs proves ineffective and/or no additional switch(es) can be found, then recommend that a qualified electrician examine and repair or replace light fixtures.

Recommendation: Contact a qualified electrical contractor.

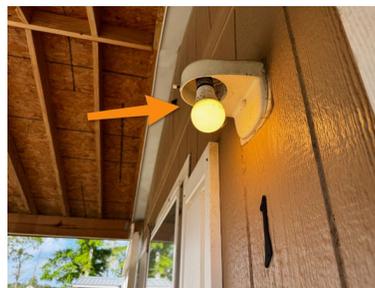
Front

2: Fixture - missing bulb cover

Lighting fixture is missing the bulb cover. This is considered a primarily cosmetic deficiency, but can provide some protection for the bulb. Recommend replacement of the bulb cover as necessary.

Recommendation: Contact a qualified electrical contractor.

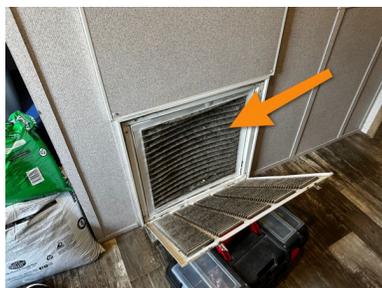
Laundry

1: Filter requires replacement

The HVAC filter appears to be beyond its expected lifespan. Recommend replacement. Do it yourself or hire an HVAC/Handyman Contractor.

Recommendation: Contact a handyman or DIY project

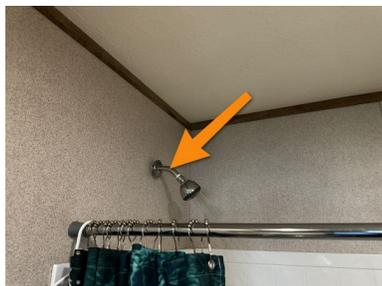
Hall Bathroom

1: Loose fixture

Plumbing fixture is loose. Recommend hiring a plumber to tighten fixture.

Recommendation: Contact a qualified plumbing contractor.

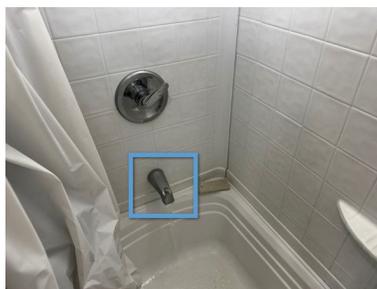
Hall Bathroom

2: Tub/shower re-caulking necessary

The tub and/or shower requires re-caulking. Re-caulking is necessary where caulking is missing or mold/mildew stains are present and have permanently set (i.e. they are no longer removable). Re-caulking can be completed DIY, or most general contractors and plumbers can re-caulk a bathroom. Confirm the use of silicon-based sealants that will prevent the penetration of water into the seams and cracks.

Recommendation: Contact a qualified Do It Yourself

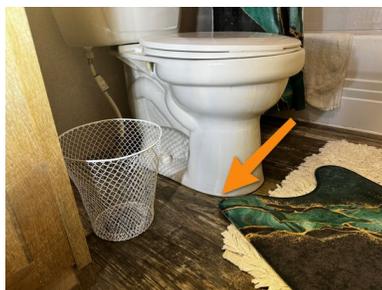
Hall Bathroom

3: Toilet needs re-caulking

The toilet caulking is missing and/or the caulking has deteriorated and is considered damaged. Recommend a plumber re-caulk the toilet.

Recommendation: Contact a qualified plumbing contractor.

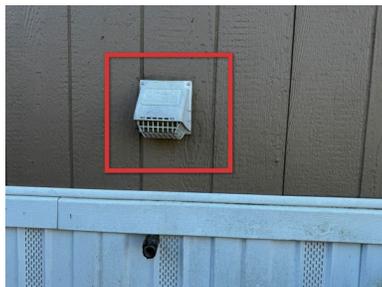
Back

▲Safety Hazard

A screened dryer vent permits lint buildup and will clog the system. This is a fire safety hazard.

Recommendation: Contact a handyman or DIY project
