Site Map
Upper Shaker Lake Dam
File Number: 1314-002

Name of Dam: Upper Shaker Lake Dam File Number: 1314-002
 County: Cuyahoga Date: September 30, 2014 Engineer: DCB

Name of Dam: Upper Shaker Lake Dam
 Date of Inspection: 9-30-2014
 File Number: 1314-002
 Class: I
 Haz.: I, Height: III, Volume: III

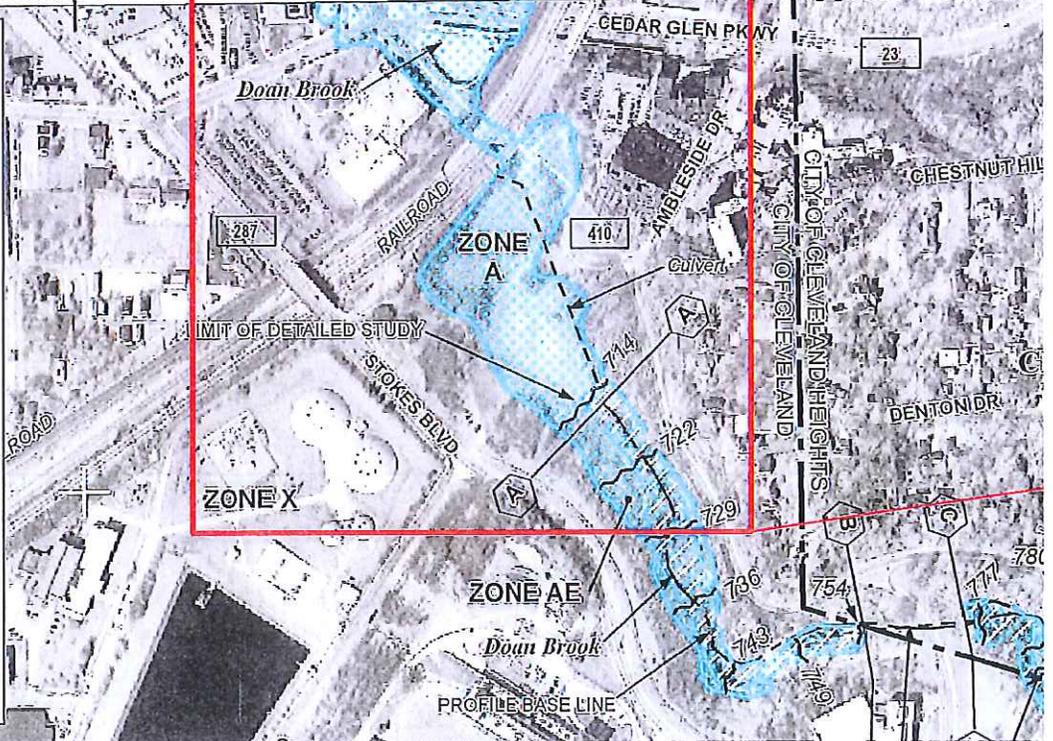
The blue-shaded area on the aerial photograph shows the 100-year floodplain from the 2010 Cuyahoga County Flood Insurance Study. Upstream of the railroad, Doan Brook enters an enclosed culvert that passes under the developed area downstream of the railroad. This map shows that there could be some overflow that does not enter the culvert but flows under the railroad along Martin Luther King Jr. Blvd. and floods several roads and buildings. In the event of a dam break, more flooding in these areas would occur.

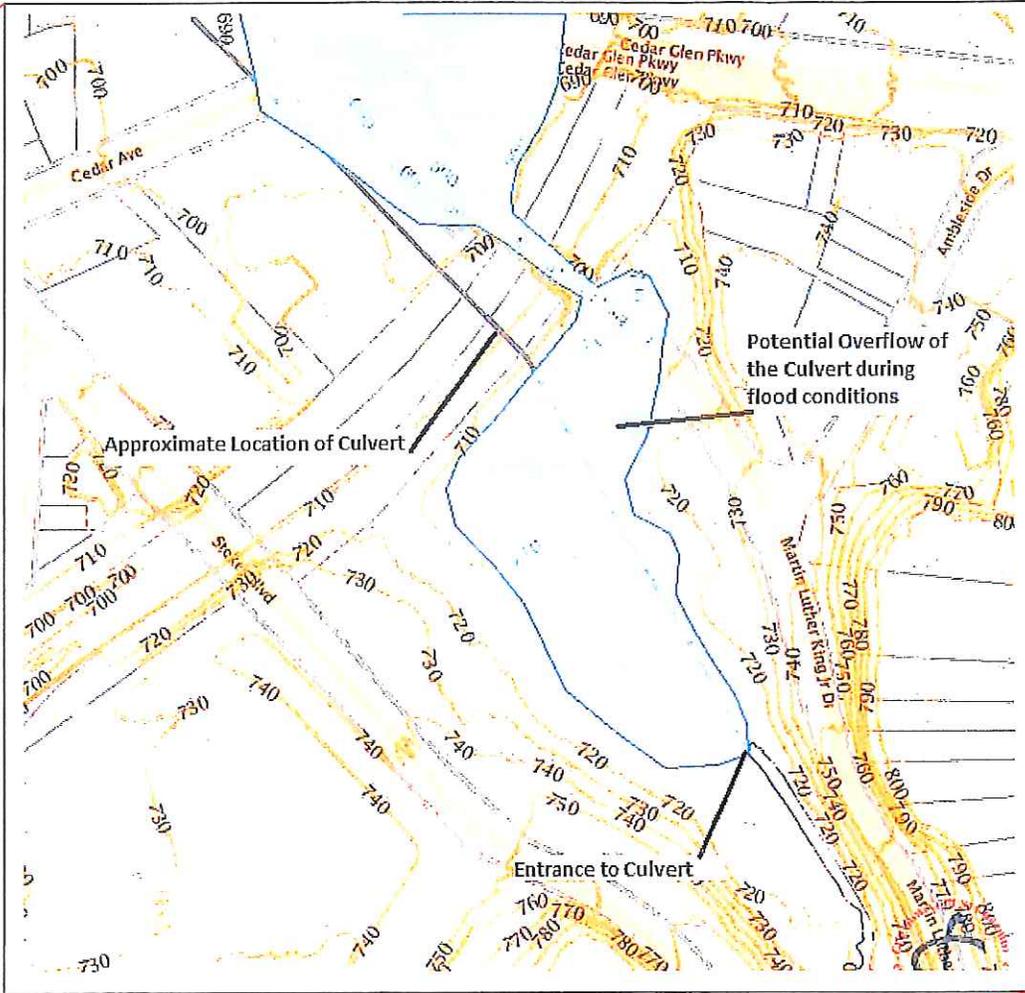
The map below includes 2-ft contours obtained from the Cuyahoga County Auditor Website. The map shows that overflow from the culvert will flow along Martin Luther King Jr Blvd, under the railroad to developed areas downstream.

The culvert begins about 1.4 miles downstream of Lower Shaker Lake Dam and about 2.6 miles downstream of Upper Shaker Lake Dam.
