Detect and Inspect LLC

36 Oak Creek Ridge Drive , Longview, Texas 75605

House | 2251 sqft | 3 bedrooms | 2 bathrooms | Year Built 1995

PROPERTY INSPECTION REPORT FORM

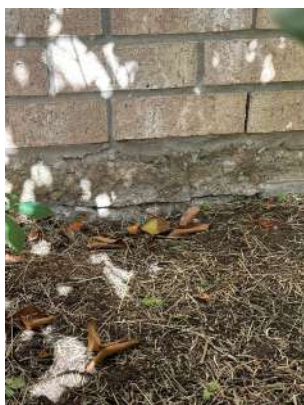
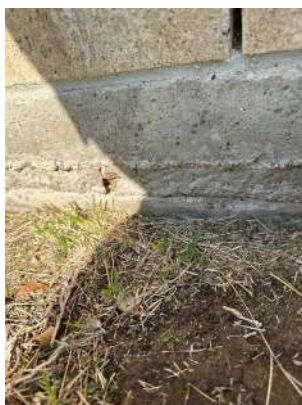
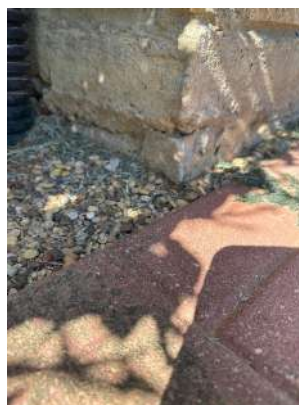
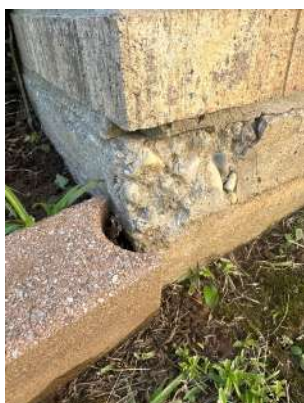
A. Foundations

The foundation appears to be performing the function intended.

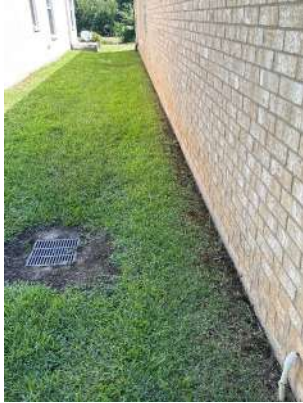
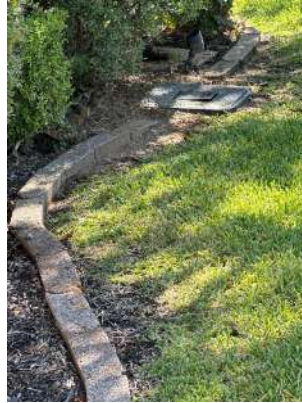
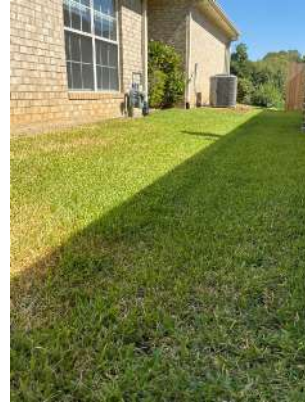
B. Grading and Drainage

Suggestion to keep trees and vegetation at least one foot away for structure.

The landscape may require a trench, drain or improved landscaping if water stands or puddles after heavy rain. I am unable to determine due to no rain at the time of inspection.

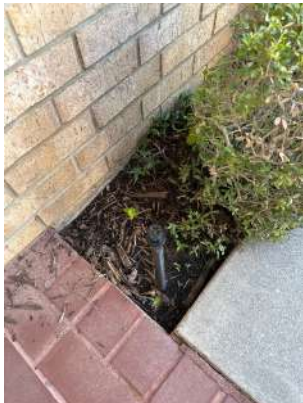
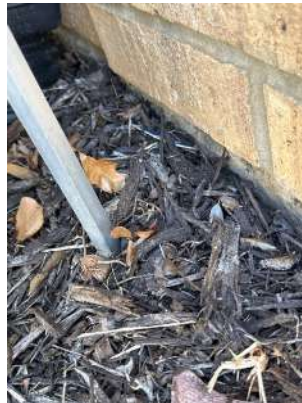
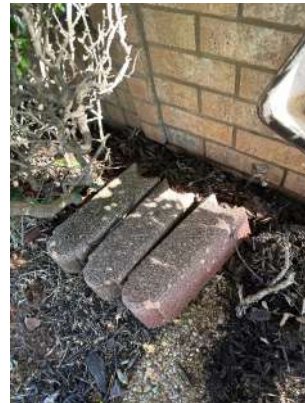
High soil levels/flower/planting beds were observed at the foundation walls. A minimum of four inches of foundation wall should be exposed under the brick veneer and a minimum of six inches of foundation wall should be exposed under the wood surfaces. High soil levels are conducive to wood destroying insect infestation, and possible water penetration into the home. When repaired, the grade should slope downward away from the home directing runoff away from the foundation. Improvements should be undertaken by professional landscaper.

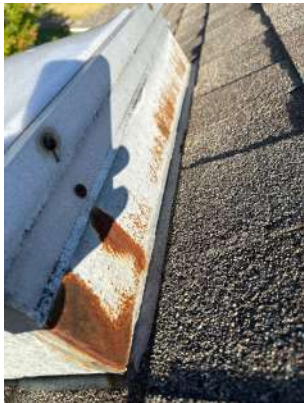
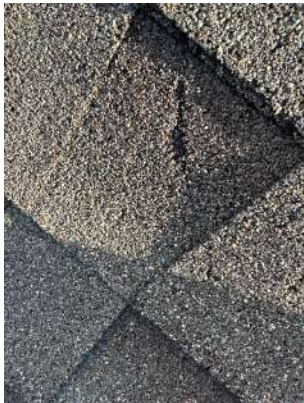
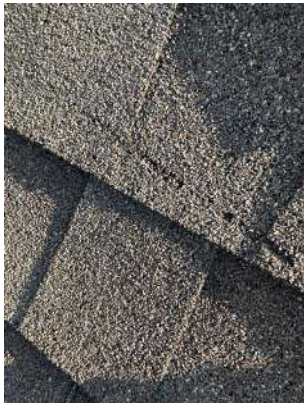
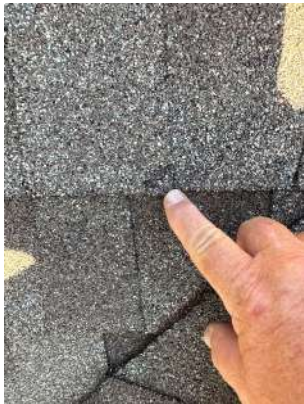
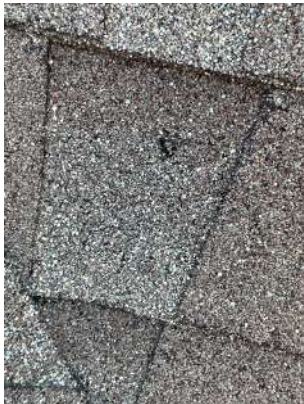
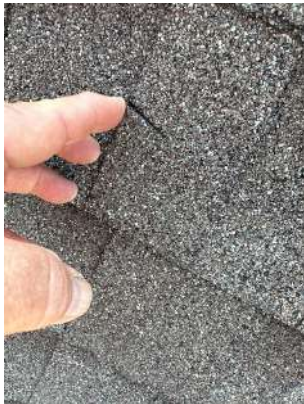
C. Roof Covering Materials

Normal wear. Roof does have small areas of damage and poor workmanship. Skylight could us some paint to prevent further rust. Vent should be six inches above the roof. Vent barley meets this requirement. All roof penetrations should be kept in good repair of painting and caulking as part of an annual maintenance program

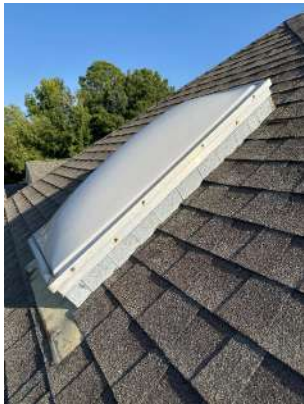
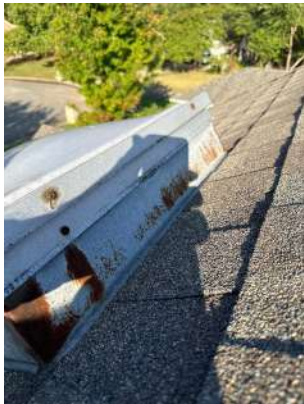
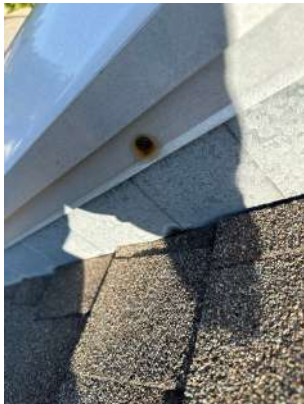
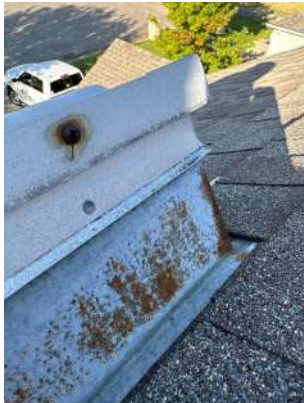
Skylight condition. Observed rust and missing fastener. Suggest correction, DIY project or qualified professional

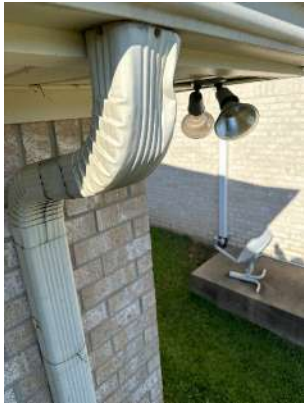
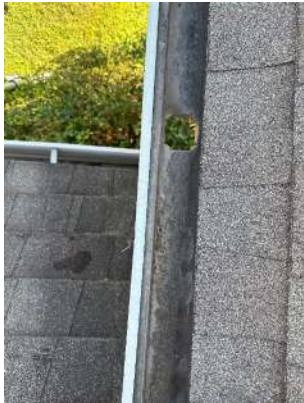
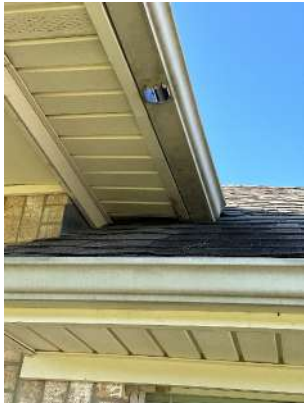
Downspouts and gutters were observed to be damaged. Damage, gutters and downspouts result in restricted flow.

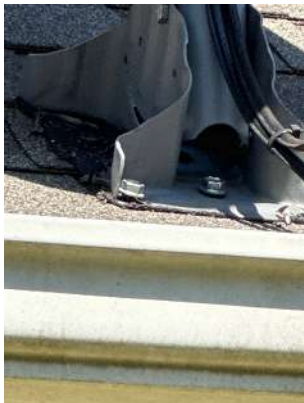
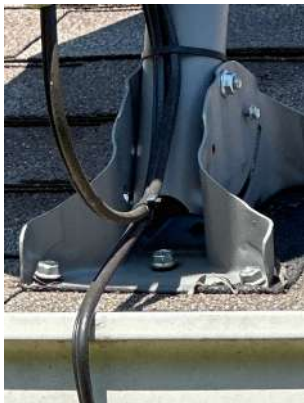
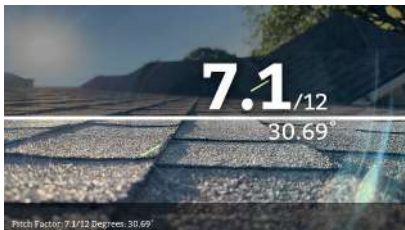
Satellite dish fasteners should be sealed DIY project or qualified professional

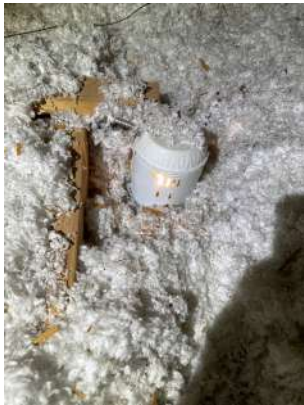
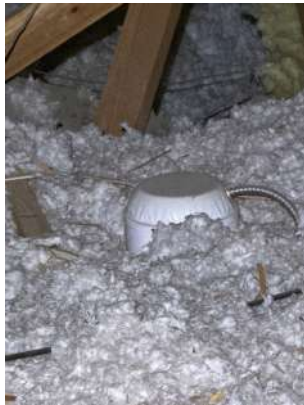
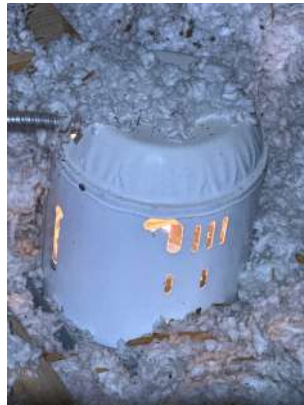
Unable to determine IC rating for canned lights. IC ratings allow insulation to be next to the canned lights. If the canned light is not IC rated insulation must be removed at least 3 inches from each canned light. IC rating will be labeled inside the canister. Consider using LED lighting because they do not carry as much heat as a Incandescent or halogen bulb. Usually canisters with openings or slits are not IC rated and the openings all for heat to disapeate.

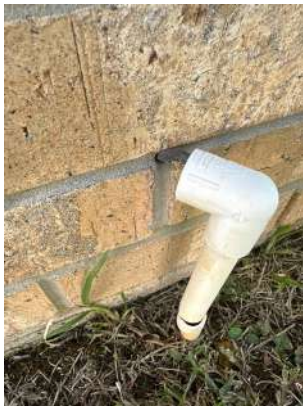
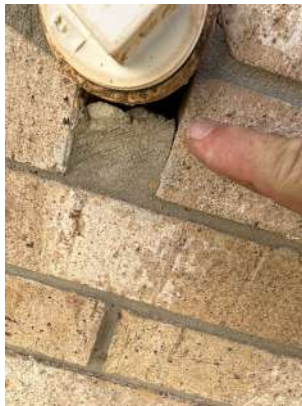
Wall penetrations should be sealed to keep out water, pest and insects. DIY PROJECT: Suggest sealing all exterior wall penetrations and adding to a yearly maintenance program.

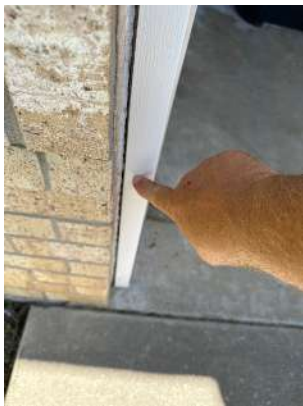
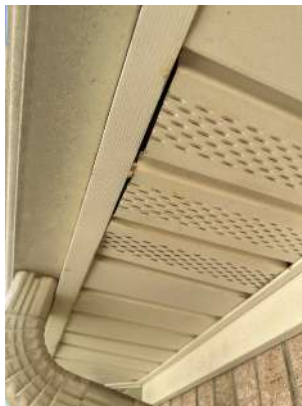
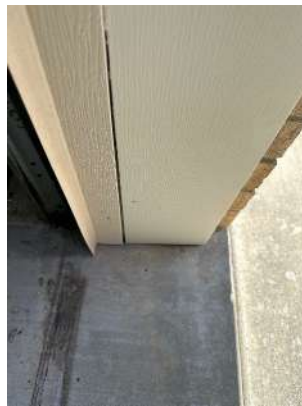
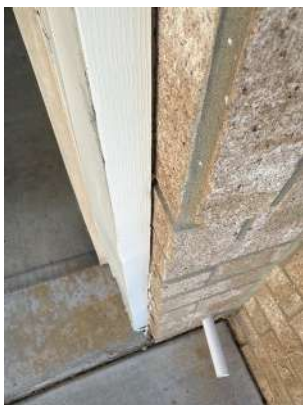
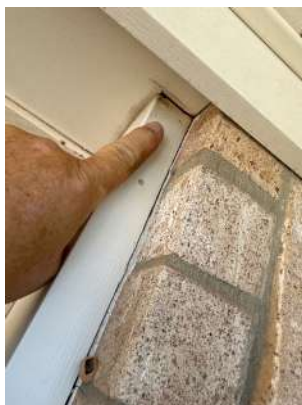
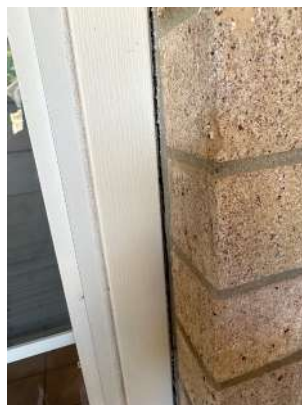
Exterior wall is:
Yearly maintenance of caulking and paint is suggested and as needed.

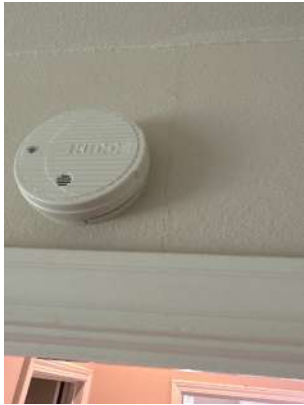
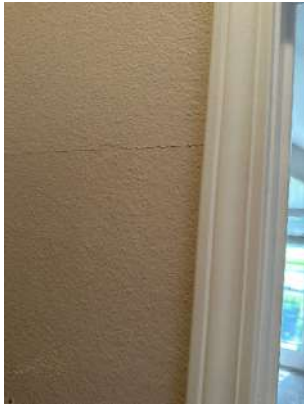
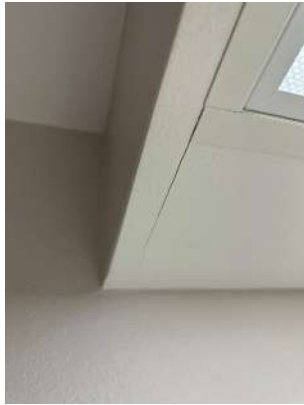
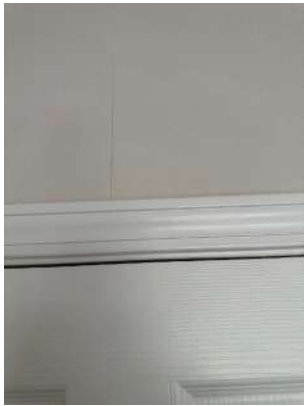
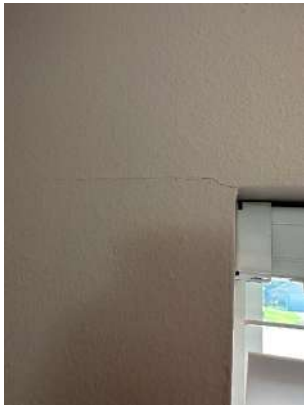
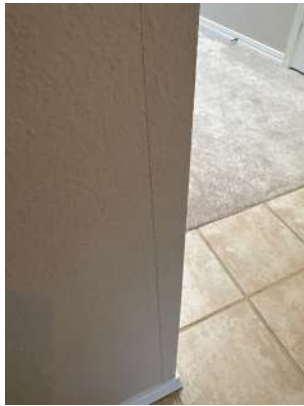
I observed crack(s) at the interior sheet rock walls; appears to have been caused from some minor settlement and or thermal expansion. Cracks should be monitored and if there is any noticeable changes have a professional builder further evaluate. This was noted but not limited to the following areas:
Recommendation: Recommend monitoring.

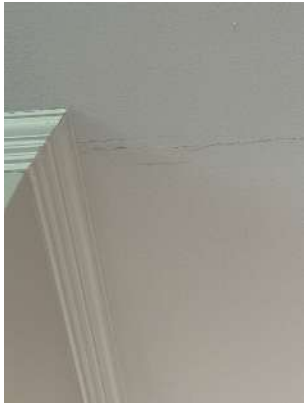
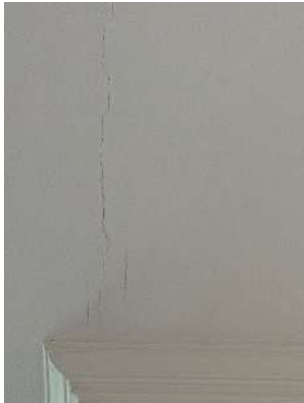
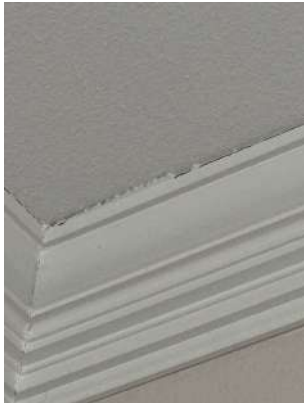
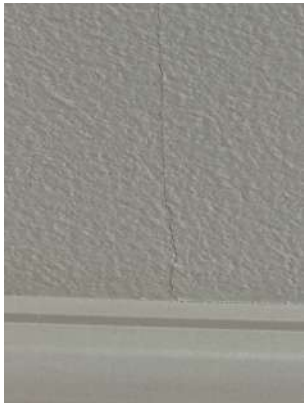
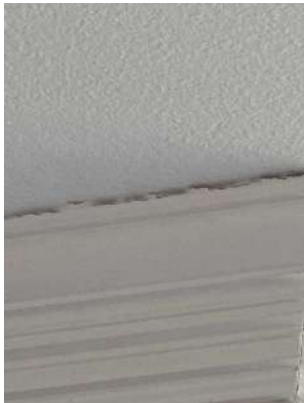
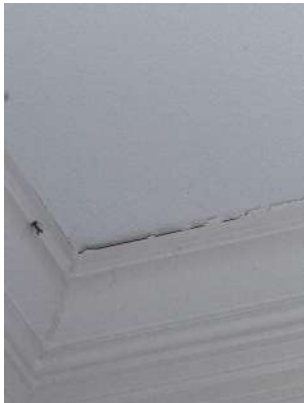
Trim and celing separation noted in various areas. Maybe due to expansion and should be corrected by a qualified professional of a DIY project.

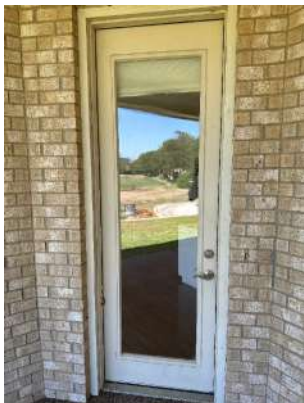
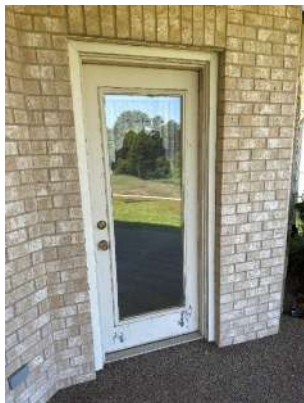
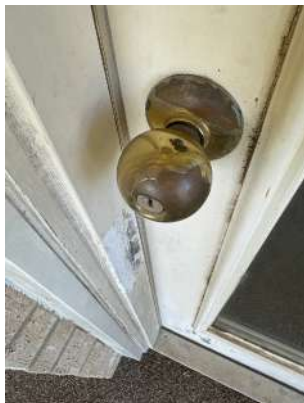
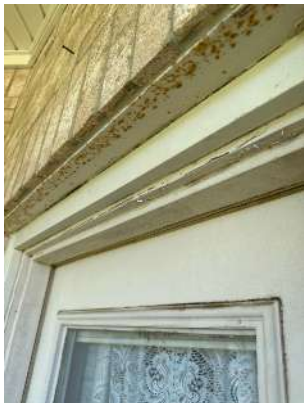
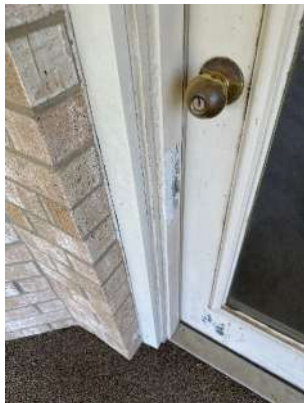
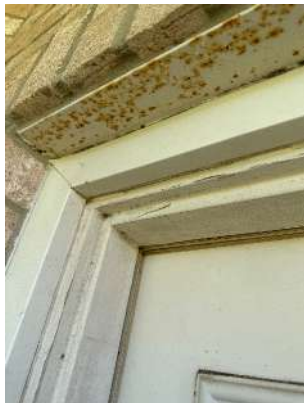
Interior Doors;
Threshold
Glazing
Weather striping
Caulking X
Handles and locks:
Garage home entrance door:
Self Closing Hinges: Yes: or No: X

At the time of construction self closing hinges were not a requirement as a 2012 self closing hinges became a requirement for all garage entry into the home tours This is a safety feature, and should be considered

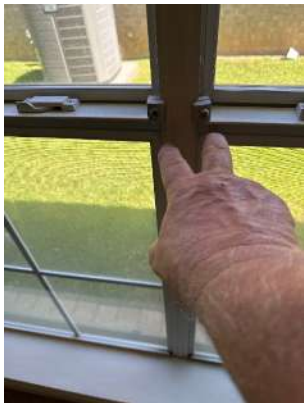
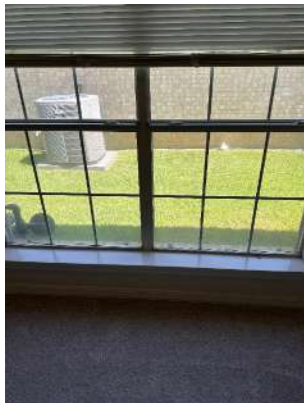
Front windows have broken seal condensation within the windows. Suggest correction by qualified window expert

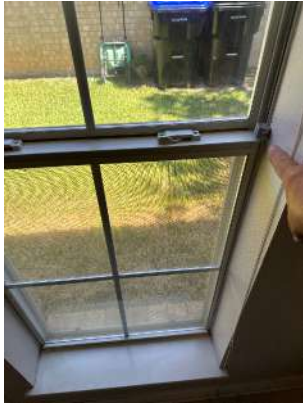
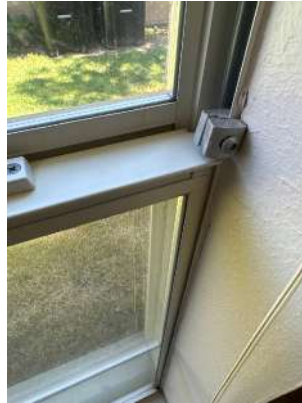
Unable to open windows due to permanent locking mechanism. Possible egress issue.

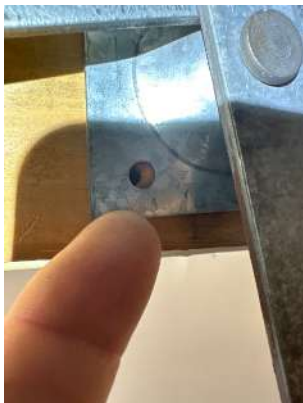
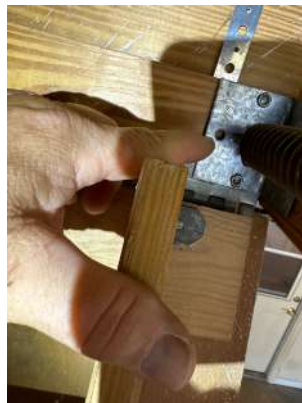
Attic ladder is not installed per manufacturing requirements suggest adding proper fasteners and proper locations

The folding attic stairway in the garage was observed to not be marked/identified fire rated. Garages are consider high fire risk areas. The gypsum board between attached garages and living space serves as fire barrier. When openings are created in the gypsum board for installation items such as folding stairways, fire retardant components rated for this application should be used.

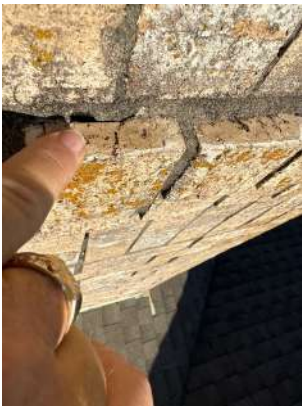
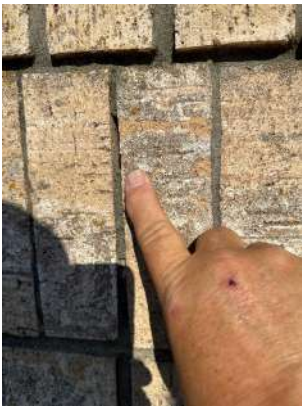
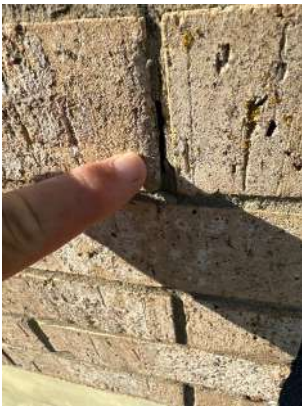
Missing, spark, arrestor on chimney, suggest correction by qualified chimney sweep or roofing contractor. Chimney cap (concrete cap) is deteriorated and allows for water to flood the the attic. Correct must be made prior to rain and snow season. See attic pictures for previous water damage areas around the chimney.

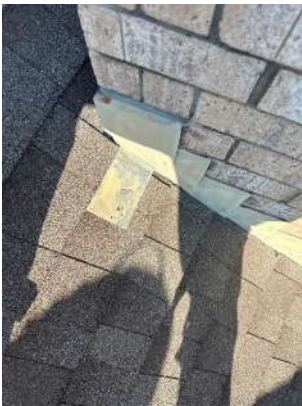
Signs of previous water damage, unable to determine moisture content due to location. Damage is due to deteriorated chimney cap. Suggest immediate repair and replacement to chimney cap.

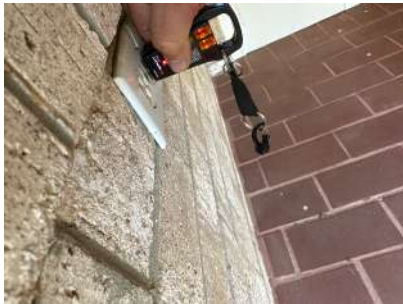
GFCI protection was not present at all the required locations of this home. Recommend licensed electrician correct deficiency.

Recommendation Contact a qualified electrical contractor.

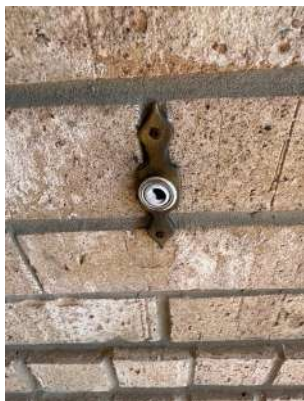
Doorbell button is broken on both doors suggest DIY project or by qualified professional

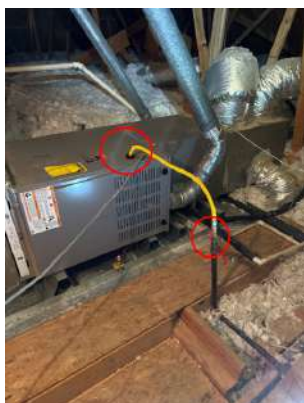
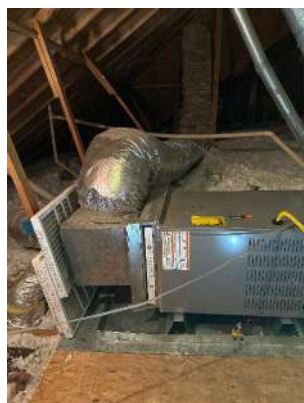
Flex pipe is not allowed to go inside air handler. Straight pipe is required to come out of the unit. Gas pipe is missing a drip leg (sediment trap) after the shut off valve. The sediment trap keeps debris and moisture from going into the unit. Suggest further evaluation and correction from a qualified professional

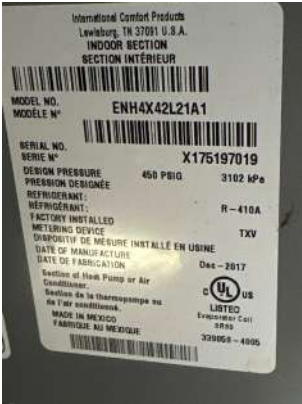
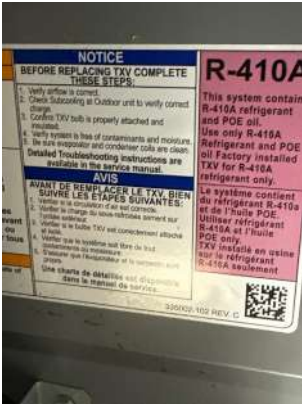
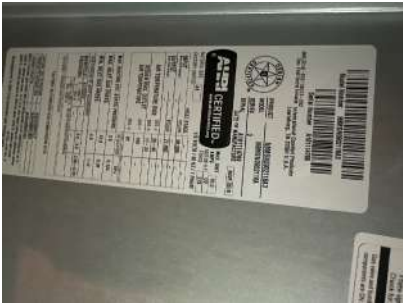
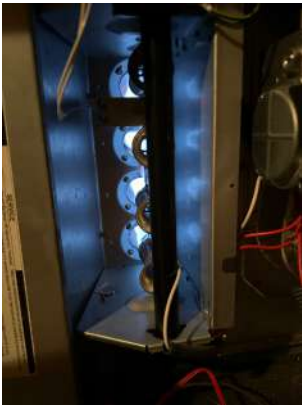
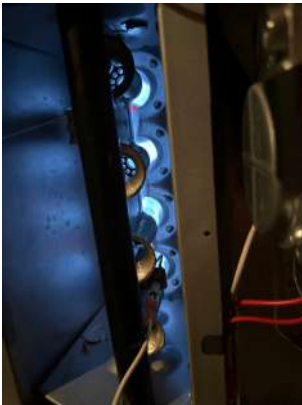
Gas: yes
Drip Leg missing
Electric:
No automatic kill-switch in attic
Filter Size: 20 x 25 x 2

Drip legs or sediment traps (the technical term) are supposed to be installed as close as possible to the inlet of every appliance (as required). The general rule of thumb is any appliance that will fire while unattended (water heater, furnace, pool heater, etc), needs to have one installed. Additionally, every appliance is to have its own manual shut off valve with in six feet of the appliance.

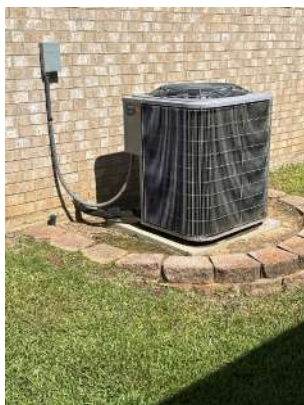
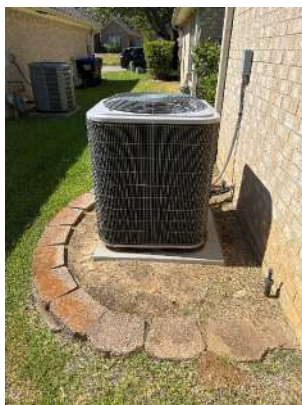
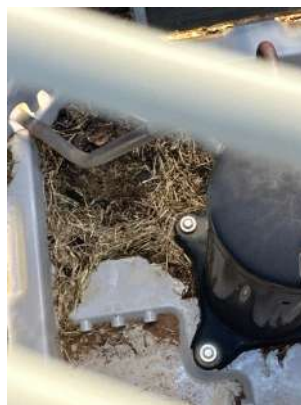
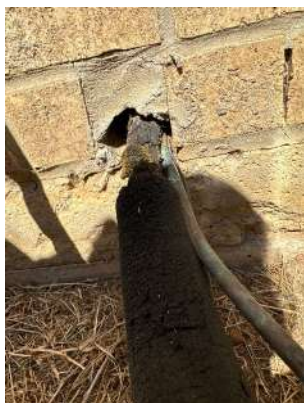
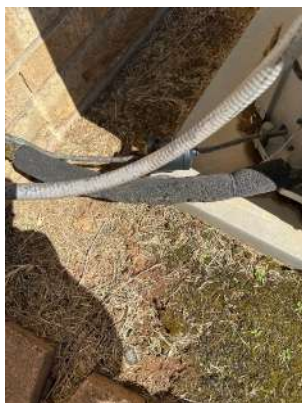
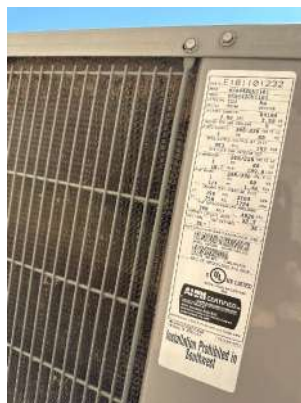
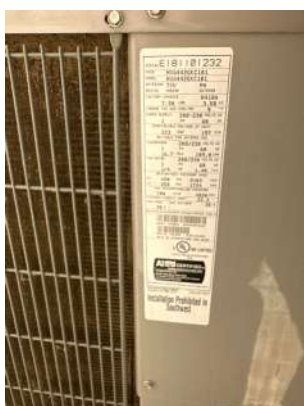
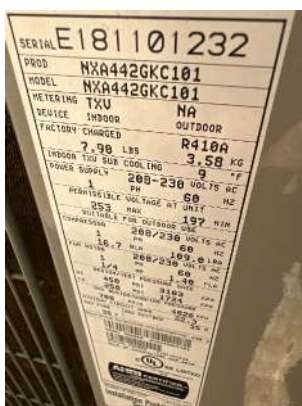
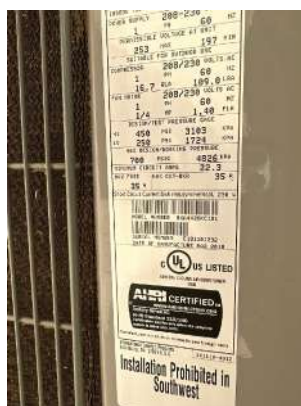
Suggest further inspection, cleaning service prior to closing
3.5 ton
14 seer
2018
Comfort maker.
410 A Coolant type

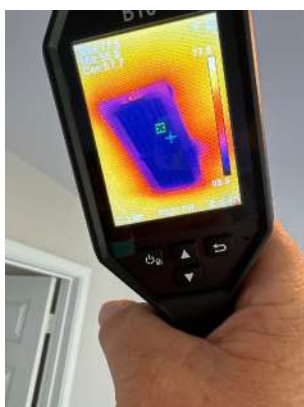
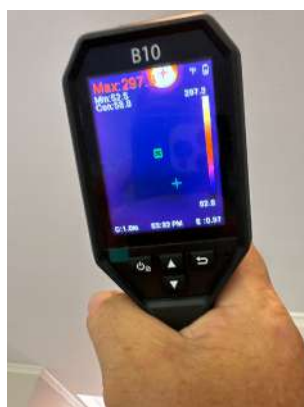
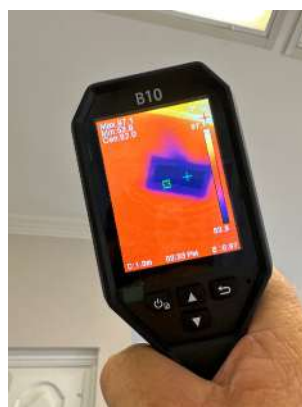
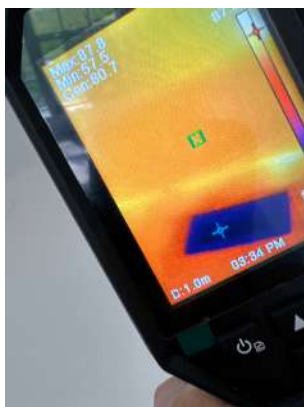
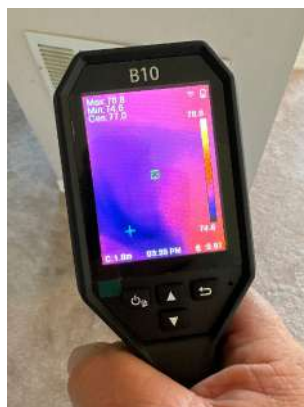
My rating from IR camera is 20. well within the limits.

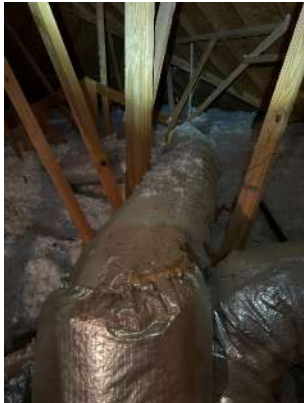
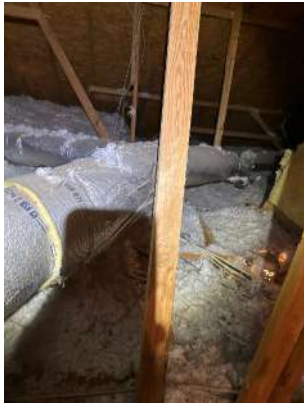
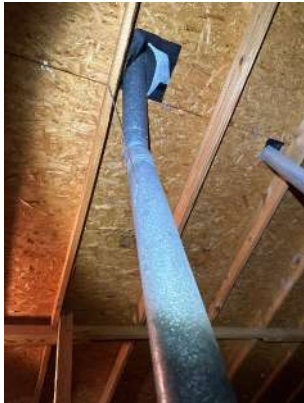
Ducks should be supported and not laying on rafters. Working as intended.

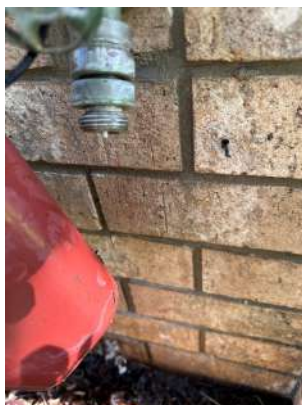
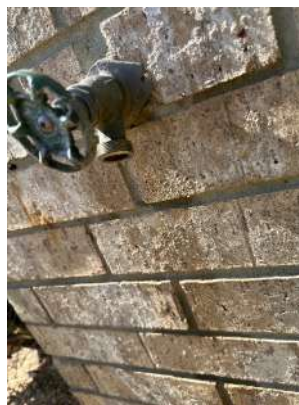
Hose bib at front and side of house leaks suggest correction by qualified professional. Side hose bib is loose and handle is broken. suggest correction by qualified professional.

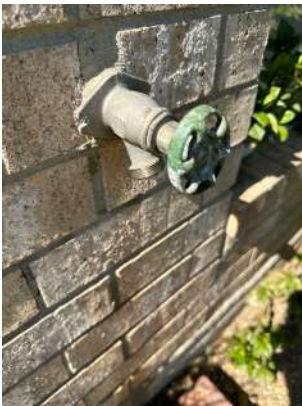
Hose bibs did not have anti-siphon device

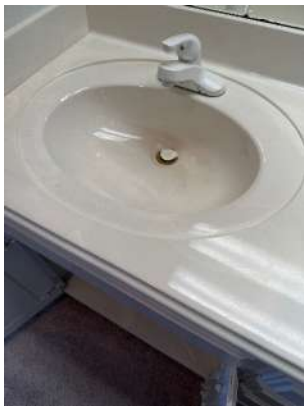
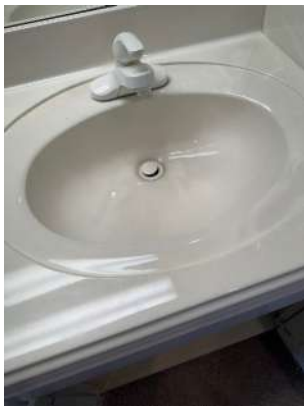
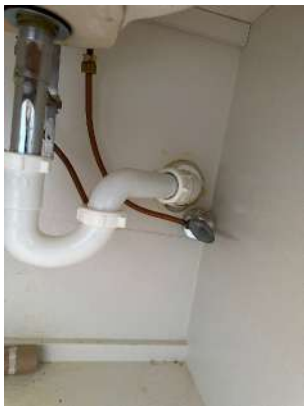
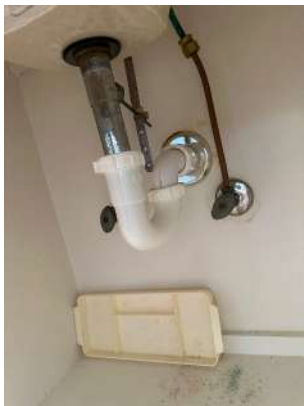
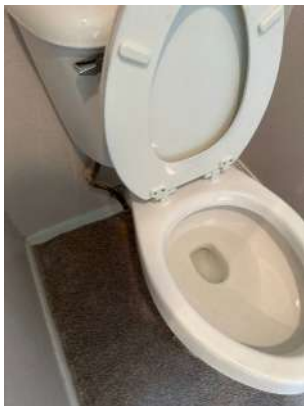
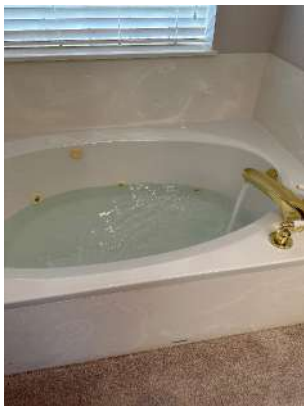
All fixtures working as intended

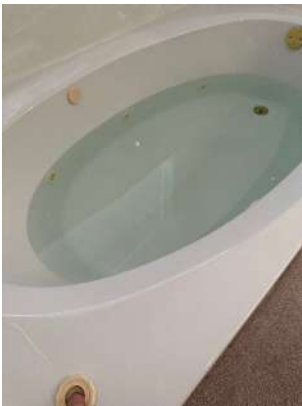
Whirlpool bath: Light switch in closet works the whirlpool bath. Unable to gain access to motor or electrical outlet to check for GFCI or proper bonding on electrical motor

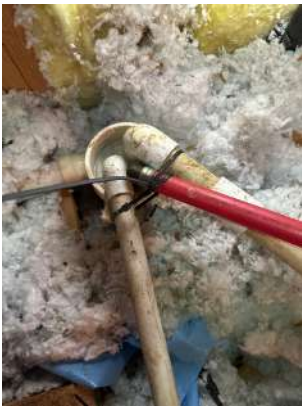
Air handler condensation pipe. TPR valve, and water tank discharge.

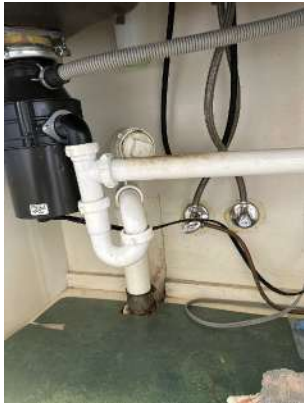
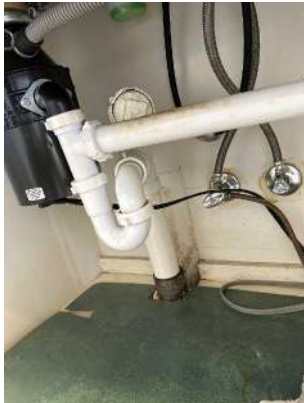
Kitchen drain working as intended

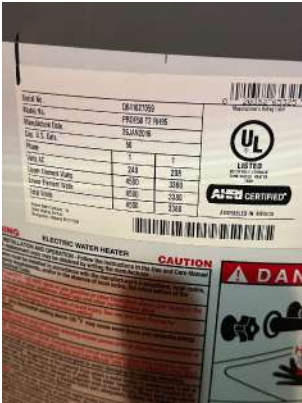
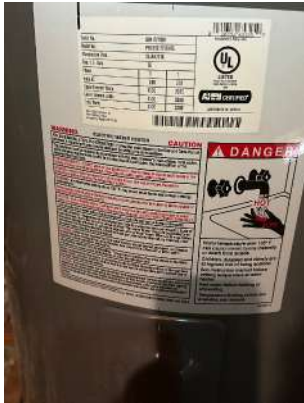
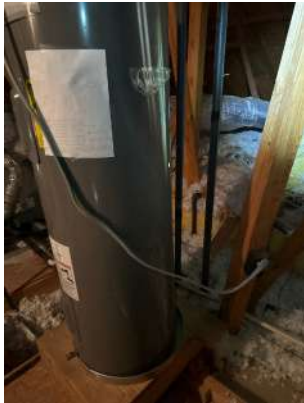
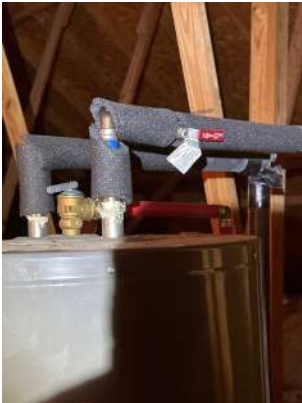
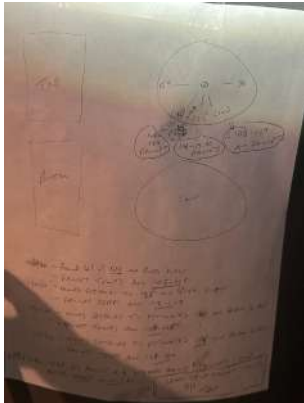
Improper installation of a temperature pressure relief valve can result in serious safety and property damage. Proper positioning is essential to ensure that the valve discharges in an area with adequate gravity flow for the purpose of removing heat buildup from water; otherwise, high pressure may build up within the system and lead to bursting pipes or tanks. Additionally, installation of these valves must meet local plumbing codes and industry standards, such as conforming to the pressure rating on each item as well as making sure piping away from the valve and its associated piping are clear of obstruction. Temperatures should not exceed preset levels. It's important for these components to be installed correctly according to factory specifications. The exit tube is restricted at the joints. In the case of using PEX for a discharge tube the fittings need to be 3/4 in which would require the tubing to be one size larger 1 in. to ensure a 3/4 continious flow. Suggest correction from a qualified plumber.

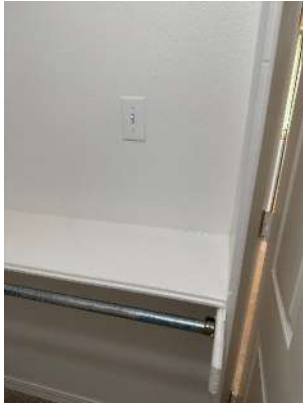
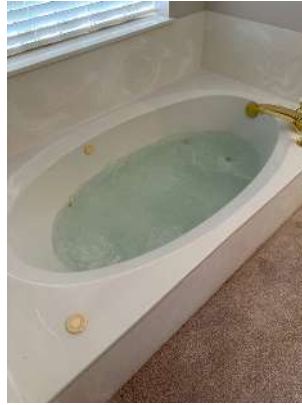
Light switch in bedroom closet operates whirlpool bath. Missing access panel unable to tell if motor is grounded or GFCI protected.

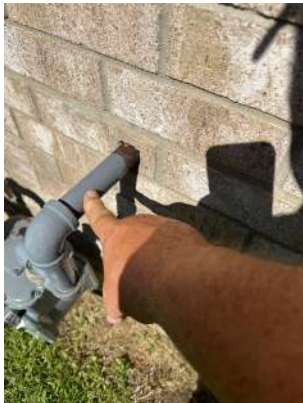
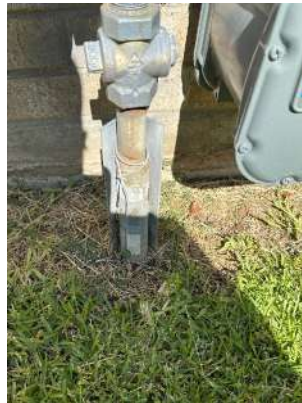
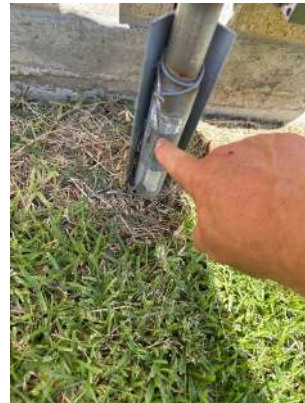
Steel gas line into the house must be bonded. Suggest further evaluation and correction from a licensed professional . Bonding was not required at the time of construction. Per today's standards bonding is required. The smaller wire is a trace wire

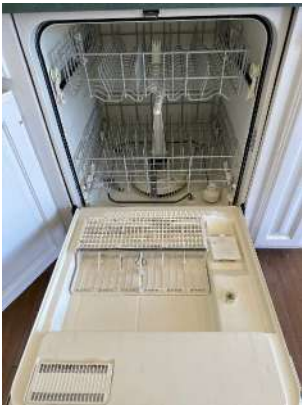
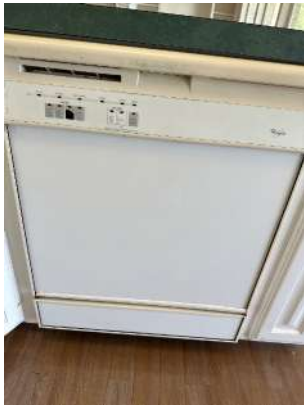
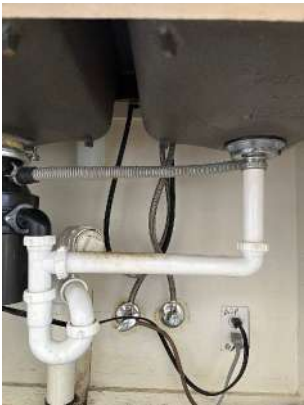
Working as intended

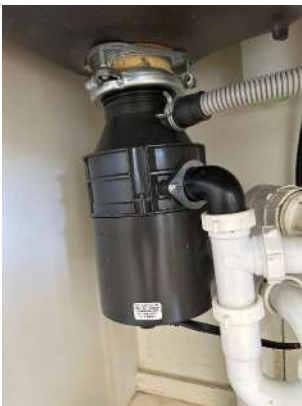
Working as intended on the day of inspection

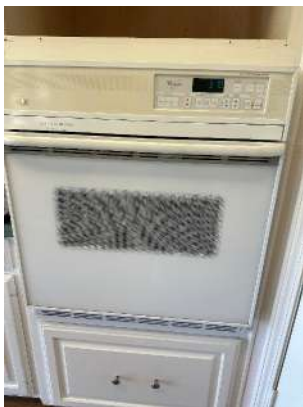
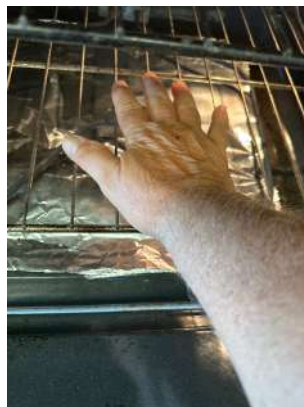
Appears to be working as intended

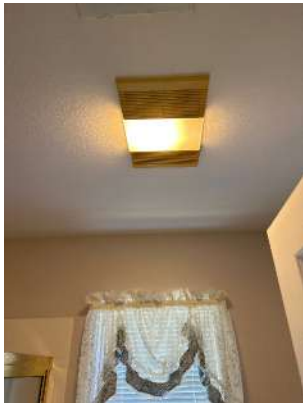
Bathrooms have heater exhaust fans all is one working as intended

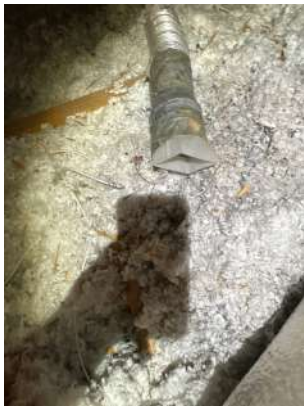
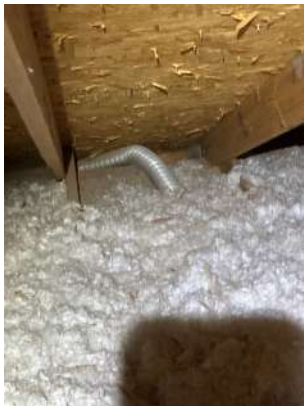
Yearly maintenance/cleaning of dryer vents are needed to keep lint from buildup and dryer efficiency. Dryer fires are one of the main reasons for house fires in the US.
Flexible dryer vent is abandoned. New vent is installed properly.
