LEAD-BASED PAINT SURVEY AND ASSESSMENT

FT. MYERS, FLORIDA - GENERAL MAIL FACILITY

November 1995

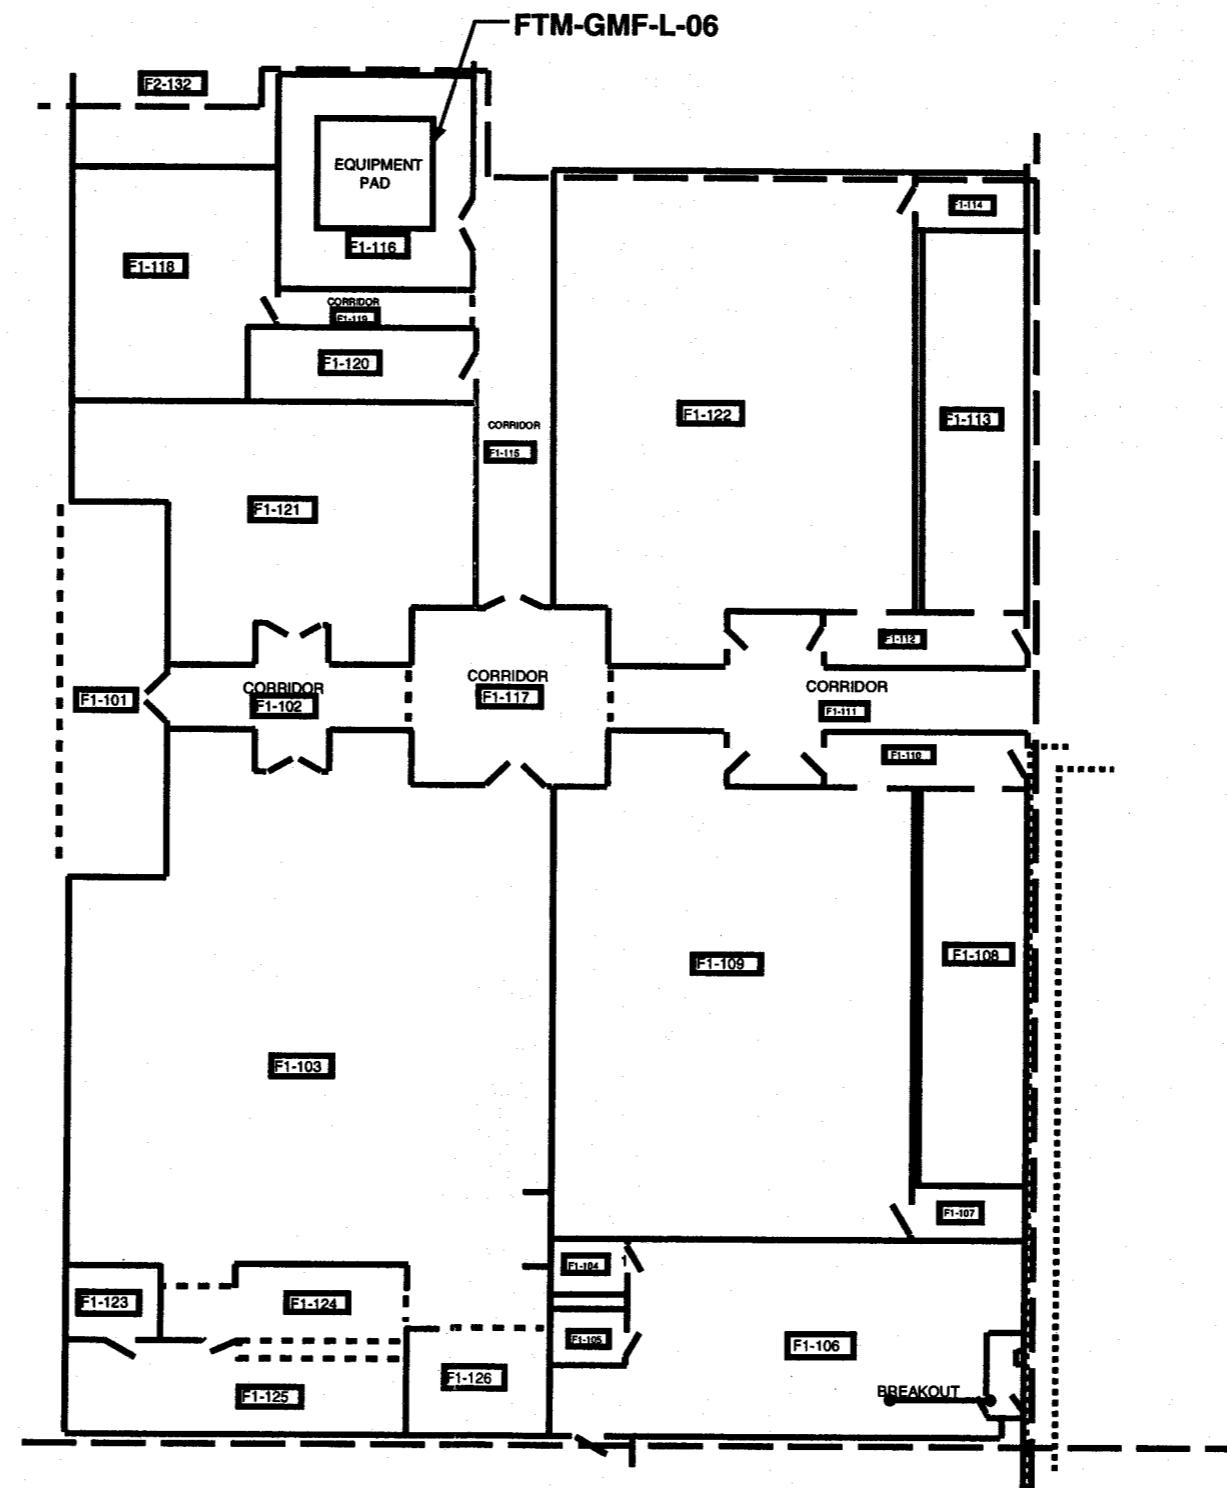
Figure 1b
LOCATIONS OF LBP SAMPLES
Ft. Myers, Florida General Mail Facility
113077-G11
United States Postal Service
Contract No. 475450-94-B-0322
Work Order No. 134.00
LBP Survey and Assessment
November 1995

FTM-GMF-L-06
Bulk Paint Sample Location
