Hernando de Soto

EMERGENCY RESPONSE

I-40 Hernando de Soto Emergency Repair

Critical Actions for a Critical Find

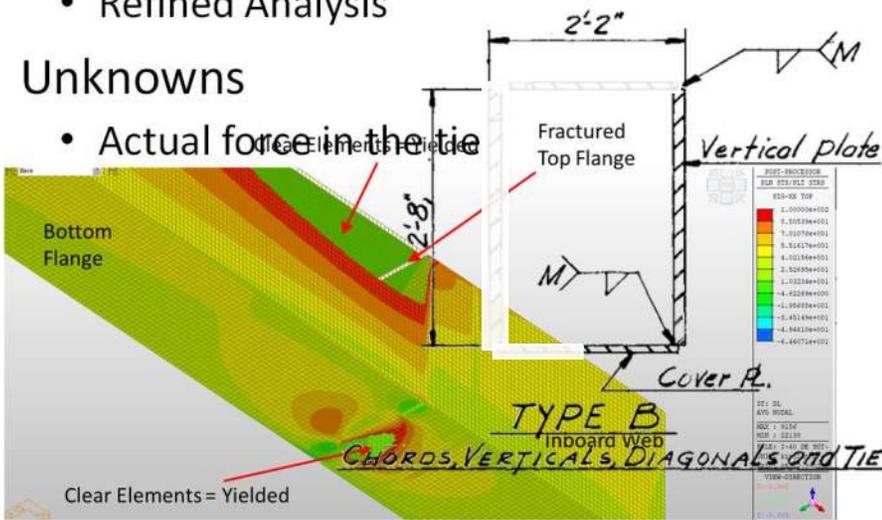
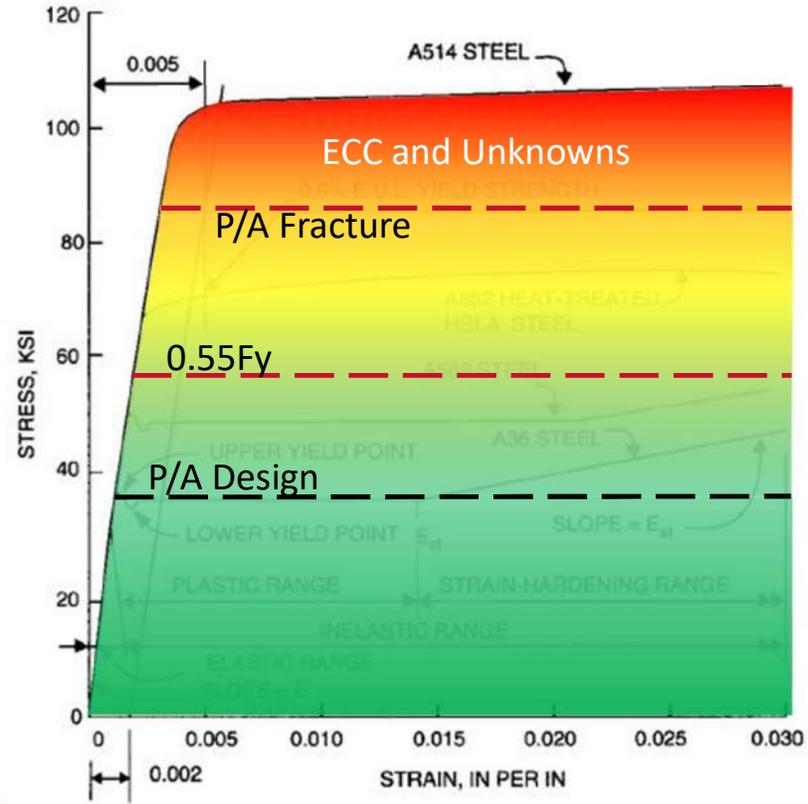
How Bad is it?

- T1 steel = 100 ksi (+)
 - P/A design = 38ksi
- Fracture 113 in² -> 51.5in² (**45%!**)
 - P/A after Fracture = 83ksi
- Eccentric Loading
 - Refined Analysis
- Unknowns
 - Actual force in the tie

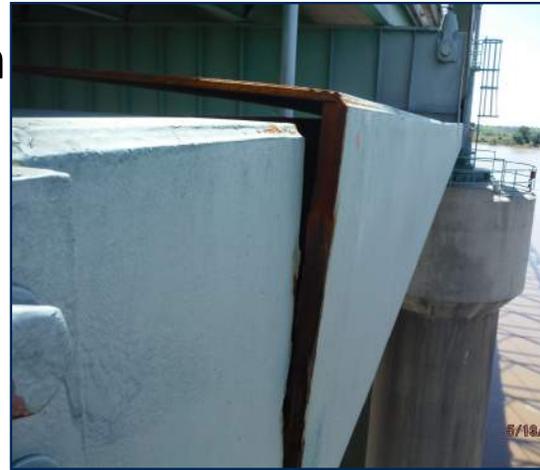
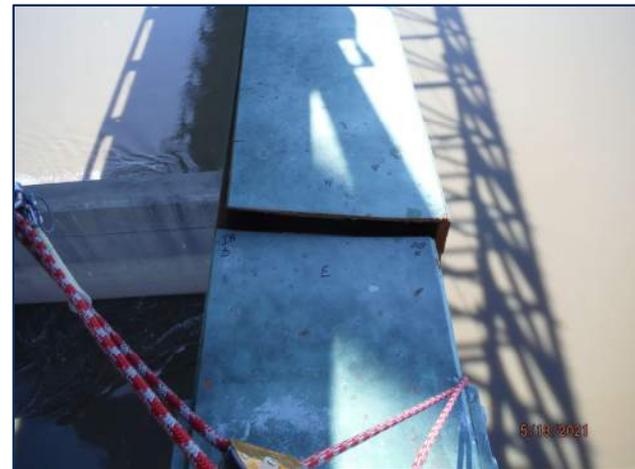
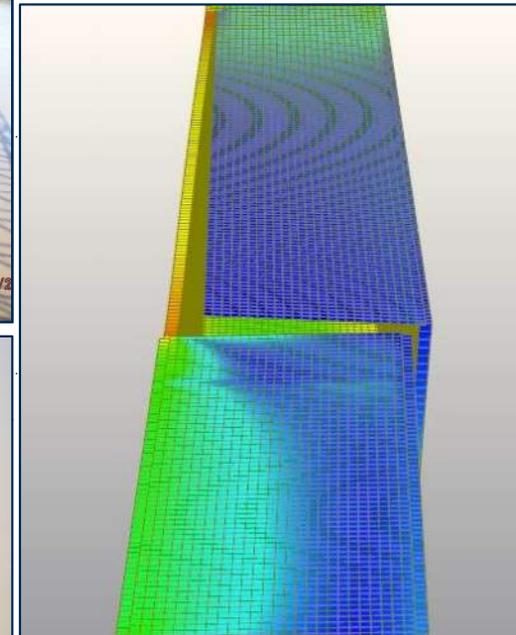
Stability and Localized Yielding

- Yielding extent on remaining section
 - Over 50% of the section was lost
 - Is there any capacity left from the remaining area of the section?
- Retrofit operations
 - Overstress the tie
 - Effect of unbalanced PT forces
 - Effect of removals
- Non-linear Analysis
 - Geometric
 - Material
 - Incremental

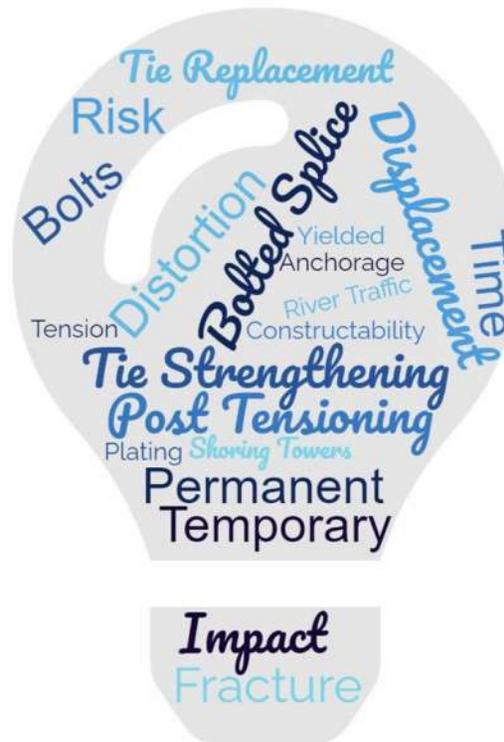
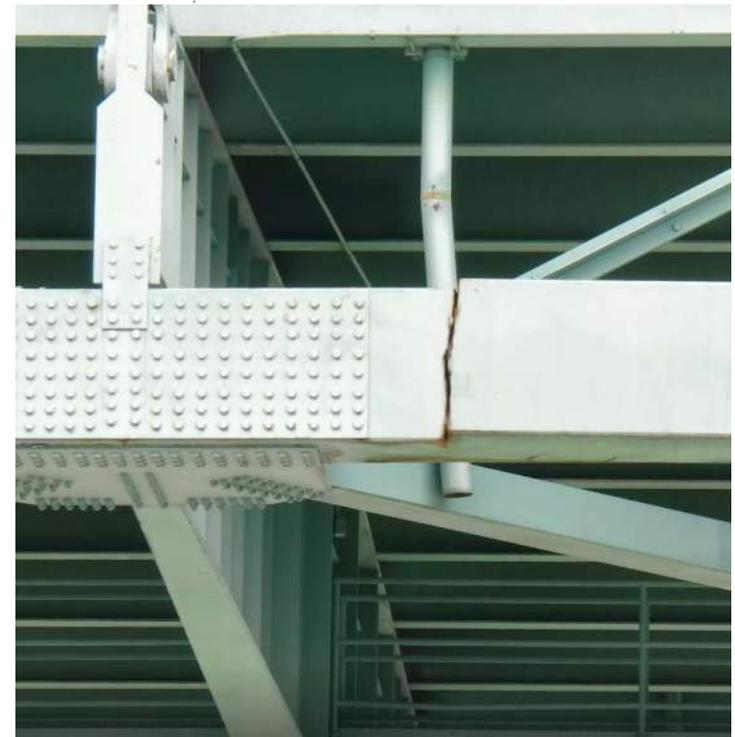
Phase 1: Stabilize the Structure

- Tie w/ 4,300 kips +/-
- Displaced laterally and rotated
- Limited reserve capacity

- **Time is of the Essence**

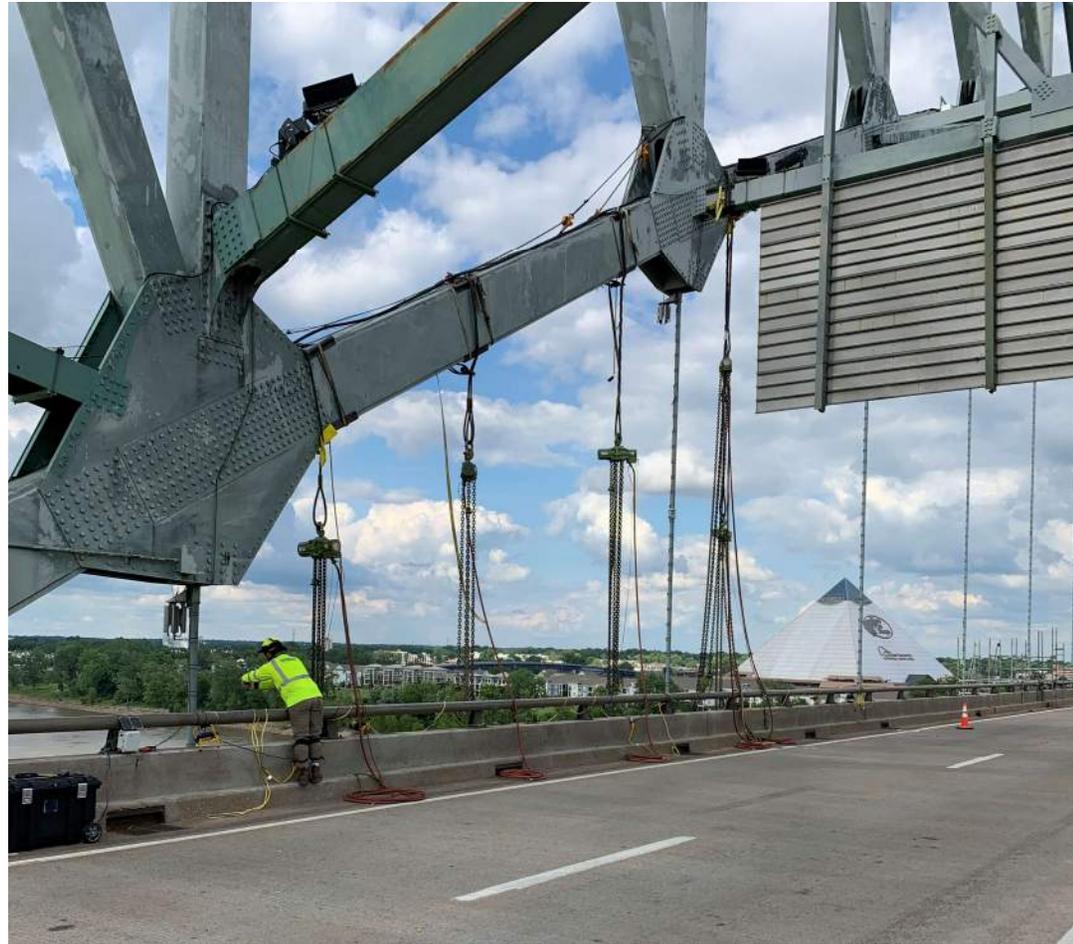
Construction

- Trucks came from west end of the bridge
- Used chain fall to move plates on Span 2 and into place
- No work barges or river access was used during the duration of the project
- Installation completed 5/25

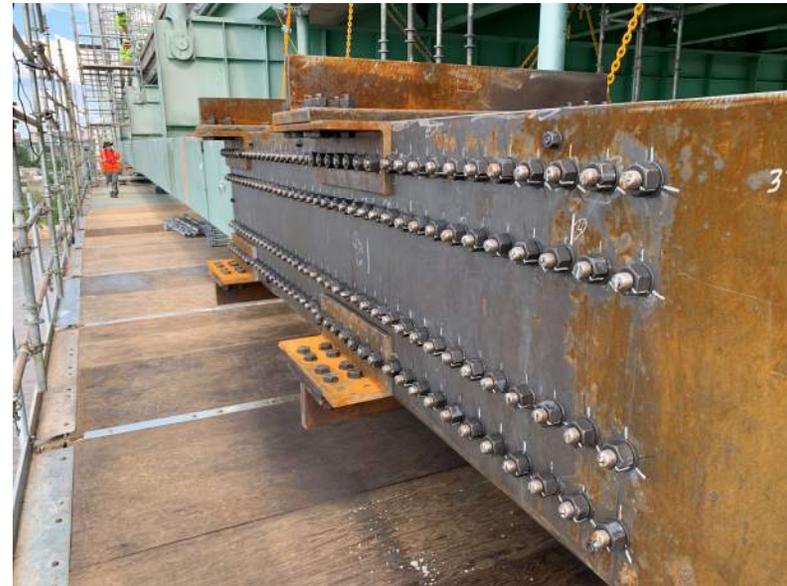
Stiffening Brackets

- Outboard PL placed w/ 3" of fill plates
- Cut floorbeam web for inboard plate
- Anchored beyond the girder twist
- Stiffening T's added to account for Eccentric connection moment
 - Eccentric connections highly loaded would try to crush box
 - Thin cover plates attached with poor welds

Offset Plate to clear Fracture and Ex Splice.

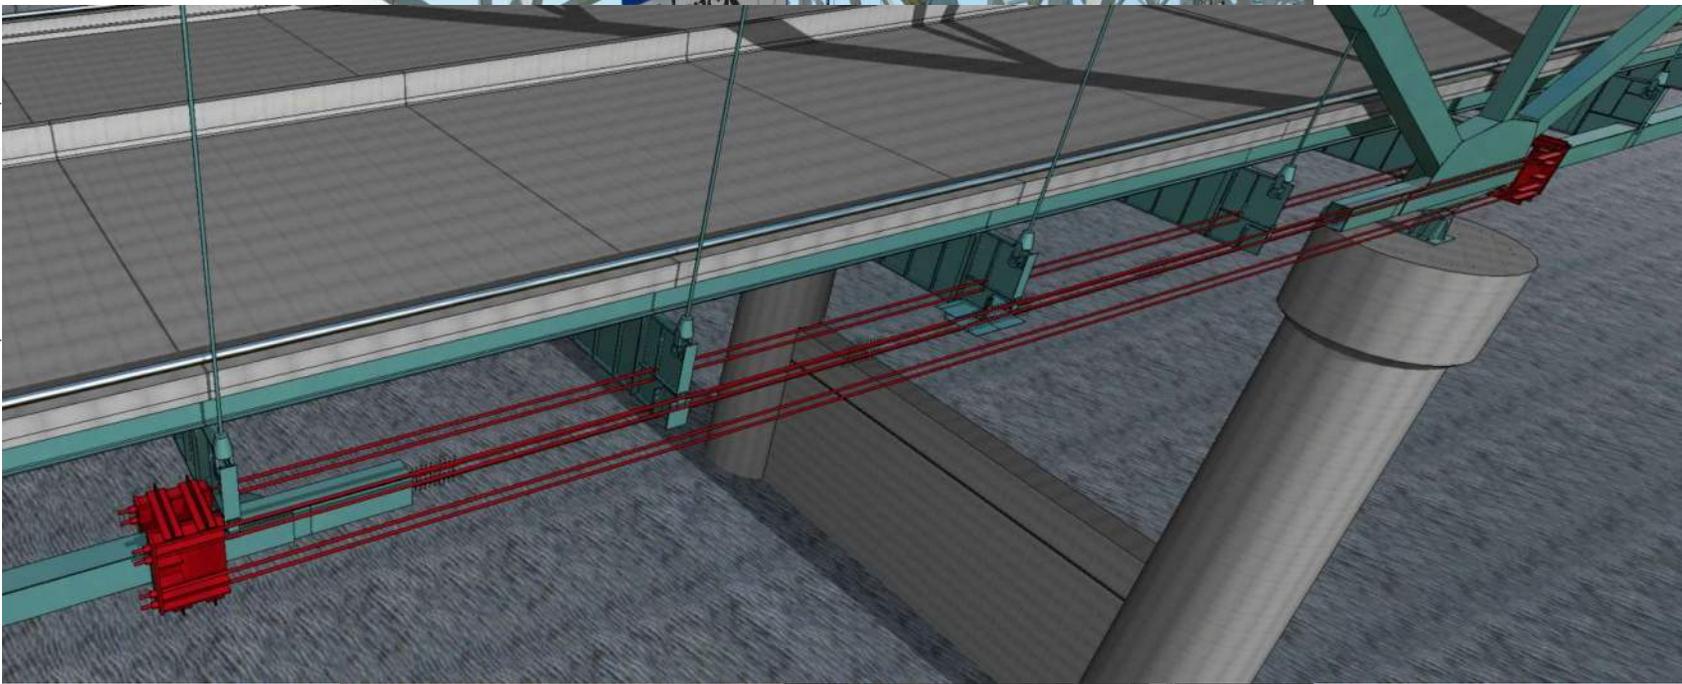
Tie Girder Complete Replacement

- Initial direction: completely remove the old/fractured tie
- End Result: Cut out Fracture and Plate back to connections

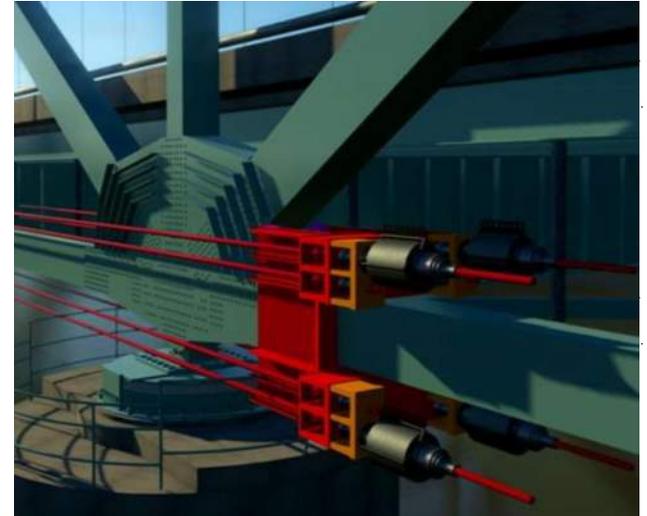
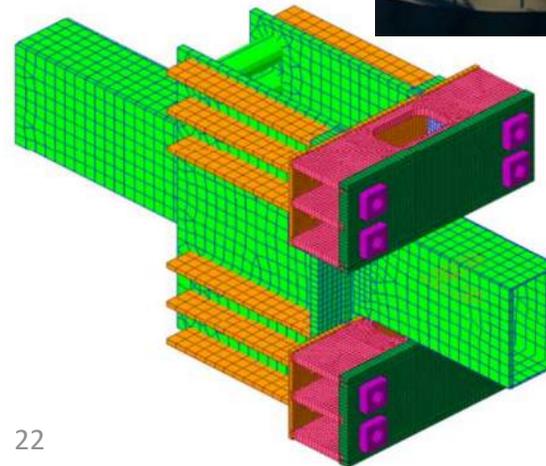
Post-Tensioning System Design

- 8 - Cold-rolled 150 ksi 3" diameter PT bars
- Allowance for fitment/eccentric loads
- Staged PT
- Monitoring Plan including direct force measurement

- Design by hand computations
- Checked/Verified with FE analysis

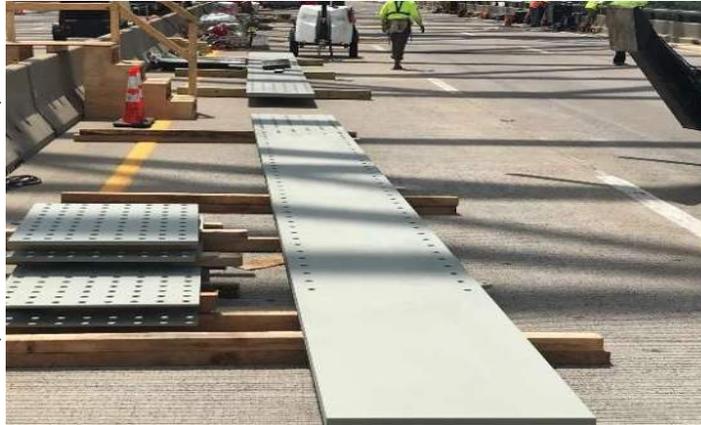
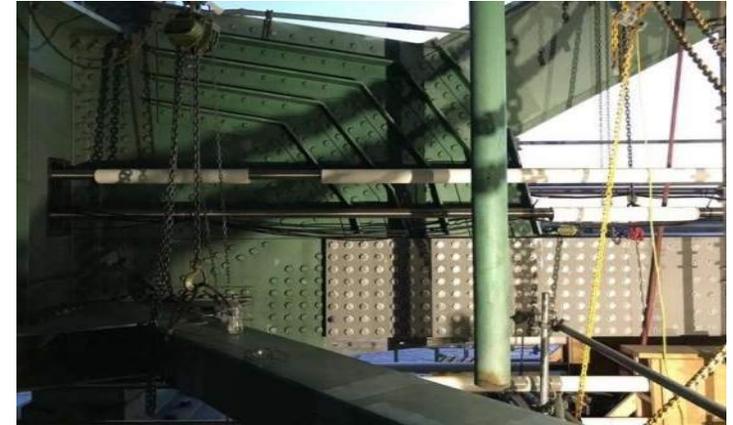
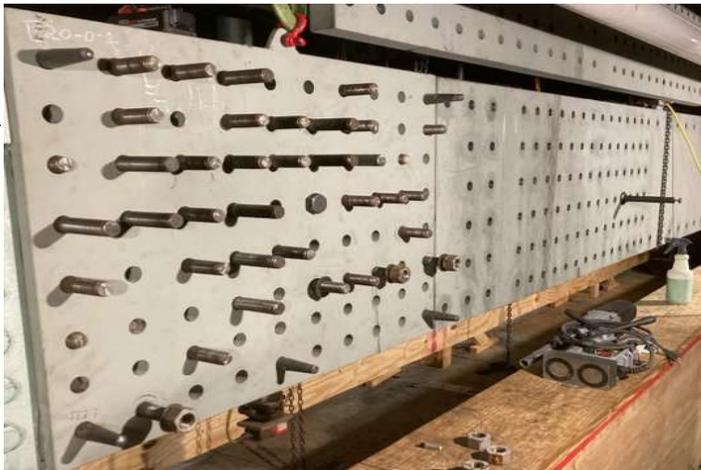
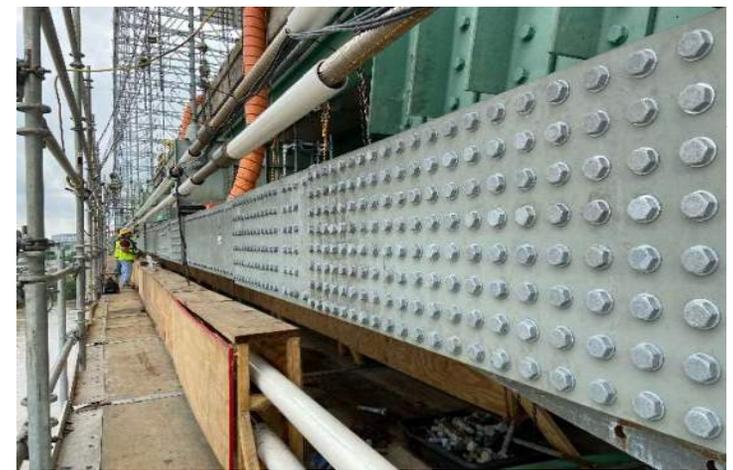
Phase 2 Plating

- Plating fabrication by W&W /AFCO in Little Rock, Arkansas
- 70 ksi material with A325 bolts
- Partial submittals / approvals for speed of fabrication
- Last Plate installed and torqued on Saturday, July 2nd

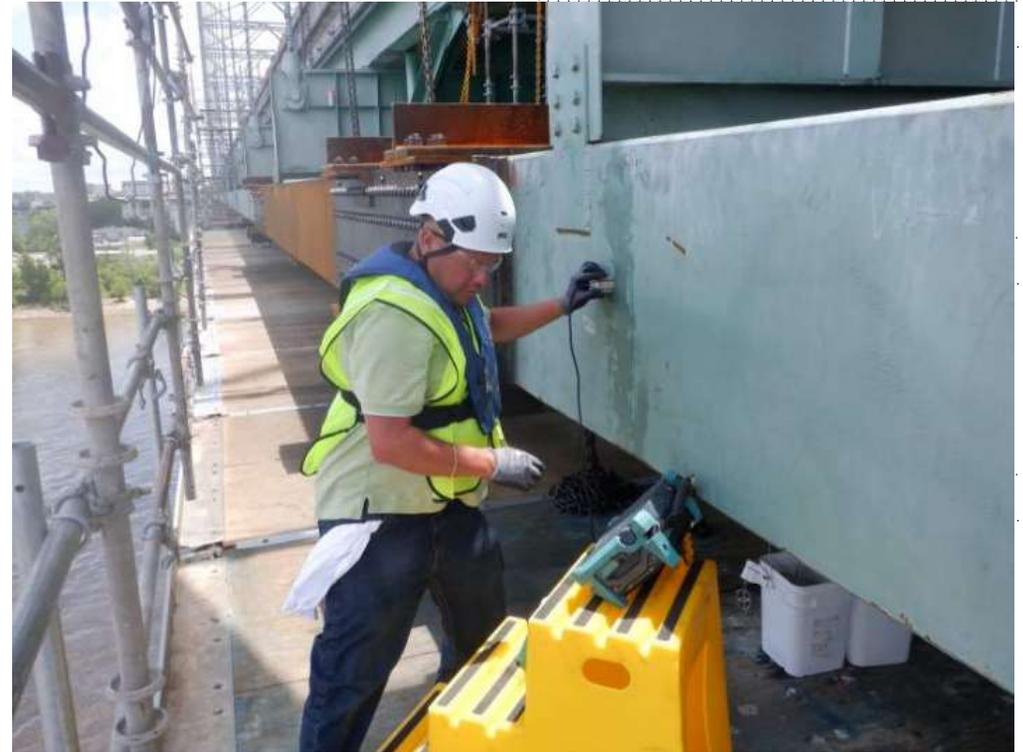
NDT Inspection of Arch Tie Member

- Full Penetration Butt Weld detail typical throughout structure
 - Potential for similar defects
 - Mitigate any potential concerns
- Arch Tie Members and Hanger Pins (Approx. 500 welds)
 - HNTB with CAN-USA (NDT)
- Arch Truss Members
 - MBI with Fickett (NDT)
