Historic Building Assessment for the Littleton Community Center Annex

120 Main Street, Littleton, New Hampshire

January 2020

Historic Building Assessment Report Funded in part by a grant from the
New Hampshire Land & Community Heritage Investment Program (LCHIP)

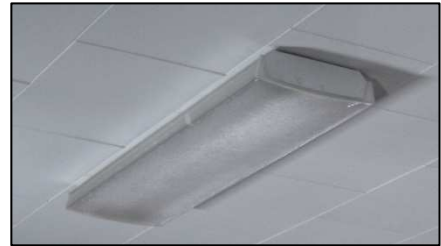
The light fixtures throughout the building are energy inefficient, of poor quality, and in poor condition. An attempt has been made to upgrade many of the Teen Town-era incandescent fixtures by installing compact fluorescent bulbs as a stop-gap measure. In rooms such as the main hall, earlier fixtures were replaced by modern florescent fixtures. Exit doors both inside and outside the building are not fully illuminated.

Figure III-7: Non-historic fluorescent ceiling fixture in main hall

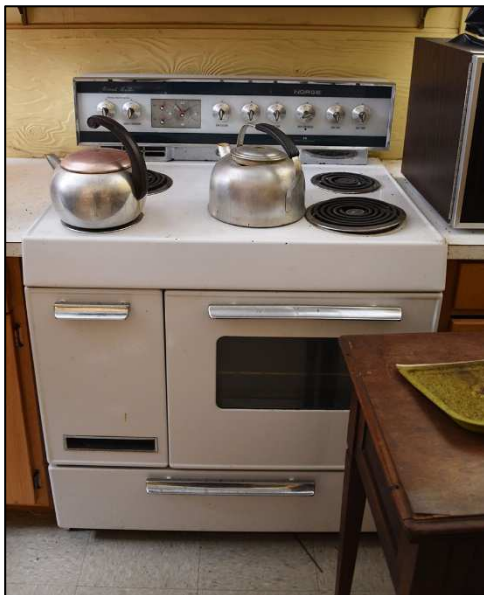
Figure III-8: 1960s stove

Within the existing kitchen area, the list of appliances includes an electric stove from the 1960s (Figure III-8) and a separate microwave oven from the 1980s. The electric stove has not been used for many years and there is ample evidence of rodent activity in the building. Because of this, the wiring may have been compromised, and should be inspected prior to any use. Though no thorough inspection was made, the gaskets around the oven are also likely to be dried out, contributing to high energy use.
