**Report ID:** 12907082100980  
**Report Date:** 7/9/2021  
**Client or Representative:** Gray Home Inspections  
**Location Address:** 8507 Billet Pl Oak Ridge, NC 27310  
**Sample Collected by:** Collected and delivered by independent home inspector  
**Sample Analysis by:** JED, GAP  
**Sample Results:**

# Sample Inspection Report Summary

**Gray Home Inspections, LLC**

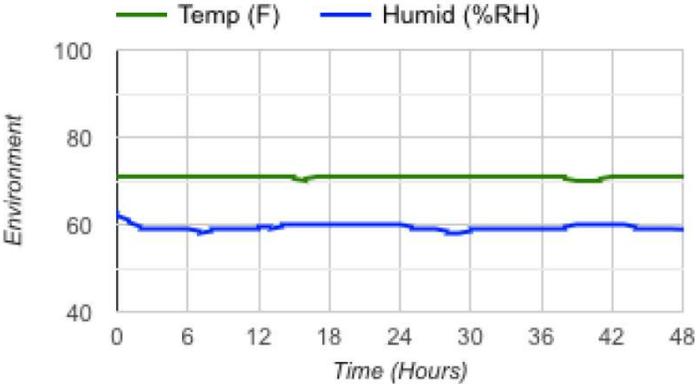
**AVERAGE RADON CONCENTRATION: 0.2 pCi/L**  
**EPA RADON CONCENTRATION: 0.2 pCi/L**

Below EPA Recommended Level of 4.0 pCi/L

Environmental Conditions    **AVG Temperature: 70.9F**    **AVG Humidity: 59.4%RH**
