January 2023

Nave Ceiling Plaster Condition Assessment Saint Ninian Cathedral Antigonish, Nova Scotia

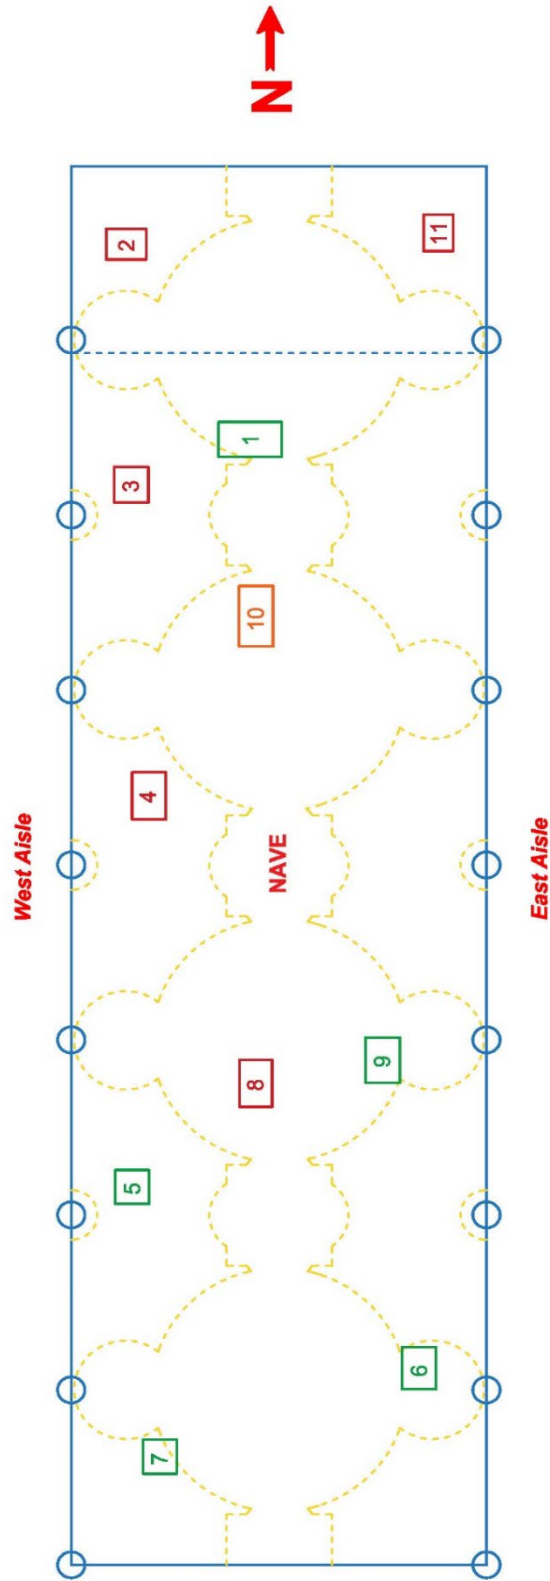
Figure 7: Plan view from attic showing approximate location of tests.

8. The plaster is badly compromised. Some staining from past moisture visible. No sign of past intervention.
9. Very minimal key loss. Lugs are poorly formed, and high percentage are non-viable (>20%). No sign of past moisture or interventions.

10. Moderate key loss. Some staining from past moisture. No obvious sign of past interventions.
11. The plaster has almost no support keys remaining. The plaster is pulling away from the lath by as much as ten millimetres. There are stains and discolouration on the plaster from past exposure to water. **This area poses a potential safety risk.** See Figure 11

A plan and schedule for stabilizing the nave ceiling plaster should be developed as a high priority. Half of the plaster we uncovered and tested is in poor or very poor condition. Although we only tested about 3% of the ceiling area, we believe these findings are representative of the remainder of the ceiling.

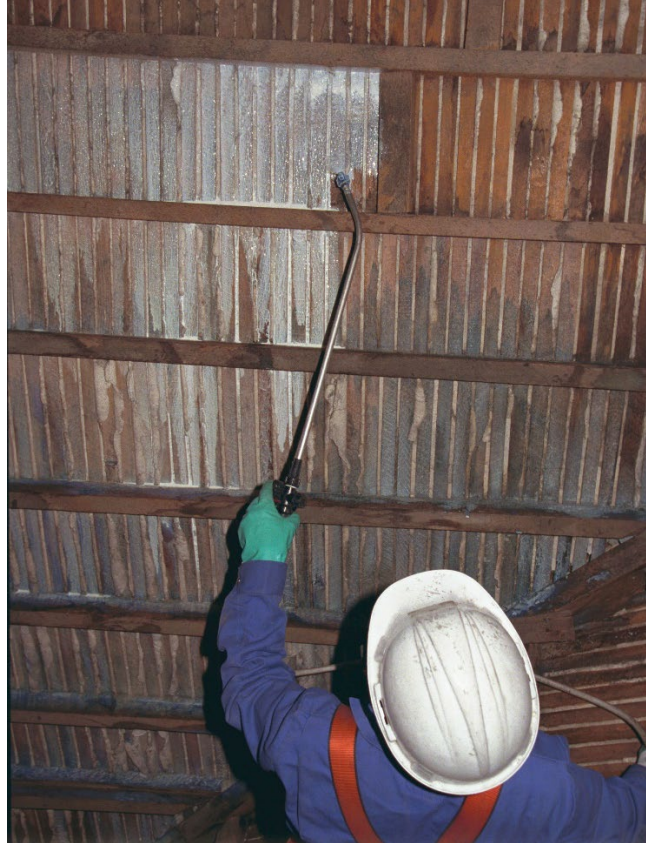
Figure 14: Initial application of consolidation agent. (Notre Dame Cathedral, Ottawa)

The consolidation process converts the plaster from a suspended system to an adhered system with the plaster strengthened and bonded to the lath with a flexible adhesive. Flexibility is important to maintain the plaster system’s inherent ability to absorb some building micro-movement. In this case the application would be from above since there is ready access to the back of the plaster in the attic. The back of the ceiling is cleaned, and all broken lugs and keys are removed by hand in the exact manner as in the testing procedure. The low-viscosity consolidation agents are spray-applied to the back surface of the ceiling and are readily adsorbed by the plaster and thoroughly coat the laths. All missing lugs and keys are then ‘re-built’ with a thickened and filled variant of the consolidation agent. The lug and key replacement material coalesces to new, light-weight acrylic lugs and keys that bond perfectly to the consolidated plaster.

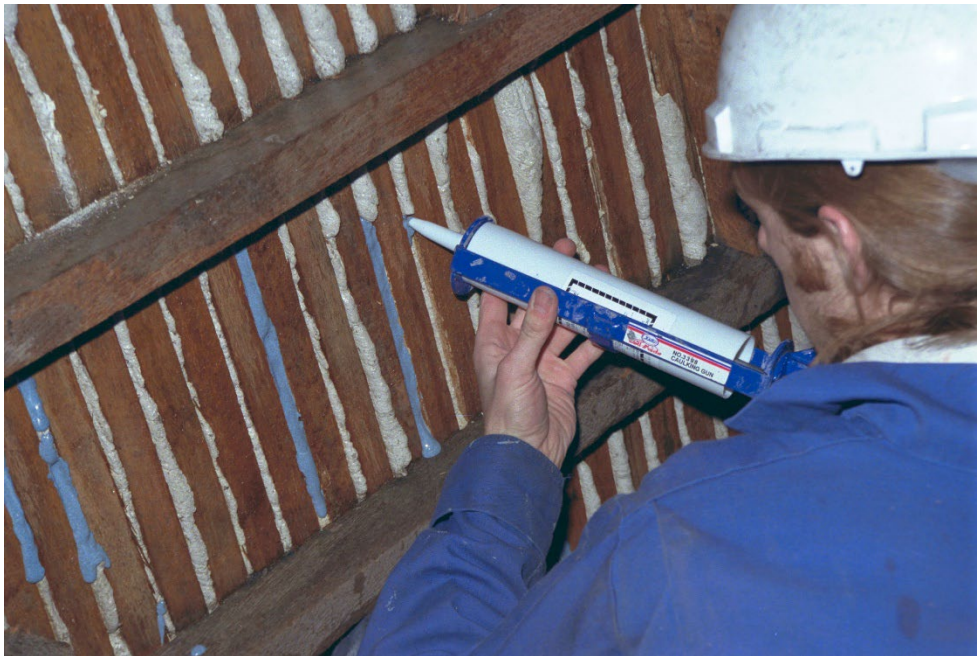
Figure 15: Missing lugs and keys are replaced with a lightweight, thickened variant of the consolidation agent.
