Oilheating

February 2003

Causes of soot damage to residential structures

By John Certuse P.E.

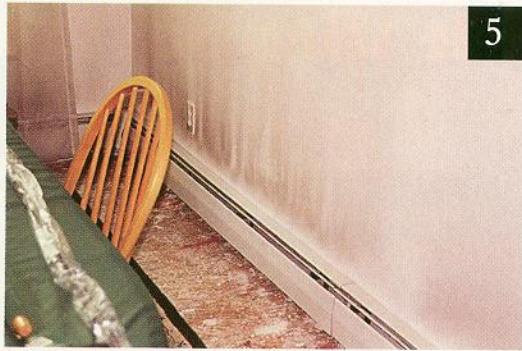
This damage can be present in heavier concentrations or even light and subtle concentrations known as "Ghosting Soot". Many times these Ghosting Soot deposits are seen above baseboard heating elements, [See photos 5 and 6] or are found coating plastic objects (food storage containers, children's toys). In some cases, they outline where the studs behind wall sheet rock are located.
