# Property Inspection Report

**123 Elm Street, Houston, TX 12345**  
**Inspection prepared for: John Smith**  
**Date of Inspection: 7/27/2022 Time: 10am**  
**Age of Home: 2022 Size: 4,098 Sqft.**  
**Weather: Partly Cloudy**

**PROPERTY INSPECTION REPORT FORM**

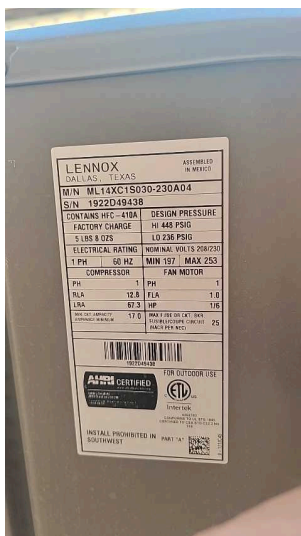
This is a Lennox AC condensing unit and it was manufactured in June of 2022.

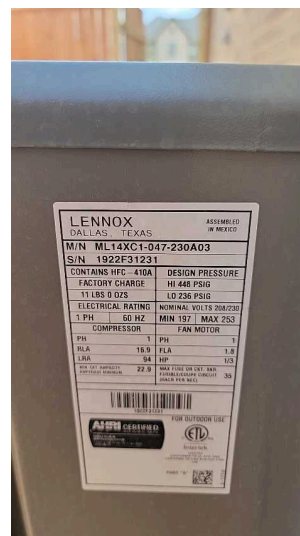
This is a Lennox AC condensing unit and it was manufactured in June of 2022.

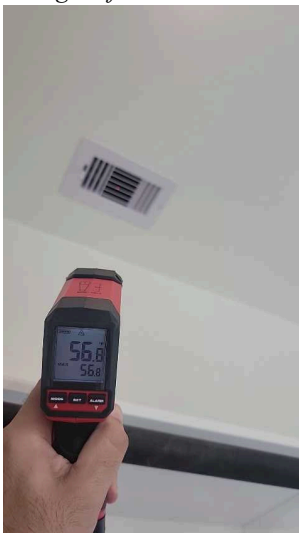
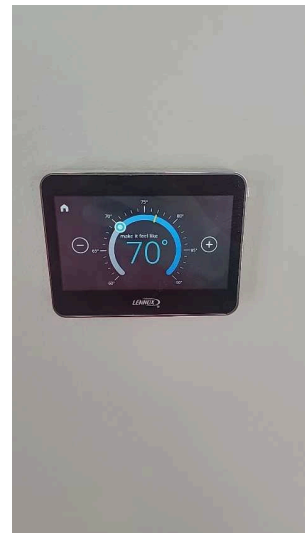
*I observed there is an insufficient temperature difference at some registers when ducts were in use. It is recommended that an HVAC technician further evaluate the system as needed. When testing the system you should have a 15 to 20 degree temperature difference between the return grille and the supply register. This was noted in the upstairs front right bedroom closet to the right of the staircase.*

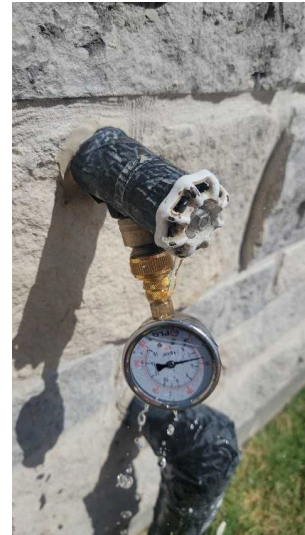
*I observed a leak at an exterior plumbing fixture when in use. This was noted at the gate valve hose bibb on the side of the house near the garage.*

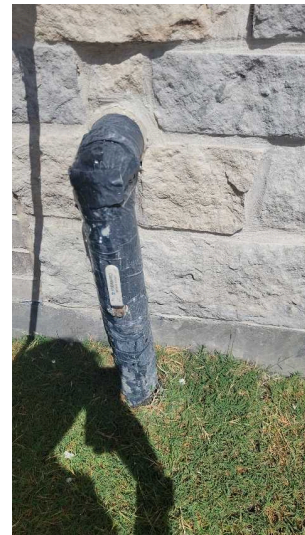
*I observed a leak at an exterior plumbing fixture when in use. This was noted at the hose bibb in the backyard.*

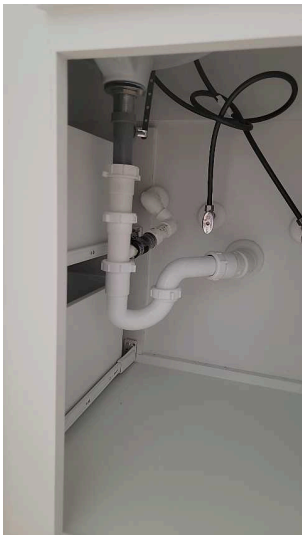
*CLIENT INFORMATION: This is a picture of the AC primary condensate drain line that discharges into the plumbing drain line under the sink. This was noted in the front downstairs bathroom in the secondary bedroom.*

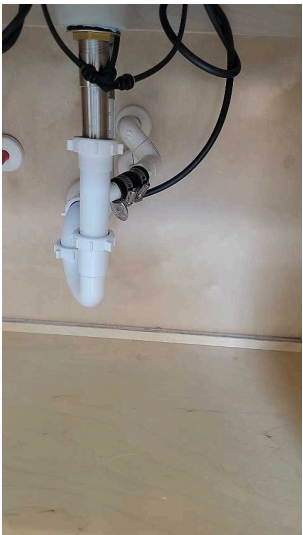
*CLIENT INFORMATION: This is a picture of the AC primary condensate drain line that discharges into the plumbing drain line under the sink. This was noted under the left sink in the master bathroom.*
