Yaesu G-5500 Rotator Controller Repair

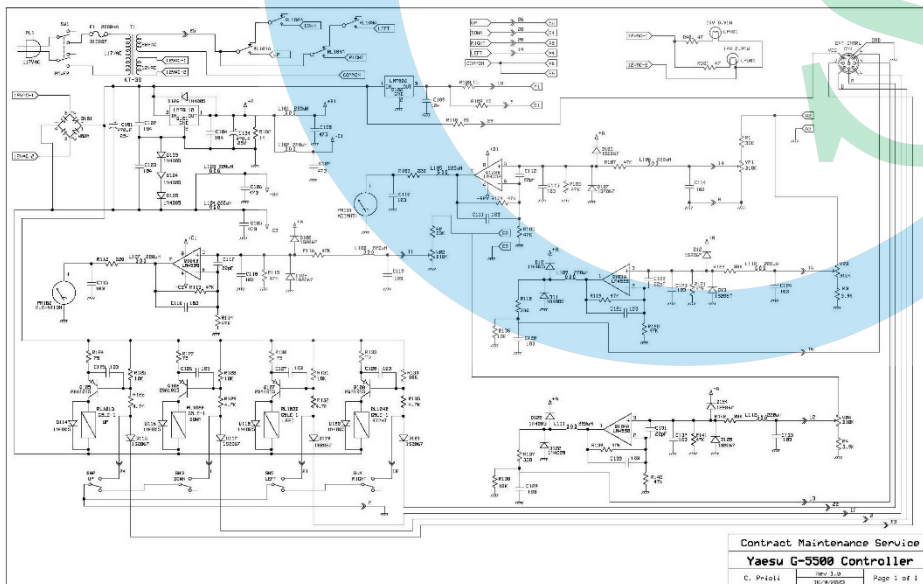
Figure 2 - G-5500 controller schematic diagram

Once again, the controller blew its fuse immediately. This showed conclusively that the problem was internal to the controller. I brought the controller to my shop for further investigation.

One of the things that Frank and I had done was that we had taken a preliminary resistance measurement of the power transformer primary winding to see if we had a direct short circuit there, which we did not, though the resistance was very low at 0.8Ω. Not having any resistance specifications for the transformer windings, I did not want to condemn the transformer... yet... though we both suspected that the resistance reading obtained was too low. What I did instead was to disconnect the transformer secondary windings from their tie points into the controller circuitry, and then to try some substitution therapy. A quick look at the schematic (Figure 2) shows that the transformer has two secondary windings, with outputs of 12VAC and 26VAC respectively.

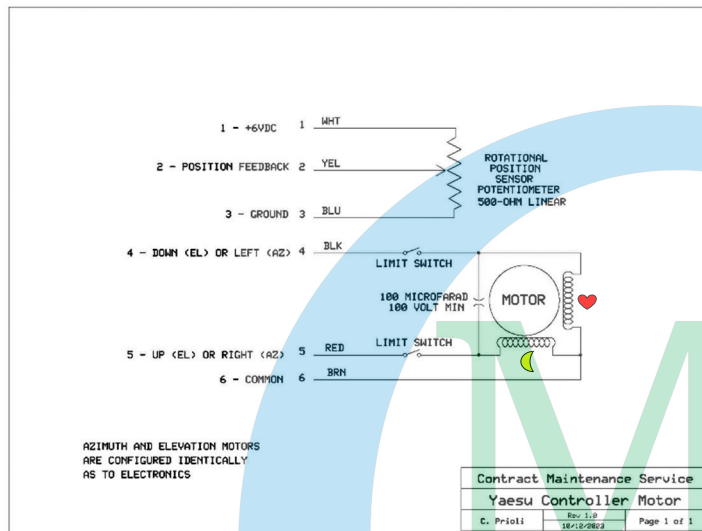
Figure 3 - Rotator motor electrical arrangement

accurately, with two motors with each motor having two separate windings. Figure 3 shows the electrical arrangement found in each of the rotator motors. The pair of windings in one motor changes the azimuth angle, while the pair of windings in the second motor changes the elevation angle. One winding of each pair produces motion in one direction, while the second winding provides the motion in the opposite direction. Let's call the motor windings AZ-forward and AZ-reverse, and EL-forward and EL-reverse. To move the antenna in the forward azimuth direction, we apply operating current to the AZ-forward winding in the azimuth motor. To move the antenna in the reverse elevation direction, we apply operating current to the EL-reverse winding in the elevation motor. In actuality, the windings are labeled as UP, DOWN, RIGHT, and LEFT, and each motor winding is controlled by a single relay that turns the current to that winding on or off. The 26VAC current flows through the relay contact sets, but the relay coils are controlled with current that is derived from the 12VAC secondary. Each axis of motion is equipped with a limit switch at each extreme of the motional range to cut off the motor current when the movement reaches the preset limit in that particular direction.

In reality, the directional control is a tad bit more complex than just one winding or the other, because in reality, *both* motor windings are energized when turning the motor in *either* direction. Refer to the Figure 3 diagram to follow along with this discussion. Let's assume that we are looking at the azimuth motor; the operation of the elevation motor is identical. When we want to swing the azimuth angle to the left, we engage the front panel switch marked "LEFT", which

causes a relay to close and pass the 26VAC out to pin #4 in the Figure 3 diagram. Pin #5 is open at the controller end, as it too goes through a set of relay contacts which are in their open condition. Pin #6 is the common current return lead for the motor and is active when the motor is turned in either direction. The current flowing from pin #4 into the motor goes into the winding with the “heart” next to it. At the same time, current also flows into the circuit branch with the capacitor, through the capacitor, and into the winding with the “moon” next to it. However, the capacitor causes a phase shift of 90° between these two currents, meaning that the two magnetic fields created in the motor are *not* unified and in phase, but that one field leads the other. The phase difference causes enough of a lag between the two fields that it can be used to “steer” the direction of rotation. The difference in the timing of the current flow through these two windings is what causes the rotator to move in that direction. If the current, on the other hand, is applied to pin #5, we have a slightly different condition. At this point, pin #4 is open at the controller end because the relay contact points for that lead are open. The current enters the winding labeled with the “moon” symbol and simultaneously flows into the capacitor in the opposite direction and into the “heart” winding, again setting up a magnetic field that is offset in phase from the field of the “moon” winding. This time, however, the offset magnetic fields cause the motor armature to rotate in the opposite direction. This technique is known as “split phase” directional control.

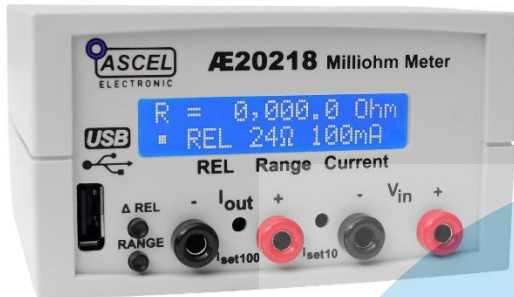
Figure 8 - Ascel AE20218 milli-ohmmeter

I said earlier that the Ascel AE20218 (Figure 8) is "quite accurate" in its results. This is partly due to the design of the meter itself, and partly due to the fact that it uses the Kelvin measurement technique, which removes all wire lead resistance from the reported results. In the case of a standard ohmmeter, the test meter leads are in-circuit and are therefore contributing their resistance to the reported value. The Kelvin system, which uses four test leads (Figure 9) instead of two and places a known and highly accurate current through the subject resistance, removes the resistance of the test leads from the equation. You can learn more about the Kelvin lead system by reading the explanatory article at <https://storage.googleapis.com/production-domaincom-v1-0-0/180/1603180/ZMb5Nhvj/25e8a371f25642848308d72e18779604?fileName=Kelvin%20Resistance%20Measurement%20Method.pdf>.

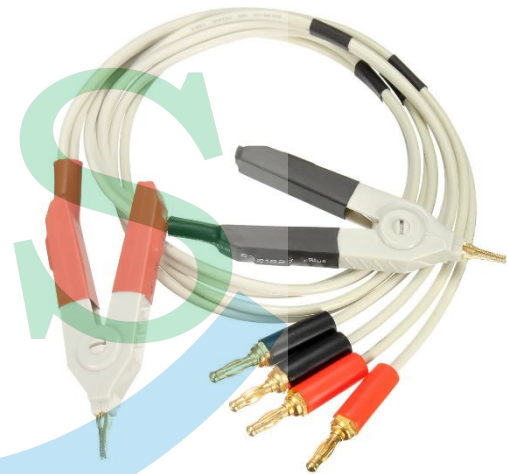
Figure 9 - Kelvin lead set for Ascel AE20218

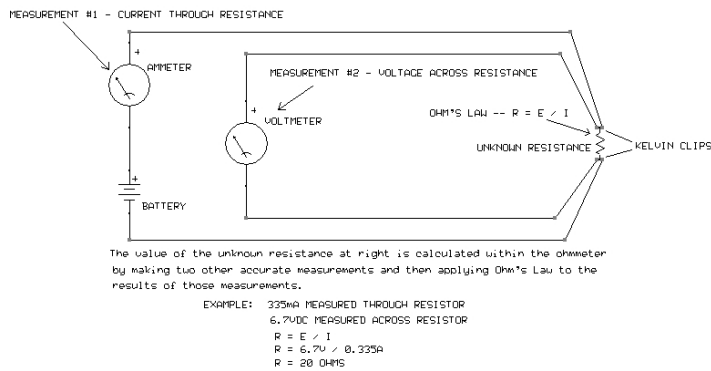
The graphic at Figure 10 illustrates the Kelvin four-wire resistance measurement system diagrammatically, providing an example of how the system works. While it is obvious that the wire leads used in making these measurements still have internal inherent resistance, that resistance is factored out by the fact that the voltmeter is connected in parallel and is a very high

Figure 10 - Kelvin resistance measurement

input-impedance meter, meaning that circuit loading is at the lowest possible level. The Kelvin test clip is a special two-wire insulated clip where the current lead and the voltage lead are not connected at all until the clip is closed onto the lead of the target resistor. The results of the current and voltage measurements are used to calculate the resistance which is then displayed on the face of the Kelvin ohmmeter.
