# At the Repair Bench – Conar 231 Tuned Signal Tracer – April 2024

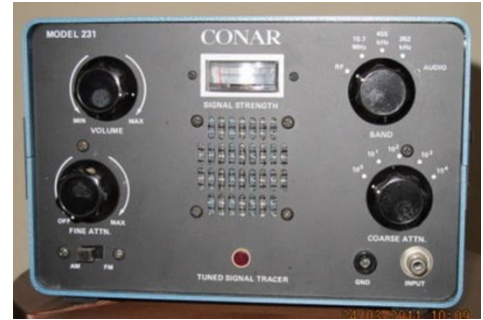
Figure 1 - Conar 231 Tuned Signal Tracer

The unit came in to my shop as an inoperative piece of equipment that was also missing its test probe and ground connector. Those two items are actually the subject of one of my build articles previously published at this point, as I designed and built a replacement active amplifying probe with the high input impedance necessary to avoid loading of the circuit under test and therefore obtaining undistorted waveform samples. The subject of *this* article is the actual repair of the Conar 231 main unit.

All in all, a fairly easy repair, though there were multiple failures to be tracked down and corrected. The moral of this story is that it's not done until it is *all* done. I packed the unit up together with the new probe and ground lead that I had fabricated, and shipped it back to its owner.

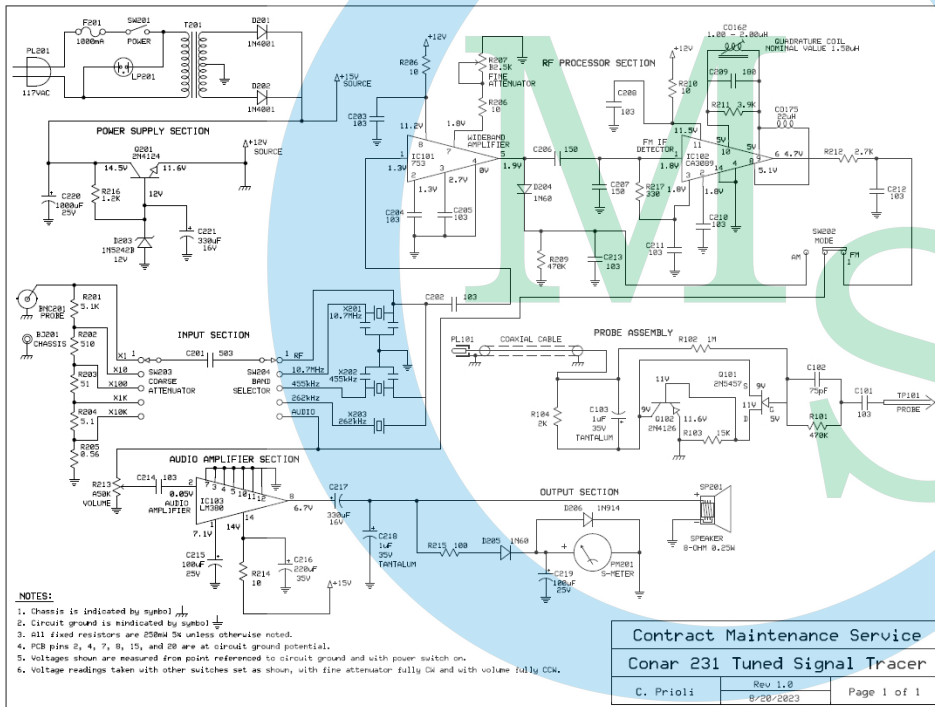
Figure 2 - Conar 231 schematic diagram

repairing the defect. The Model 231 also provides two untuned input selections, an RF option and an AUDIO option. The unit schematic is shown in Figure 2. This schematic was derived from the unit itself and was drawn in the *ExpressSchematic* software that I like to use.

With three failed polarized capacitors in this unit so far, and considering the age of the unit and therefore its capacitors, I elected to go proactive and replace the remaining polarized capacitors, which included a pair of 100µF/25V axial electrolytics, a second 330µF/16V radial electrolytic, and a single 220µF/35V radial electrolytic. It was good repair practice to replace all of these capacitors based upon the rate of failure already seen and the overall age of the parts involved.
