At the Repair Bench – Icom ID-4100A Shutdown – March 2023

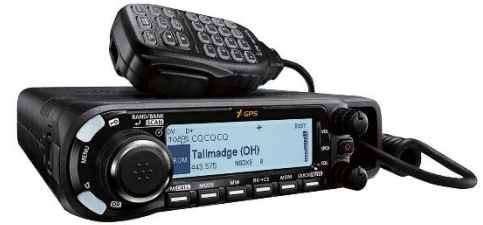
Figure 1 - Icom ID-4100A

I had been having occasional problems with my Icom ID-4100A (Figure 1) powering itself off, most often at the end of a transmission, but occasionally during receive operations. There was no rhyme or reason to when this would happen. It might happen twice during a net, or it might go several weeks without occurring. I was always able to restore the radio to operation by power-cycling the power supply, and I was therefore half convinced that the problem was internal to the radio, so I set about trying to locate the problem.
