# LILLY HOME INSPECTIONS

## INSPECTION REPORT

CLIENT(S) NAME(S):	Clients N/A,e	AGE OF HOUSE:	~ 30 years
JOB ADDRESS:	Any Road	SQUARE FEET:	~ 2115 ft2
CITY & STATE:	Any town	HOUSE FACES:	Northeast
INSPECTION DATE & TIME:	Inspection Date	REALTOR:	Your realtor
WEATHER CONDITIONS:	Hopefully Sunny	TEMPERATURE:	~ 78 degrees
DWELLING CONDITION:	Unoccupied	ATTENDEES:	Inspector & Client
INSPECTED BY:	Randy Lilly	INSP. END TIME:	Anytime
Inspector's Signature:

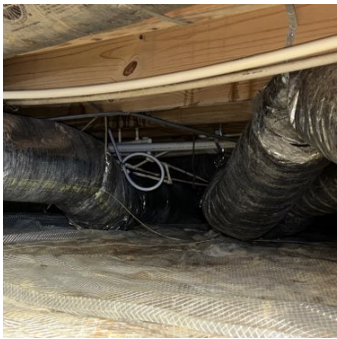
<p>Crawl Space Access Location:</p>	<p>Left House Side. Some of the crawl space areas were too small to safely access.</p>

<p>How Crawl Space is Inspected:</p>	<p>Physically</p>	
<p>Crawl Space Noted Items:</p>	<p>1. Crawl space - the crawl space weatherstrip observed to be turned into an unvented crawl space with an air handler unit installed. This needs to be evaluated and repaired by a licensed company. See the summary section. The unit will need to be routinely maintained.</p>

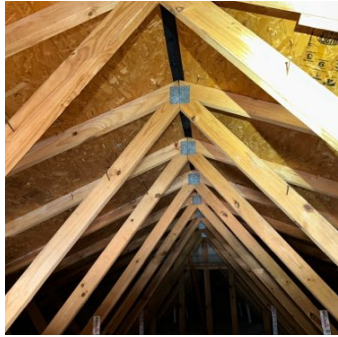
4. Observed light surface wear in various locations.

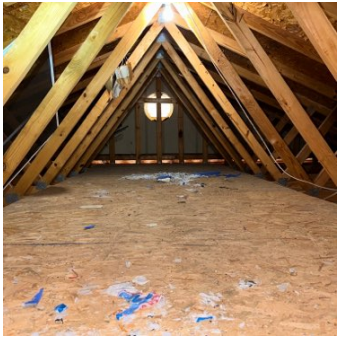
Attic Noted Items:	1. Observed flooring and a light over the garage area. 2. Some attic areas were too small to physically access.

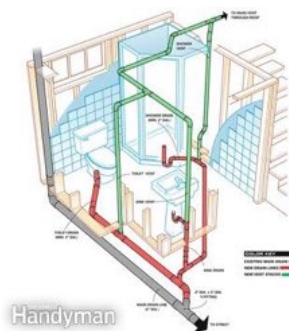
Bath 1 Items:	<ol style="list-style-type: none"> <li>1. The light switch needs a coverplate.</li> <li>2. Observed a slight dip in the floor in front of the toilet.</li> <li>3. The towel bar needs to be better anchored.</li> </ol>	
Bath 2 Location:	Hall Bath	
GFCI Protection	The GFCI protection in this area appeared to operate as intended.	
Bath 2 Items:	<ol style="list-style-type: none"> <li>1. The entry door rubs the frame and needs repaired. The door top edge needs to be repainted.</li> <li>2. The towel bar needs to be better anchored to the wall.</li> <li>3. Seal the gap between the flooring and the shower.</li> </ol>	
Bath Noted Items:	N/A	
Bath Recommended Items:	N/A

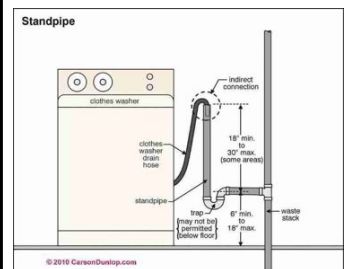
Laundry Moderate Items:	<ol style="list-style-type: none"> <li>1. The door will not properly latch when closed and needs repaired.</li> <li>2. The water lines need to be better anchored up.</li> </ol>
Laundry Noted Items:	<ol style="list-style-type: none"> <li>1. The laundry equipment are not part of the home inspection and are not inspected.</li> </ol>
Laundry Recommended Items:	<ol style="list-style-type: none"> <li>1. Recommend installing a pan with a drain under the washing machine.</li> <li>2. Recommend the outlets be GFCI protected.</li> </ol>
