**January 12, 2022**

Re: Supplemental Geotechnical Evaluation  
Proposed garage  
136 Tamalpais Road, Fairfax, California  
APN 001-121-22  
DAC Project No.: 1458-6321G

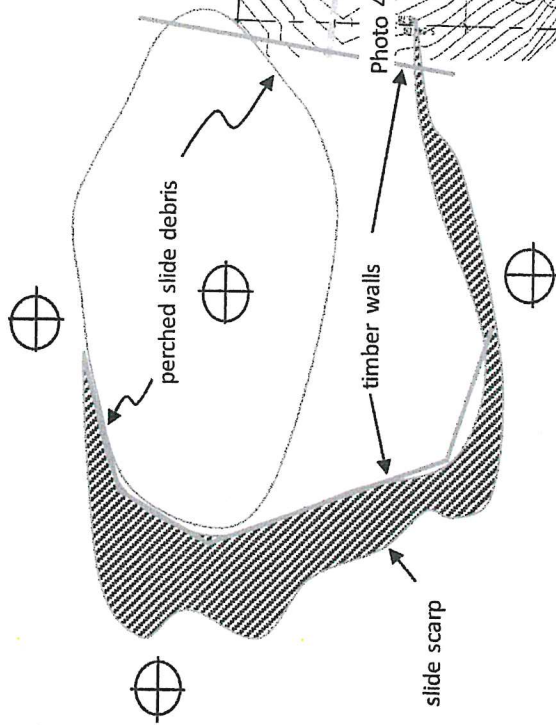
There is a swale that plunges from the landslide scar and, continuing downslope, crosses onto the subject site (Photo 3). The topographic contours in Figure 1 show this swale. The swale ends at a paved terrace/patio, as shown in Figure 1 and Photo 4. Judging from the topography, we believe that the terrace was constructed by placing fill within the former swale. This fill body likely has the shape of a triangular pyramid, rotated 90° from vertical, and with a maximum vertical thickness of approximately 10 ft near the downslope (northeast) side of the terrace.

**Photo 4.** Terrace, looking downhill (northeastward) from above. Note swale plunging toward terrace.

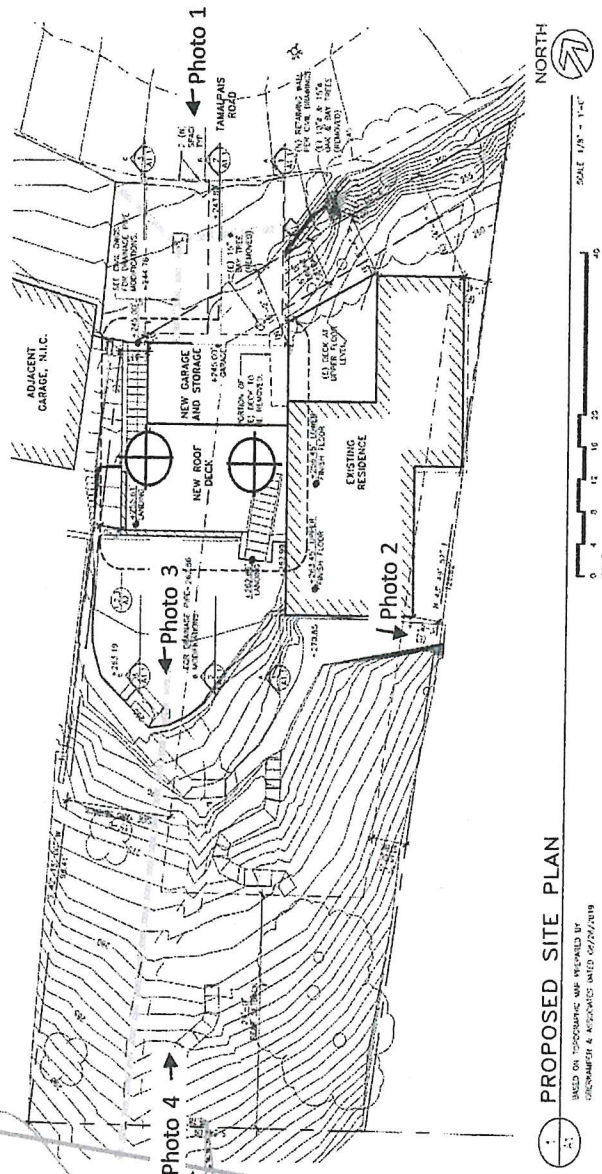
**Figure 1**

Mr. Hubinski was a resident when the 1986 landslide occurred. Reportedly, slide debris flowed down the swale below the slide and onto the terrace and continued farther downslope. The lower timber wall shown in the report by Hom & Associates (1989) (Figure 1) extends a few feet above grade and thereby forms a small debris basin that can intercept potential debris-flow material that originates upslope.

Base: New garage, 136 Tamalpais Road, Fairfax, California, by Friedrich C. Devine Associates, dated June 15, 2021. Upslope features from Plate 1 of report by Horn & Associates (1989).
