Water Storage Facility 2019 ROV Inspections City of Johnson City

Johnson City, TX

September 2019

Audit Title
City of Johnson City Inspection #1

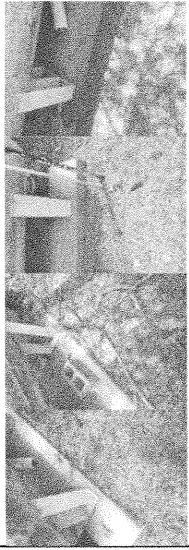
Appendix 3	Appendix 4
Rate condition of the fence (1= Poor, 2= Fair, 3= Good)		3	
Structure Foundation			
Photo foundation

Appendix 5	Appendix 6 Appendix 7 Appendix 8
Foundation type?		Concrete pads	
Rate the overall condition of the foundation? (1= Poor, 2= Fair, 3= Good)		3	
Facility Plumbing			
Photo(s) of all plumbing

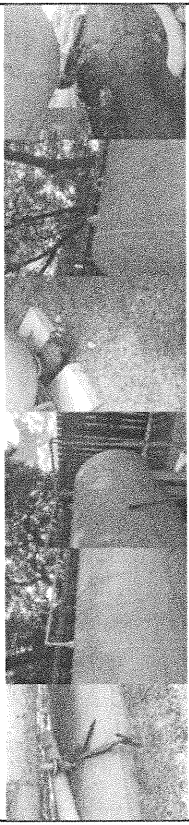
Appendix 9	Appendix 10 Appendix 11 Appendix 12 Appendix 13 Appendix 14
List all plumbing on facility		Inlet, Outlet, Drain	
Rate the overall condition of the plumbing (1= Poor, 2= Fair, 3= Good)		3

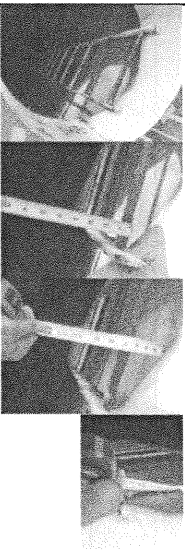
Question	Response	Details
Water Access Ladder		
Does facility have a water access ladder?	Yes	
Water access ladder photo

Is water access ladder in good condition?	Yes	
Width of ladder	17"	
Length of standoff	7"	
Diameter of rung	3/4"	
Does water access ladder have fall protection? (OSHA requirement)	No	Recommend a slider fall protection system be installed
Water Level Indicator Probes		
Does facility have water level indicator probes?	Yes	
Do the water level indicators probes appear to be in good condition?	Yes	
Water Level Float		
Does facility have a water level float indicator?	Yes	
Are the float and guide wires in good condition?	No	
List deficiencies of float system	Float wire broken, Guide cables broken	
Need for repair and or replacement of float system?	Yes	Recommend a new water level float be installed
