Job Name: Crompton and Knowles  
 Job Number: 71187168  
 Area: Building 7

FORMER CROMPTON AND KNOWLES SITE  
 1602 N. MAIN STREET  
 CHARLOTTE, NORTH CAROLINA

PROJECT NUMBER  
 71187168  
 SHEET  
 1-R

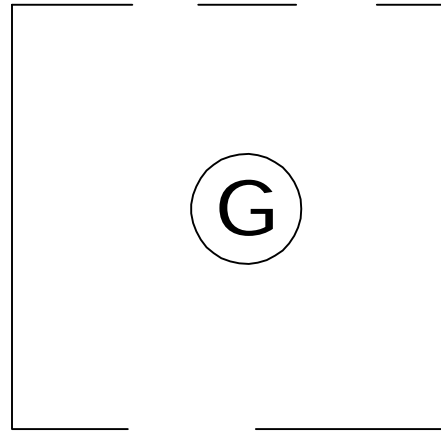
PROJECT NUMBER  
 71187168  
 SHEET  
 15-1

IDENTIFIED ASBESTOS-CONTAINING MATERIALS  
BUILDING 17 - 1ST FLOOR

ASBESTOS-CONTAINING FLOOR TILE AND MASTIC
