Geotechnical Evaluation of Ross Valley Detention Basins
(Except Phoenix Lake)

**GEOTECHNICAL AND GEOLOGIC FEASIBILITY STUDY
LOMA ALTA, LEFTY GOMEZ FIELD, MEMORIAL PARK
AND RED HILL PARK DETENTION BASINS
WATERSHED FLOOD DAMAGE REDUCTION &
CREEK MANAGEMENT STUDY
MARIN COUNTY, CALIFORNIA**

April 6, 2010

Project 960.05

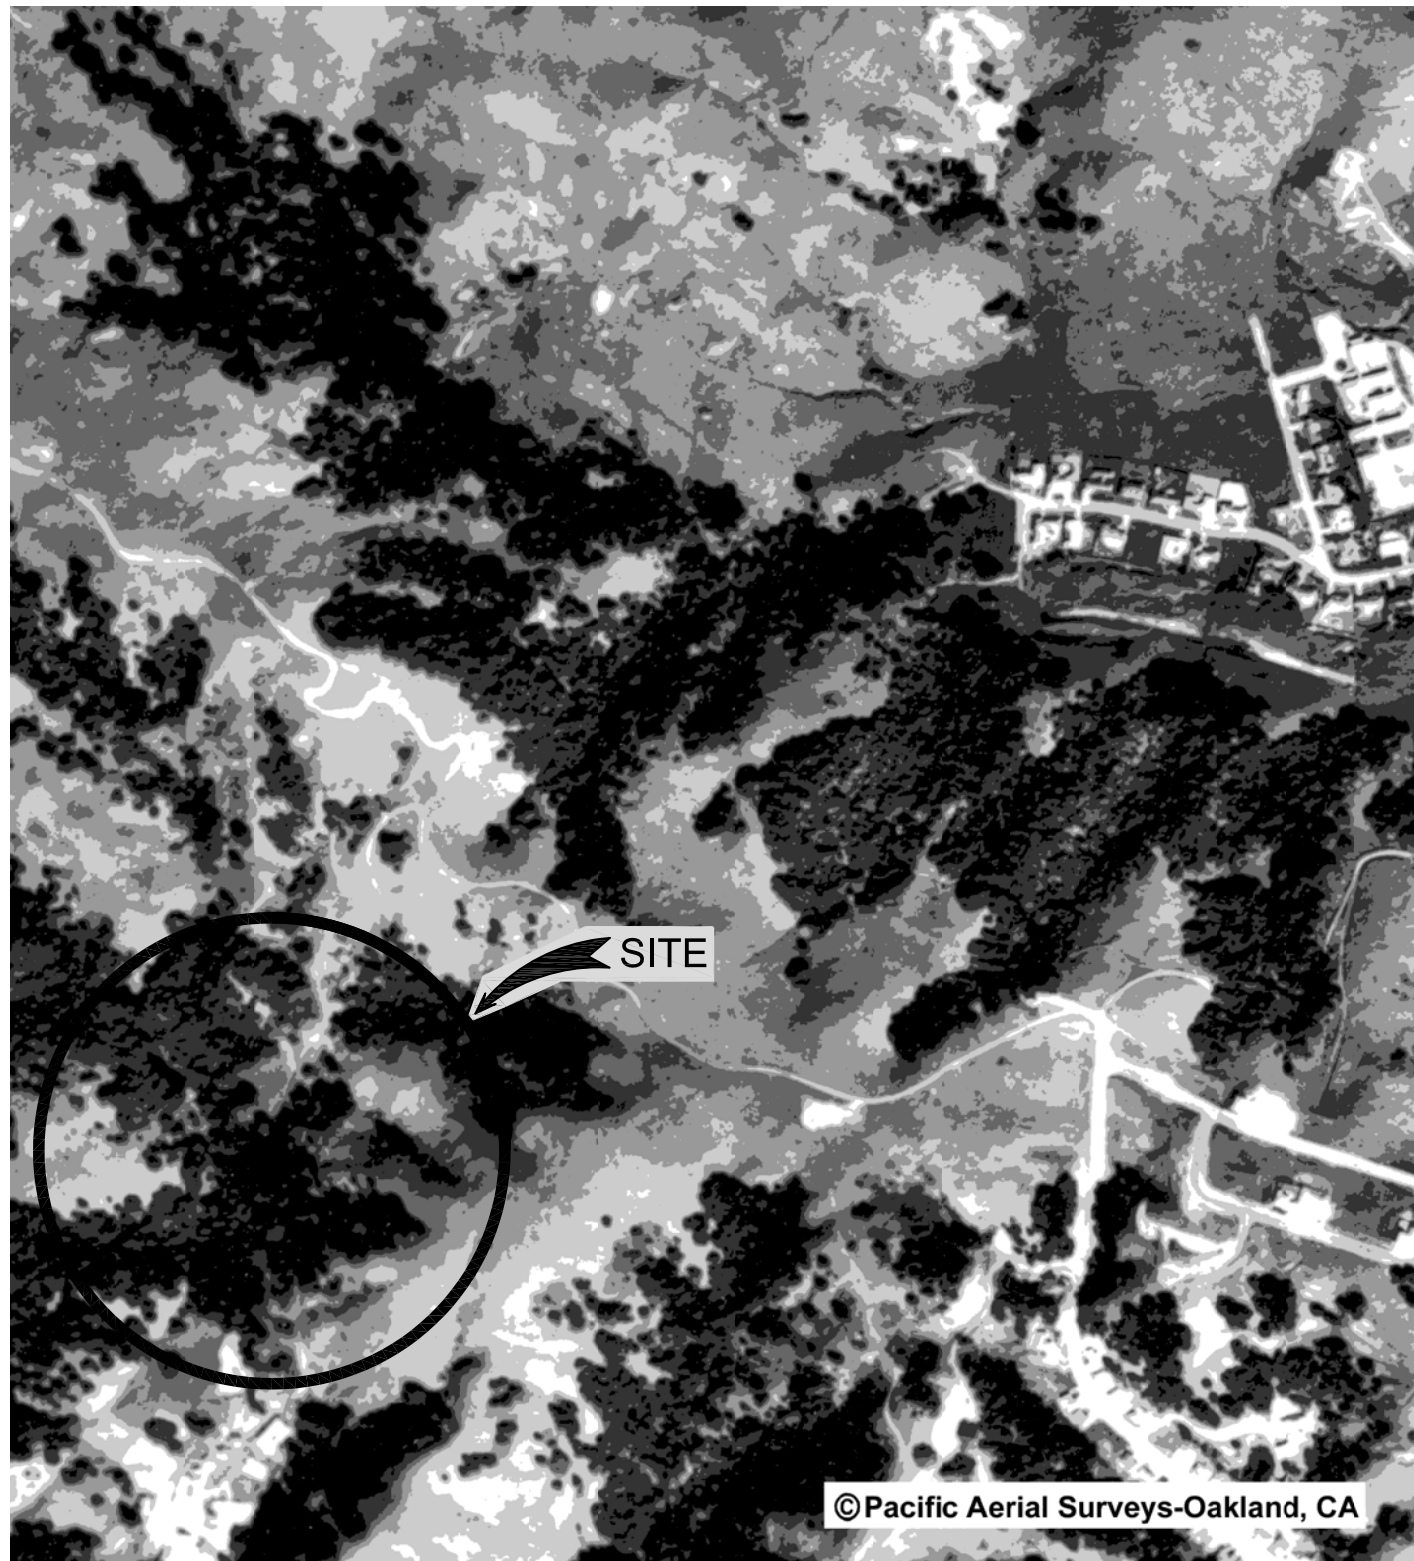
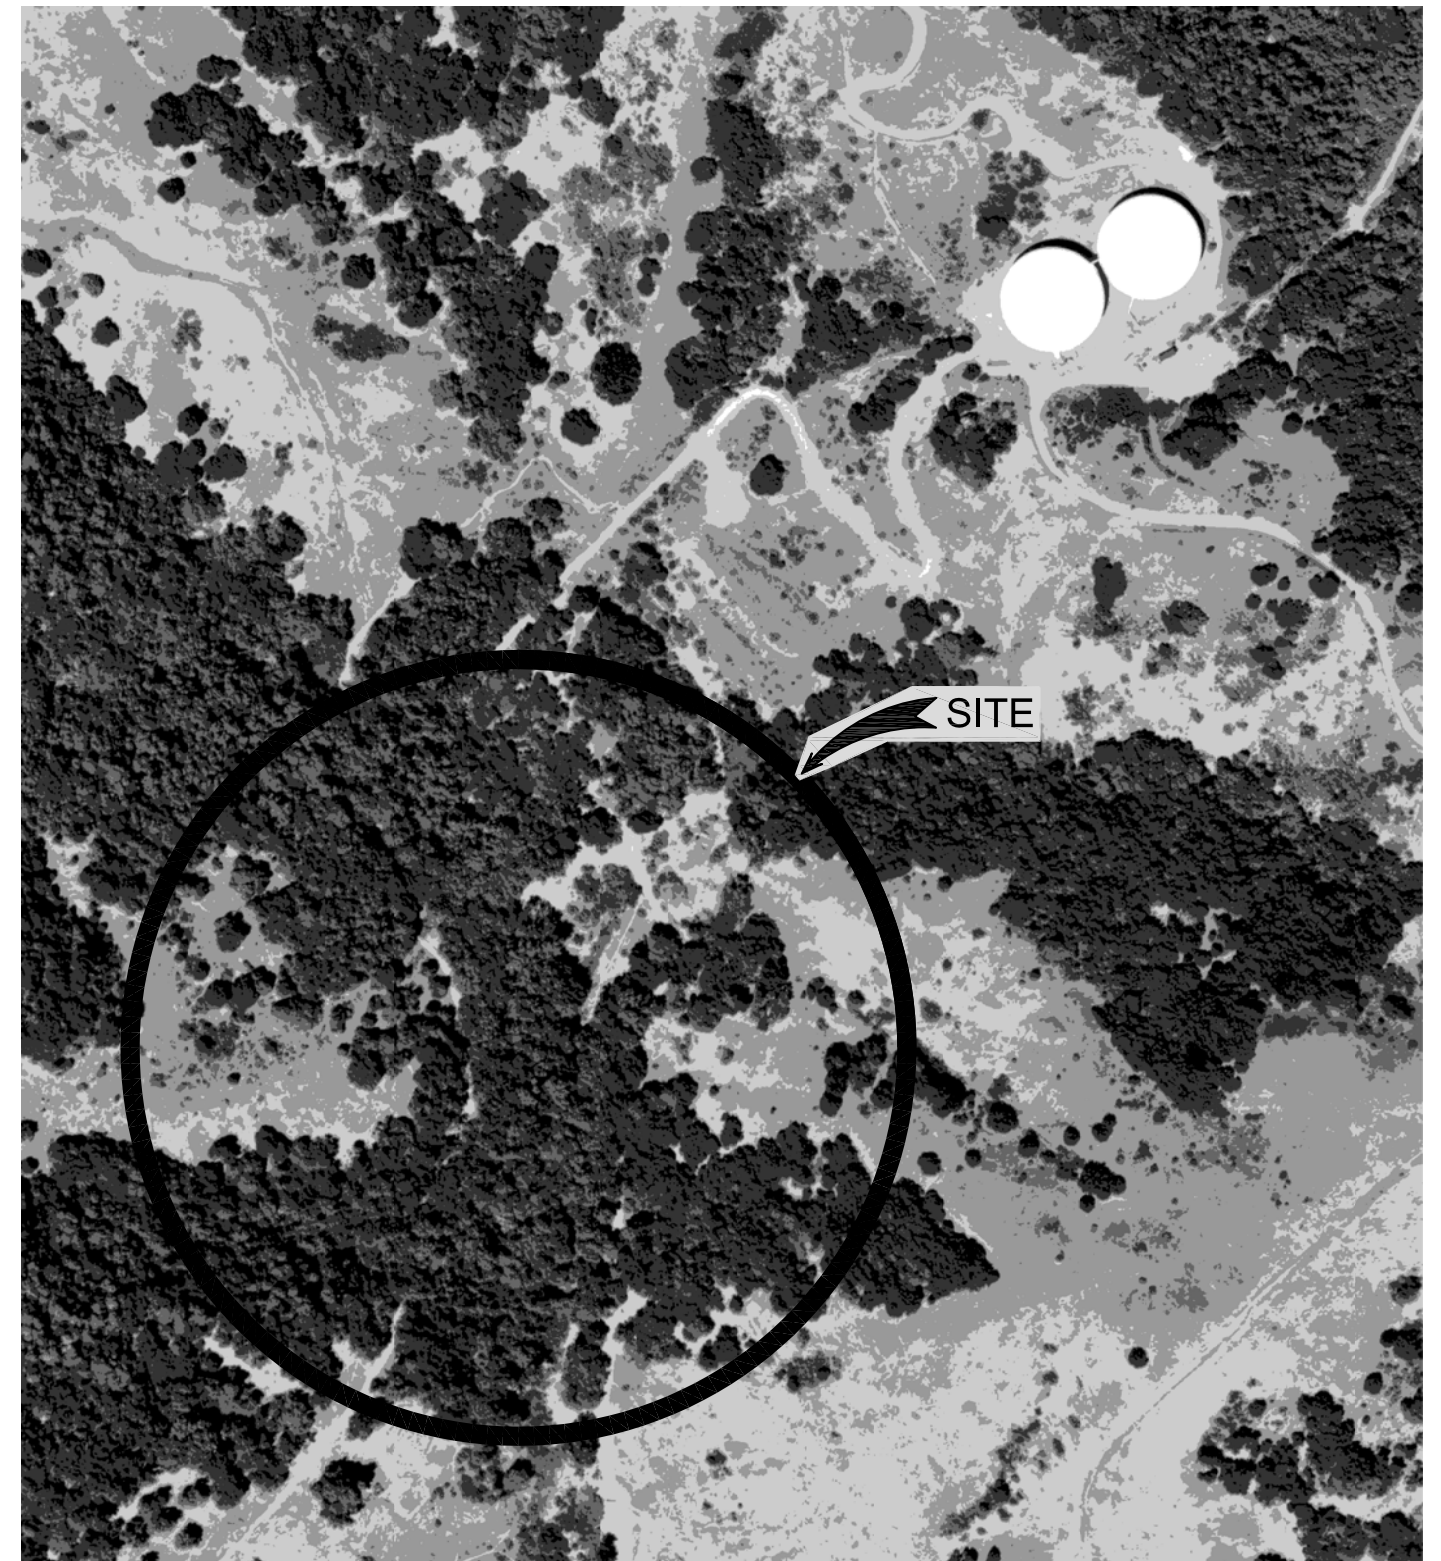
7
FIGURE

AERIAL PHOTOGRAPH TAKEN MARCH 8, 1958
NOTE FIRE ROADS AND ABSENCE OF WATER TANKS AT SMITH SADDLE (CENTER LEFT)

AERIAL PHOTOGRAPH TAKEN AUGUST 9, 1995
NOTE WATER TANKS AT SMITH SADDLE (UPPER RIGHT)

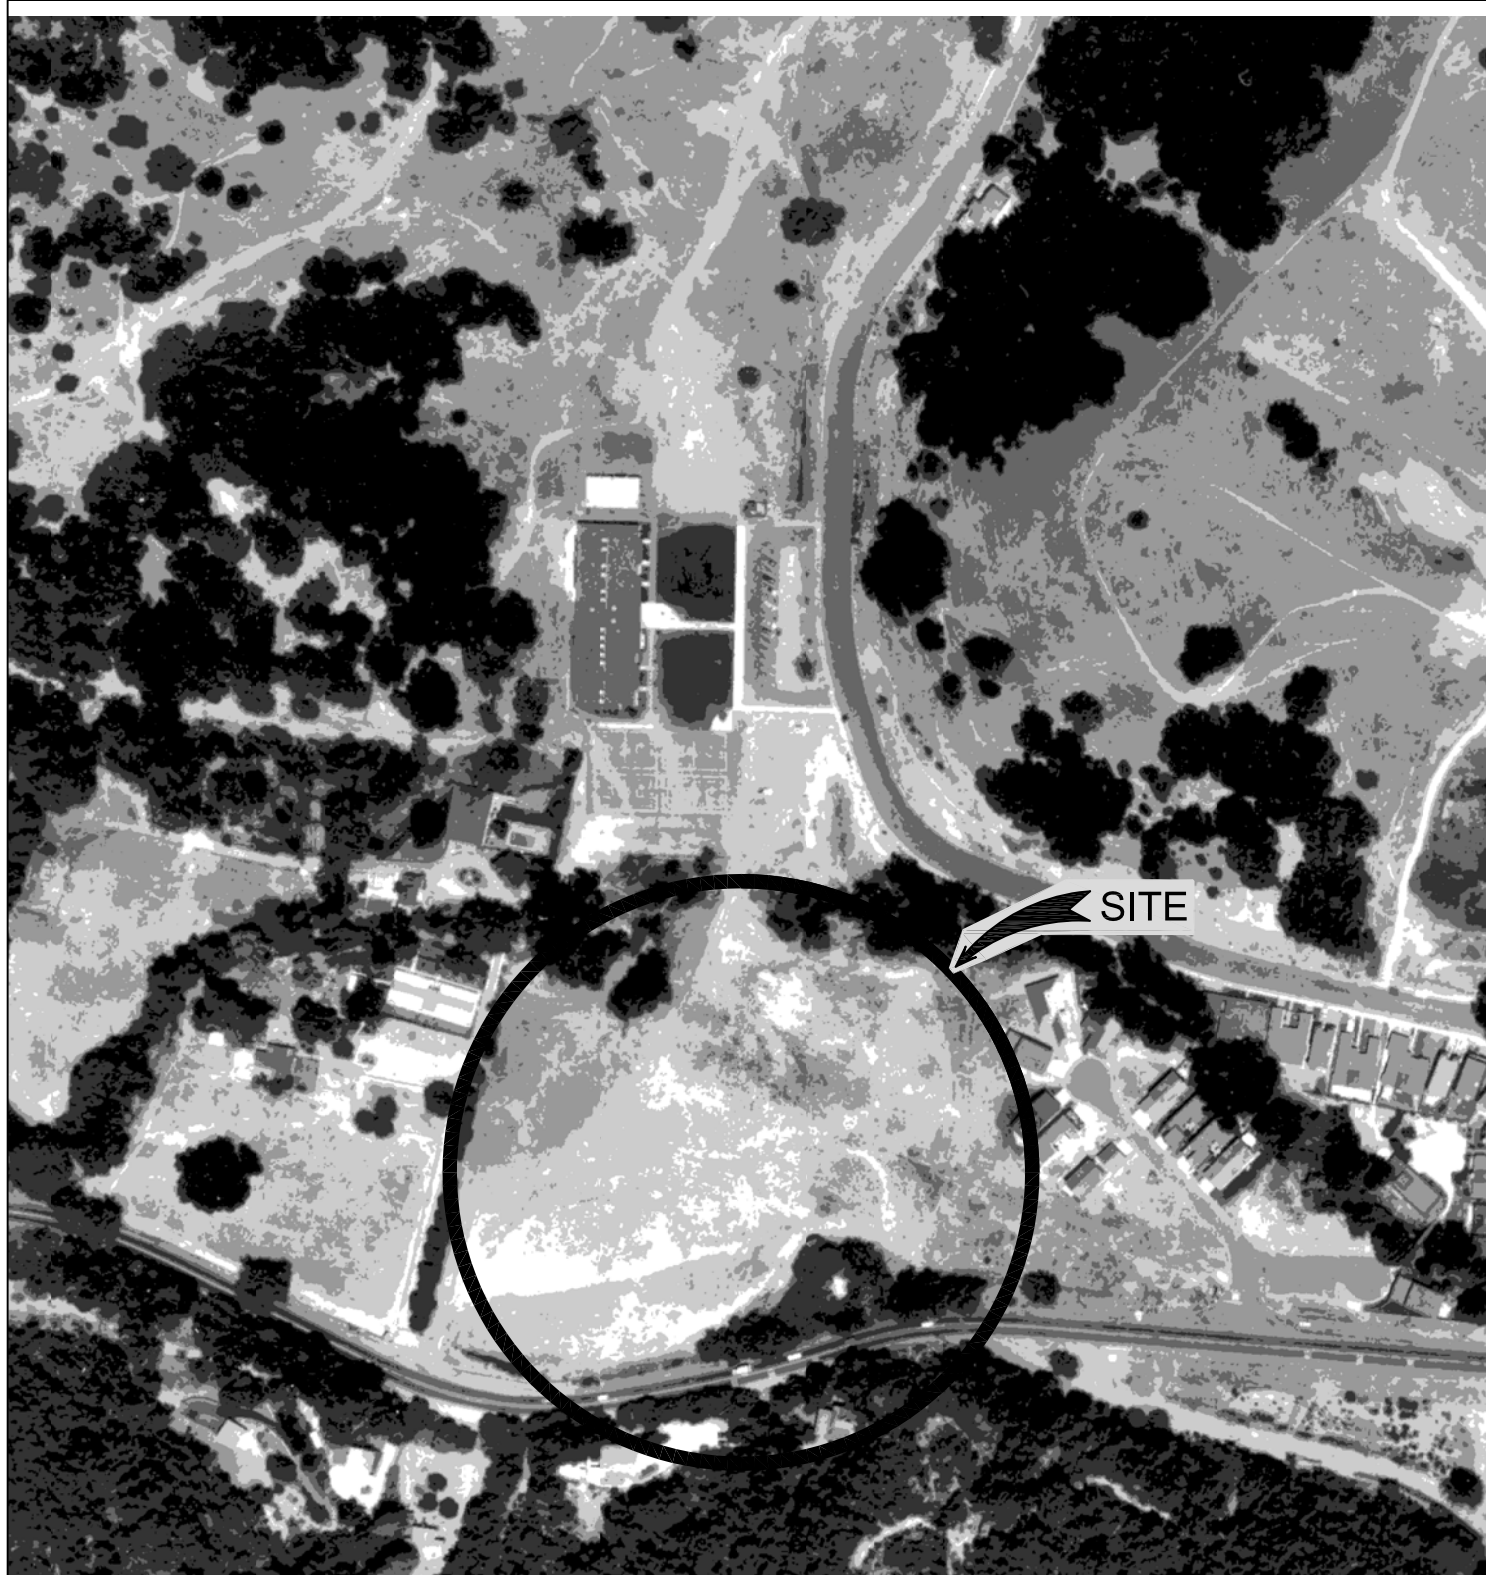
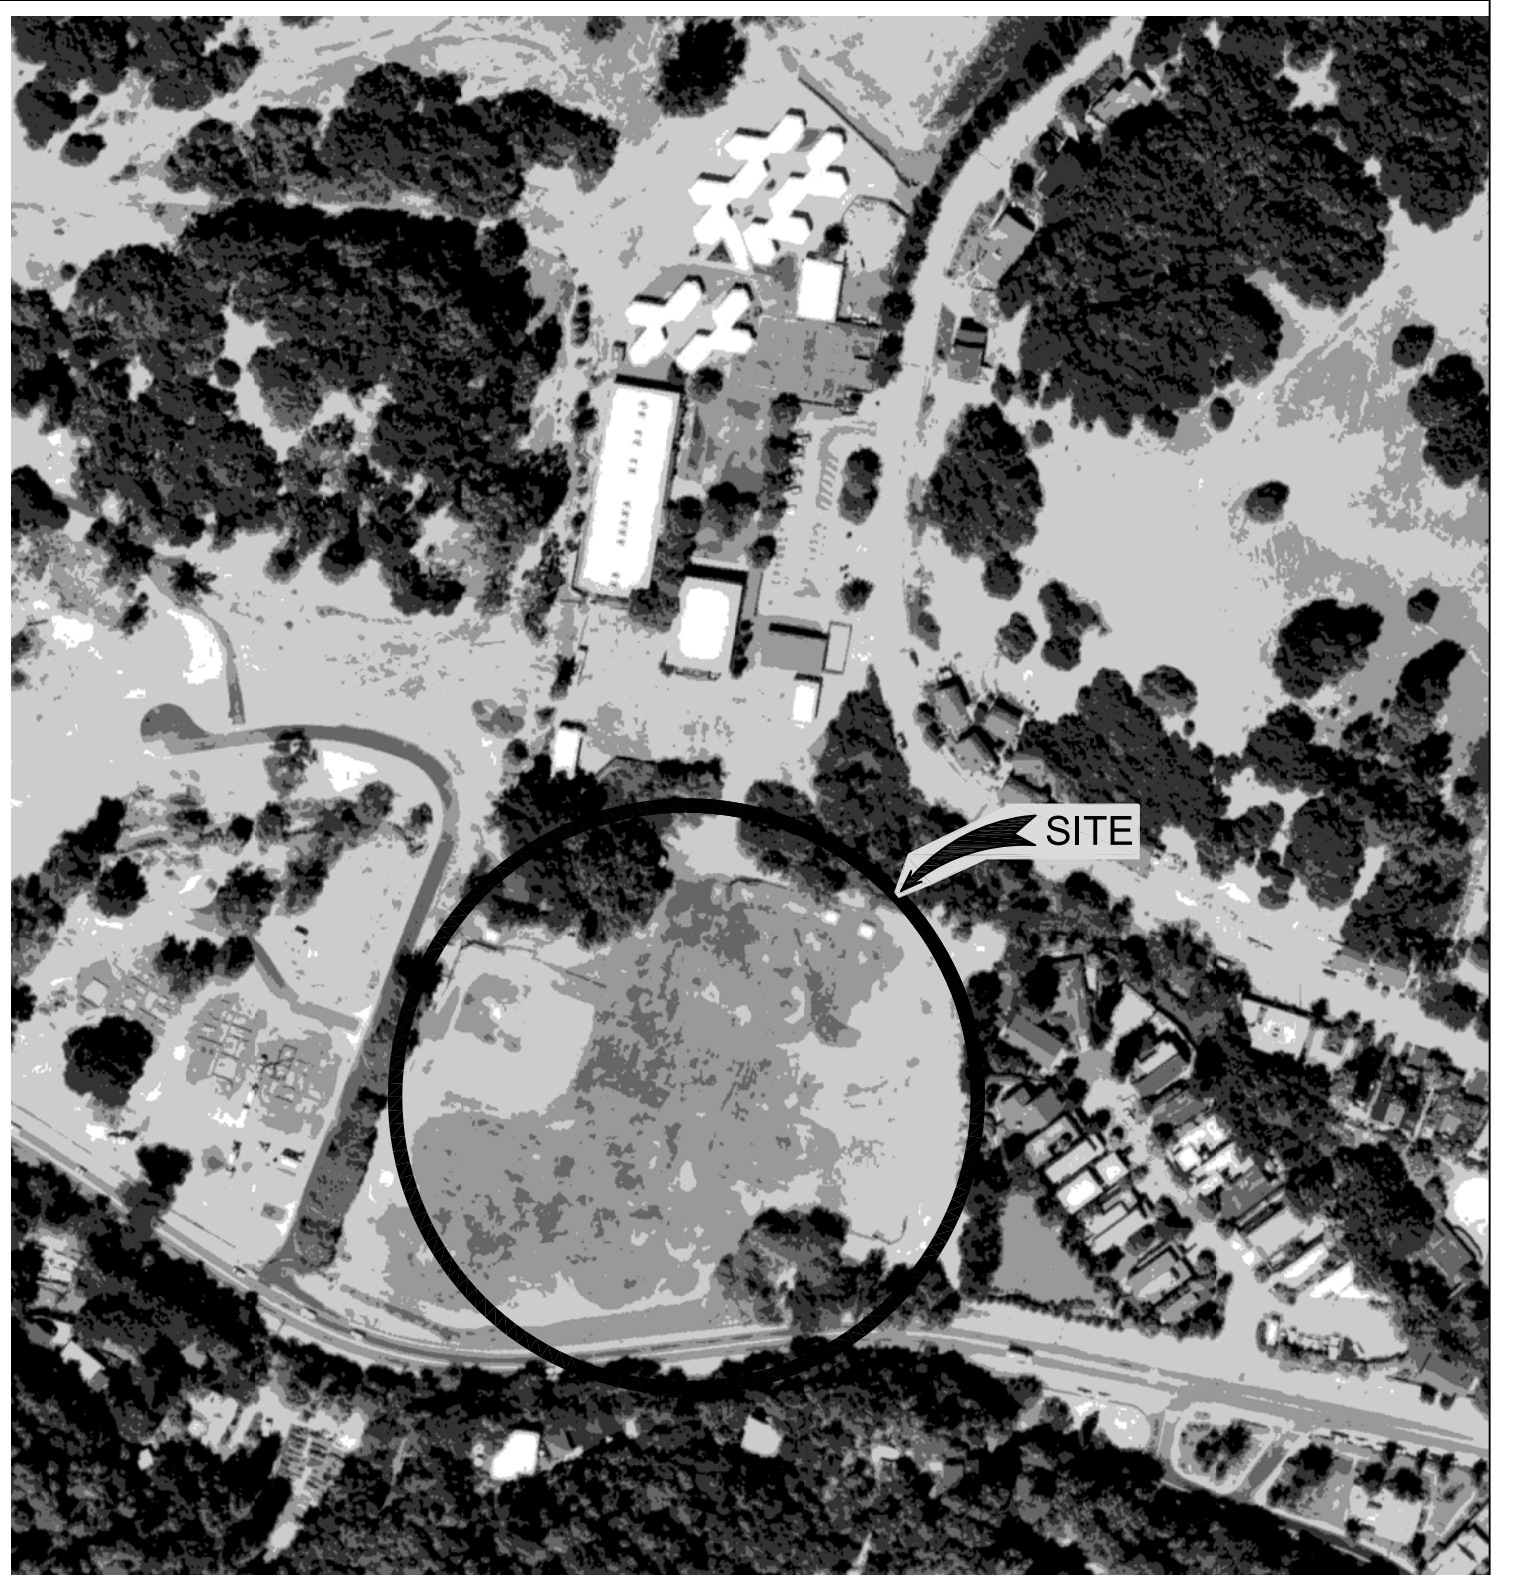
8
FIGURE

AERIAL PHOTOGRAPH TAKEN JULY 2, 1970

AERIAL PHOTOGRAPH TAKEN AUGUST 9, 1995

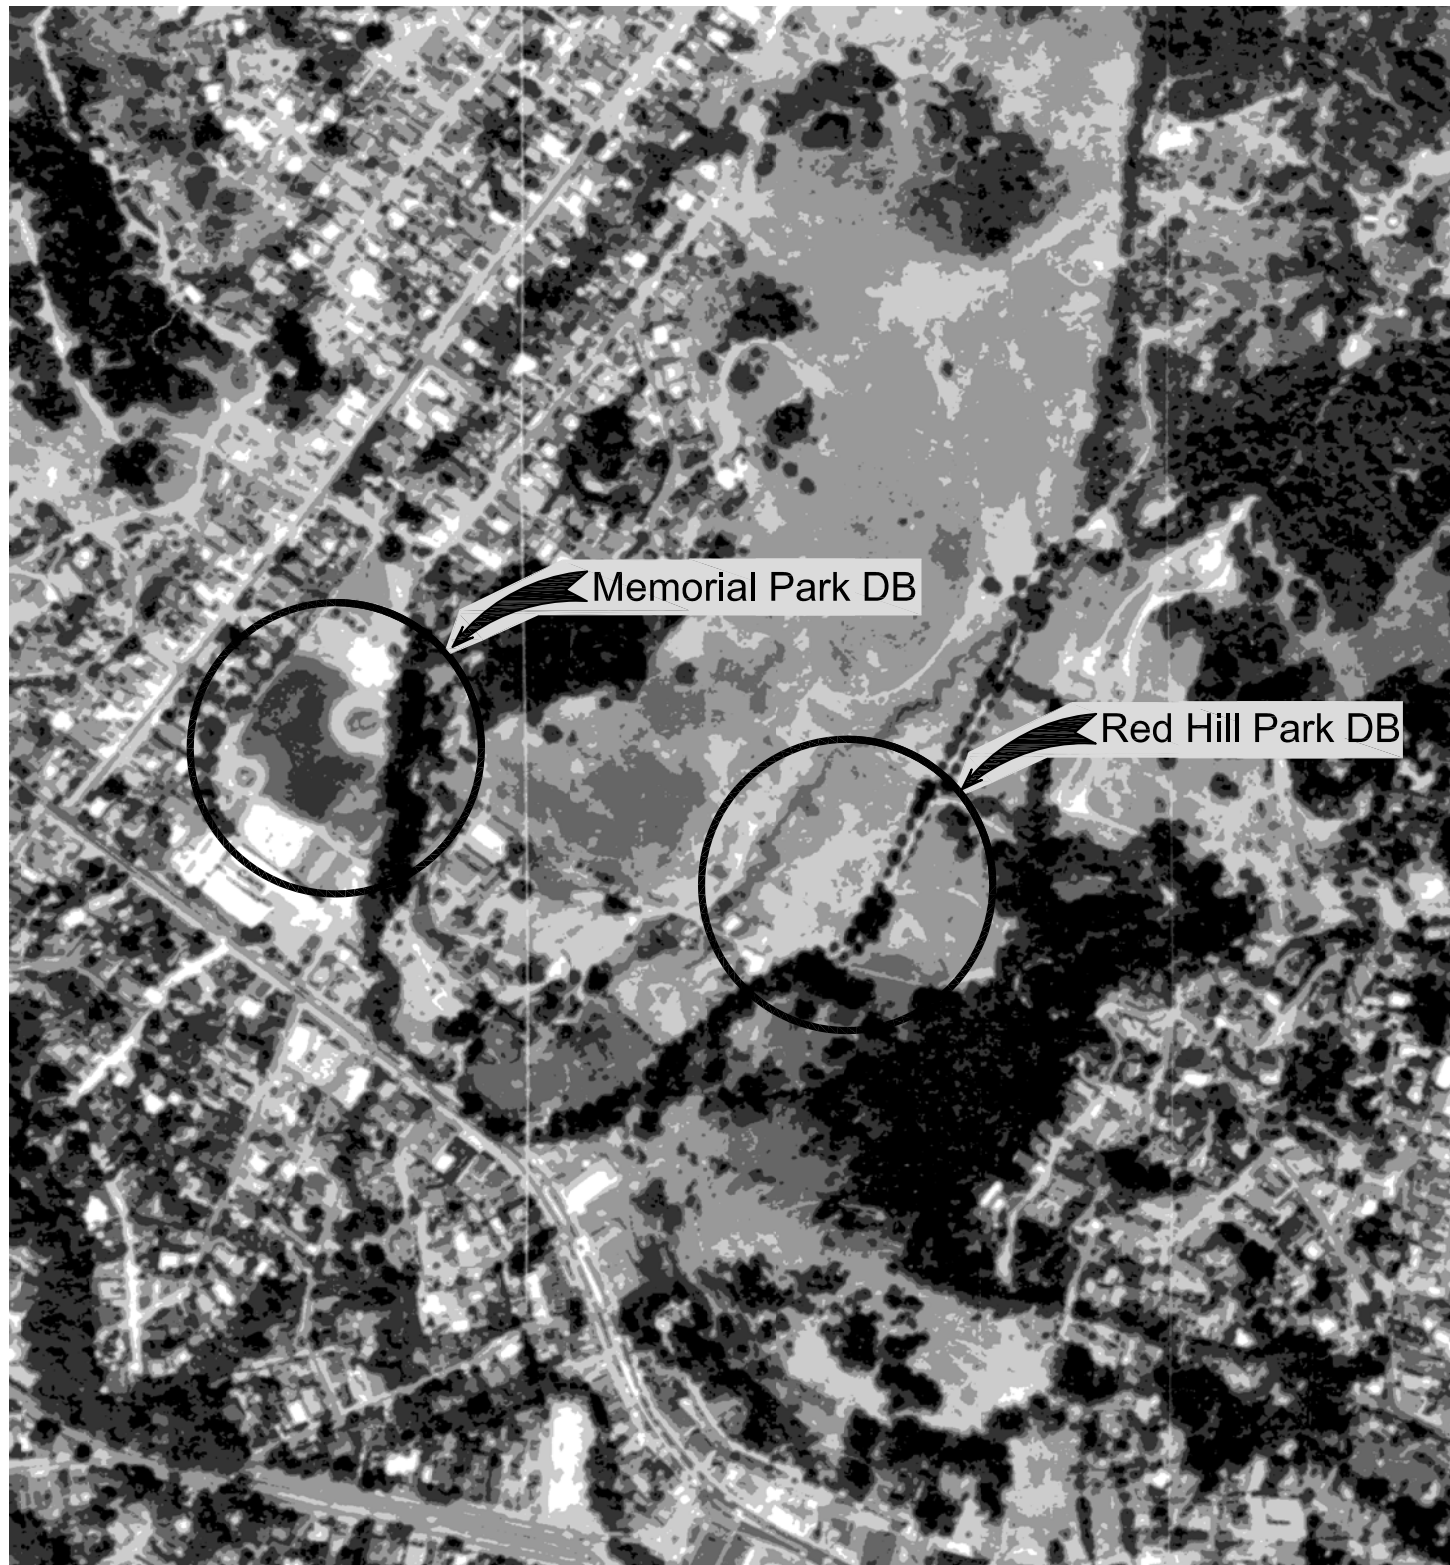
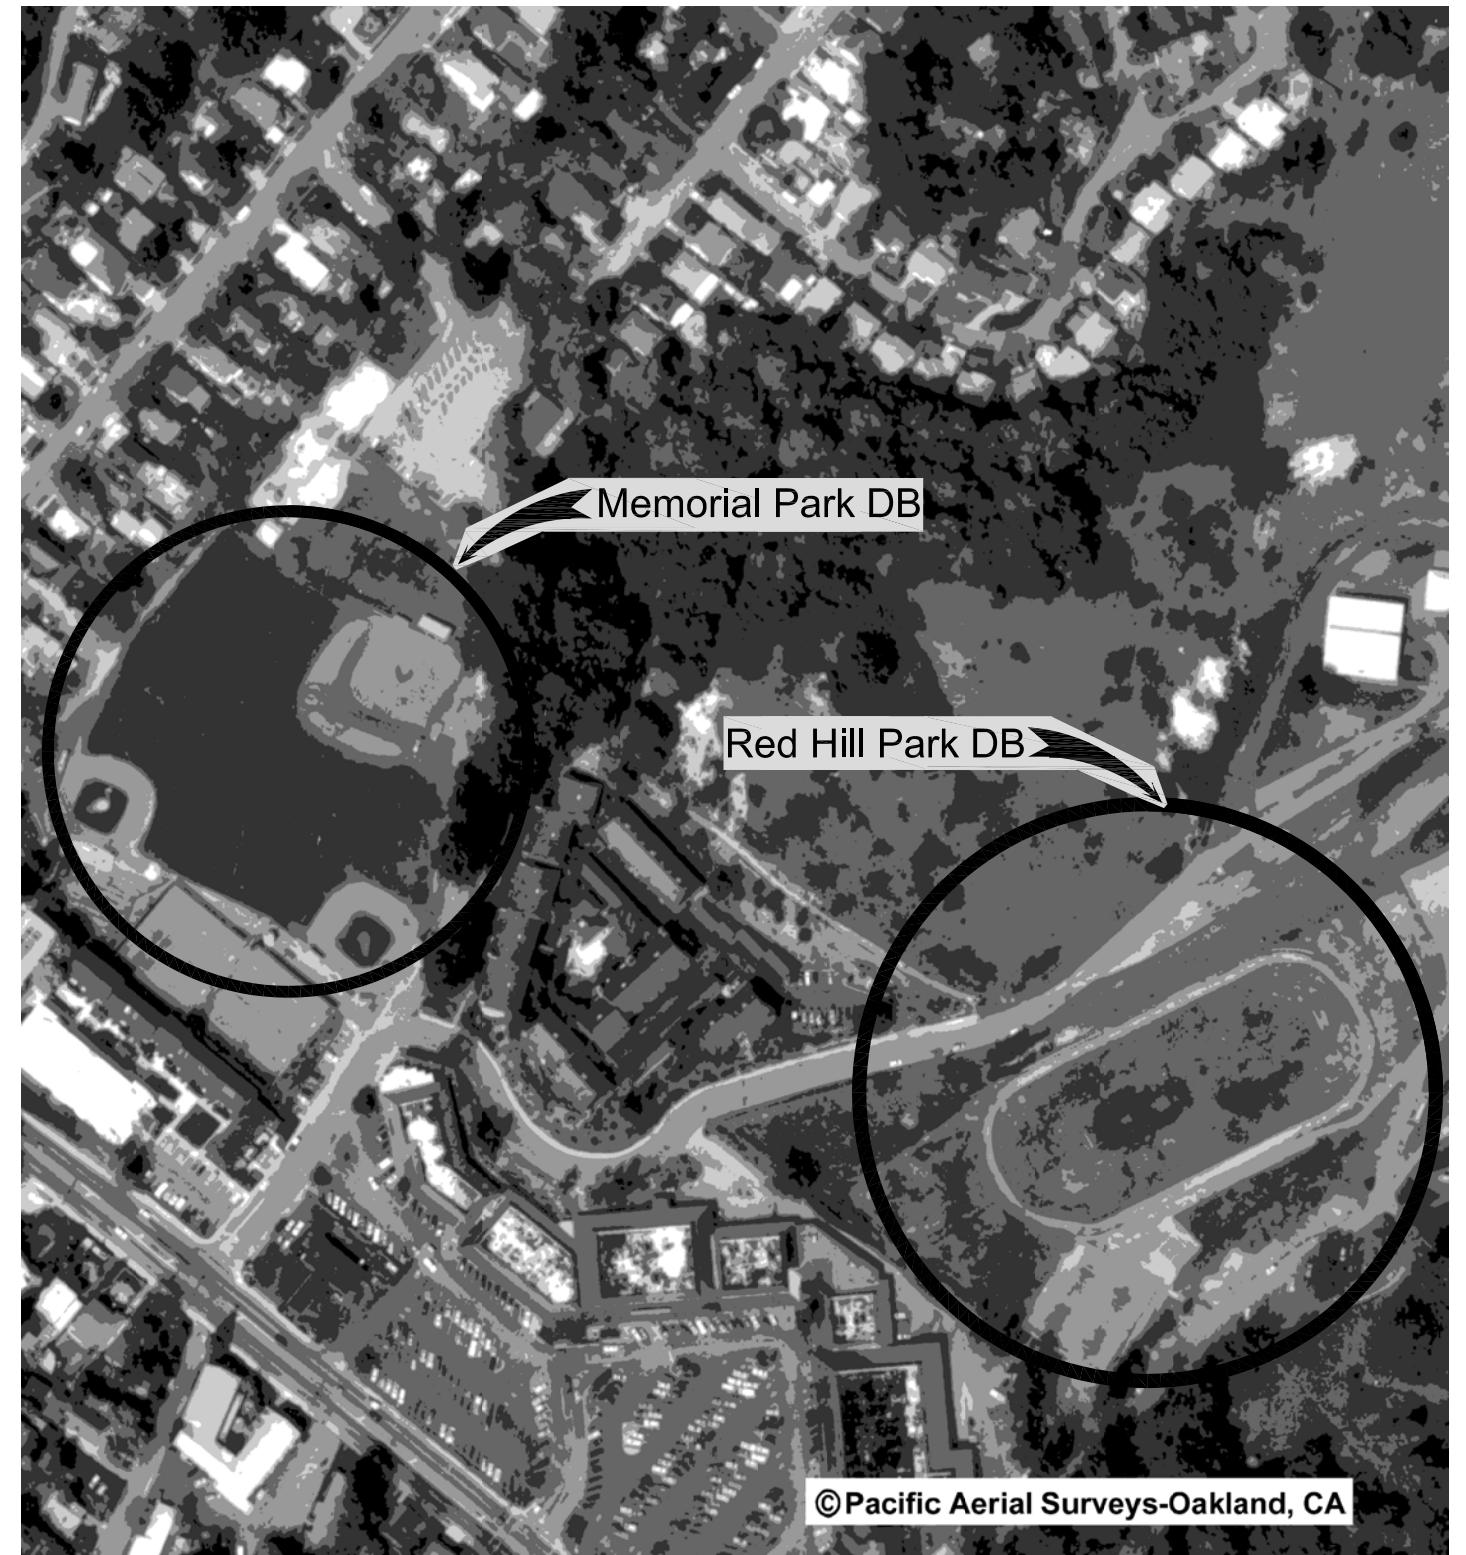
AERIAL PHOTOGRAPH TAKEN JULY 9, 1963
NOTE NATURAL DRAINAGE CHANNEL AT DB-6 SITE.

AERIAL PHOTOGRAPH TAKEN MARCH 15, 1990
NOTE EXTENT OF DEVELOPMENT AND OF FILL PLACED AT DB-6 RELATIVE TO 1963 PHOTO.
