Willis Evans Canyon Creek at San Geronimo Valley Dr. (2005)

East Fork Woodacre Creek at the Woodacre Improvement Club (2005)

Woodacre Creek at Park St. (2006)

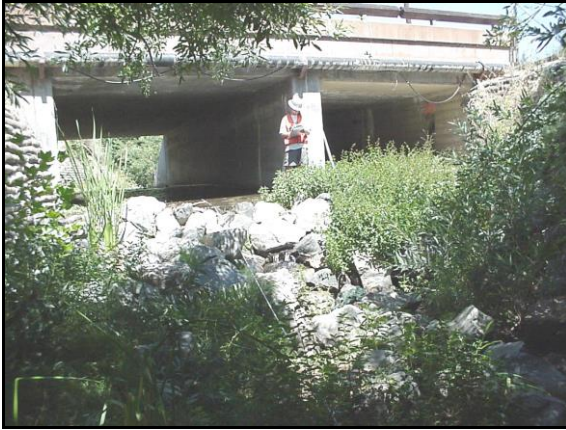
Vineyard Creek in the Novato Creek Watershed (2008)

Before: This double box culvert on Vineyard Creek had a perched outlet with more than a five foot drop over riprap. It failed to meet fish passage criteria for all species of adult salmonids and all classes of juveniles.

After: Since the boxes were properly sized and in good shape, a retrofit fish passage project included installation of baffles within a large double box culvert to aide steelhead passing upstream during high flow conditions. The downstream channel was stabilized to prevent channel scour and to aid salmon when swimming upstream

through the culvert to spawn. The project completed in October 2008.

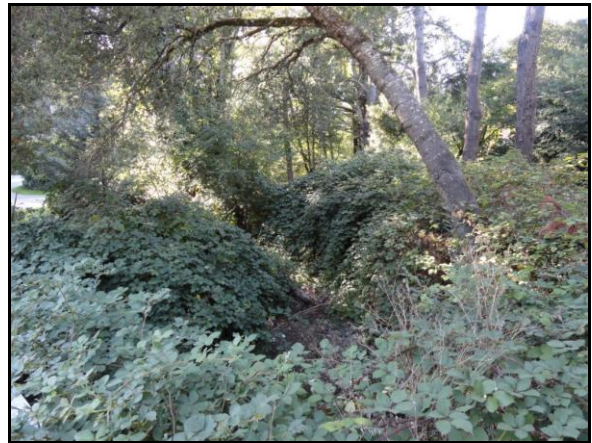
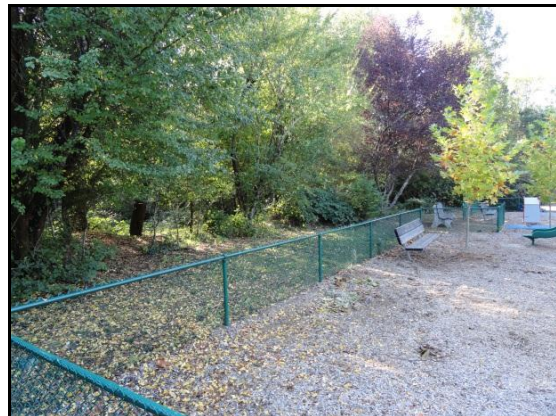
Existing Conditions: This circular concrete culvert near the confluence of Montezuma Creek with the mainstem of San Geronimo Creek was identified in the passage assessment report (Taylor 2003) as a partial barrier to coho and steelhead. Elimination of the barrier and restoration of the riparian zone in this reach of Montezuma Creek was later identified as a high priority in the San Geronimo Valley Landowner Assistance Program (SGVLAP); as part of the SGV LAP, a conceptual design was developed for the project. The full design for the project and implementation funds to construct it, are being sought through various grant programs for restoration.

Barrier Removal Design: The proposed restoration project includes removal of non-native invasive plants in the riparian zone of Montezuma Creek in an area where it flows through a County Park in downtown Forest Knolls. Marin County Parks will be a partner in the restoration of this site.
