**GEOTECHNICAL DATA REPORT
LAS GALLINAS LEVEE SYSTEM
SAN RAFAEL, CALIFORNIA**

July 3, 2013

**SUBJECT: Geotechnical Data Report
Las Gallinas Levee System
San Rafael, California**

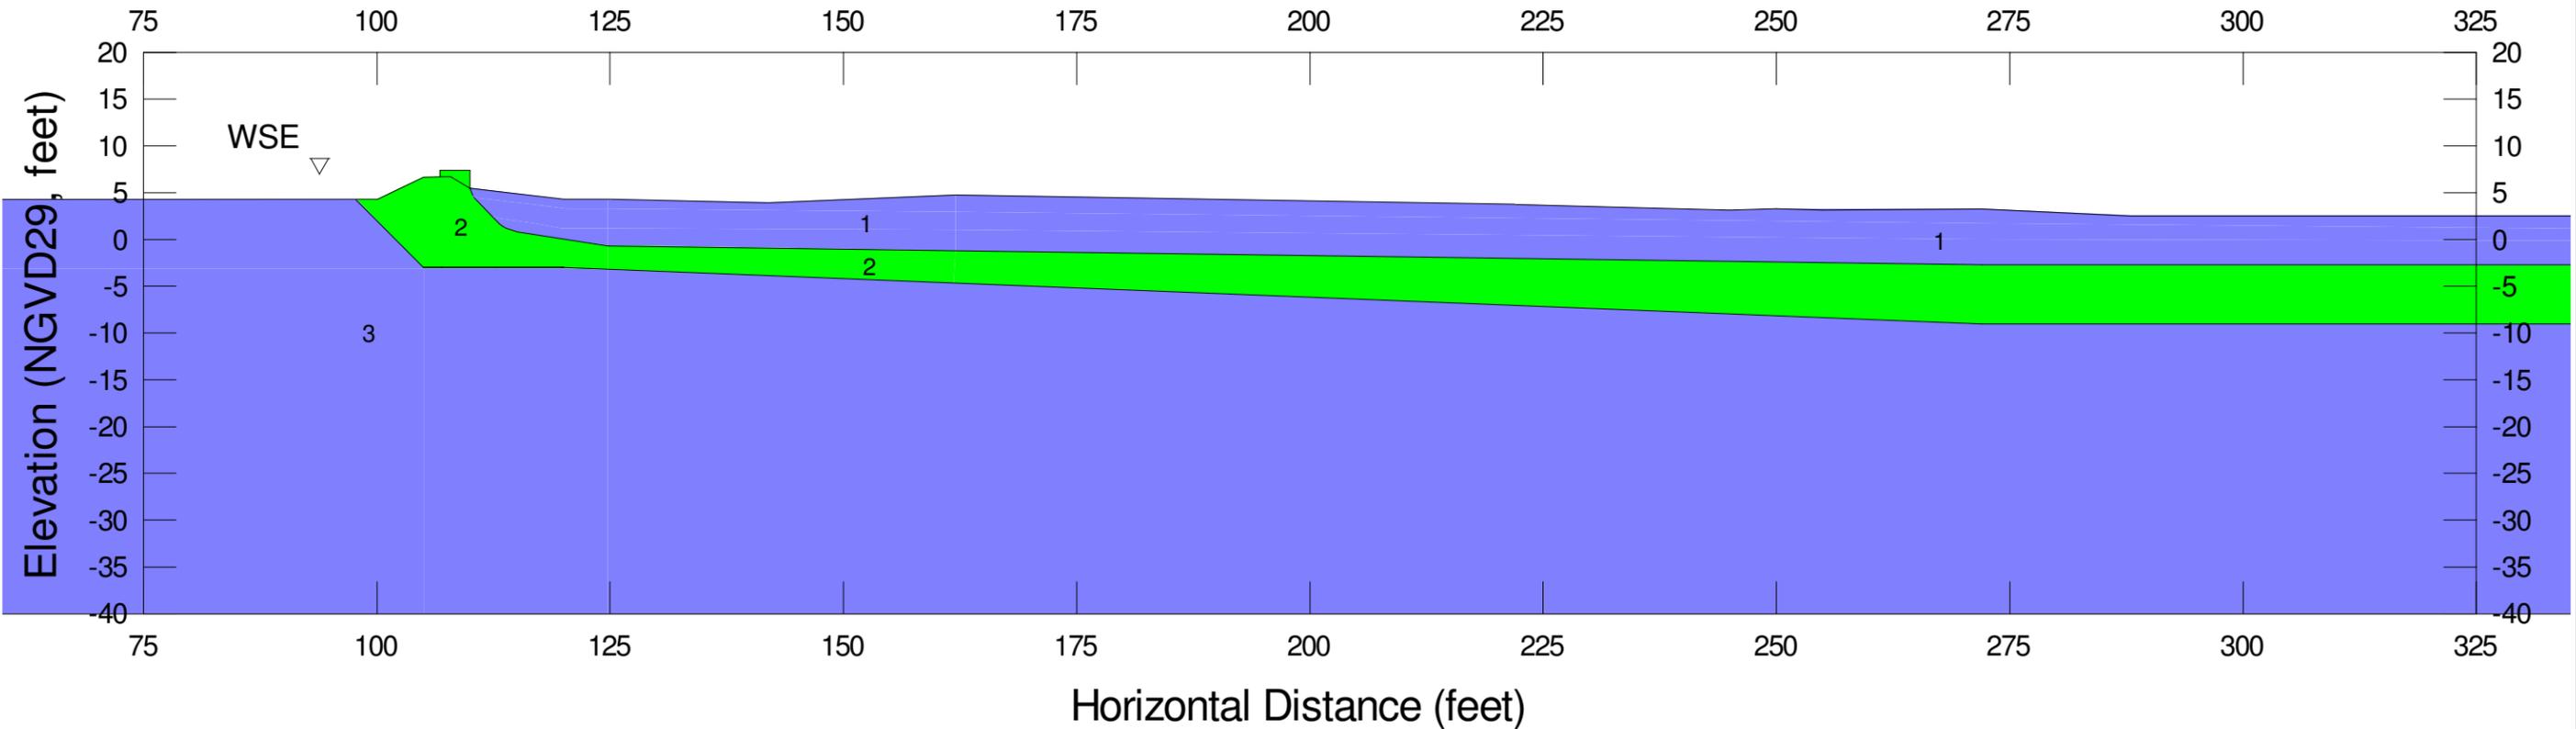
Bright People. Right Solutions. www.kleinfelder.com	PROJECT NO. 96670	SEEPAGE FRAGILITY ANALYSIS EXISTING CONDITIONS: 4 FT. BLANKET	PLATE 5
	DATE: 5.10.2013		
	DRAWN BY: R. Yuen	GEOTECHNICAL DATA REPORT LAS GALLINAS LEVEE SYSTEM SAN RAFAEL, CALIFORNIA	
	CHECKED BY: C. Hall		
FILE NAME:

Approximate Blanket Thickness at Levee Toe: 4 ft

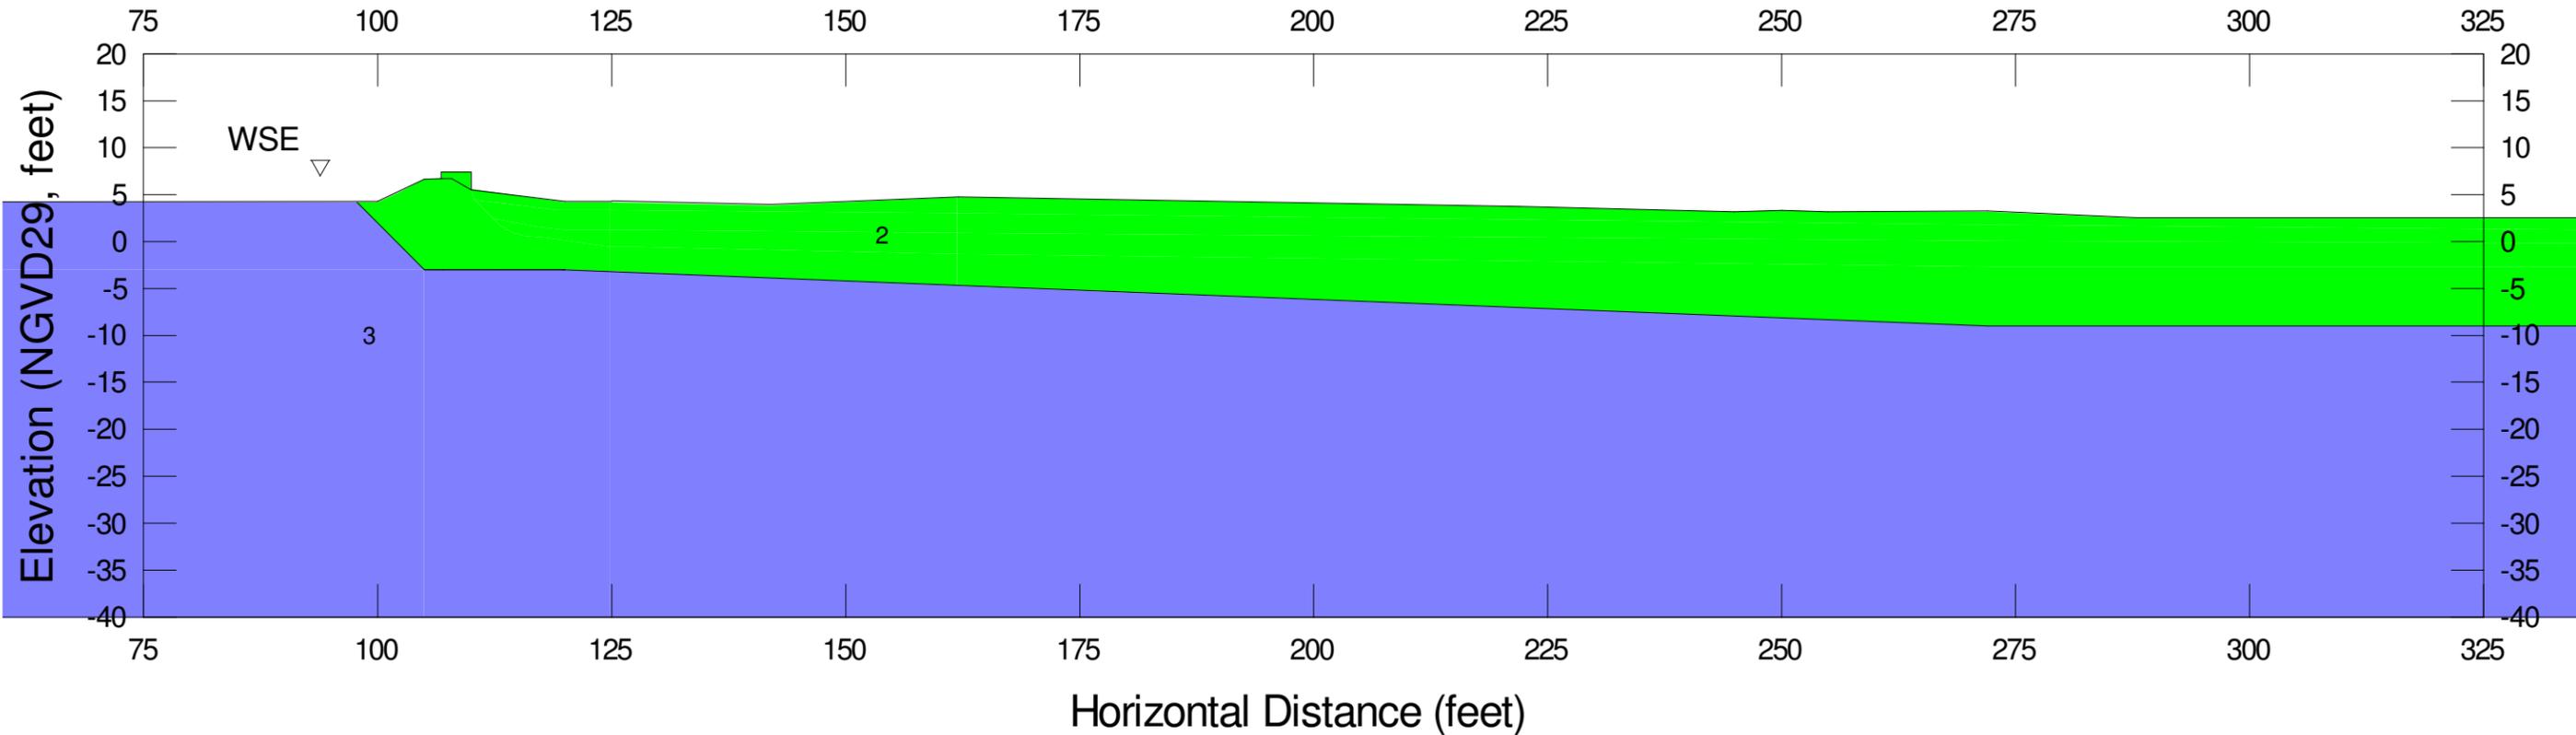
Bright People. Right Solutions. www.kleinfelder.com	PROJECT NO. 96670	SEEPAGE FRAGILITY ANALYSIS EXISTING CONDITIONS: NO BLANKET	PLATE 6
	DATE: 5.10.2013		
	DRAWN BY: R. Yuen	GEOTECHNICAL DATA REPORT LAS GALLINAS LEVEE SYSTEM SAN RAFAEL, CALIFORNIA	
	CHECKED BY: C. Hall		
FILE NAME:

Approximate Blanket Thickness at Levee Toe: 0 ft

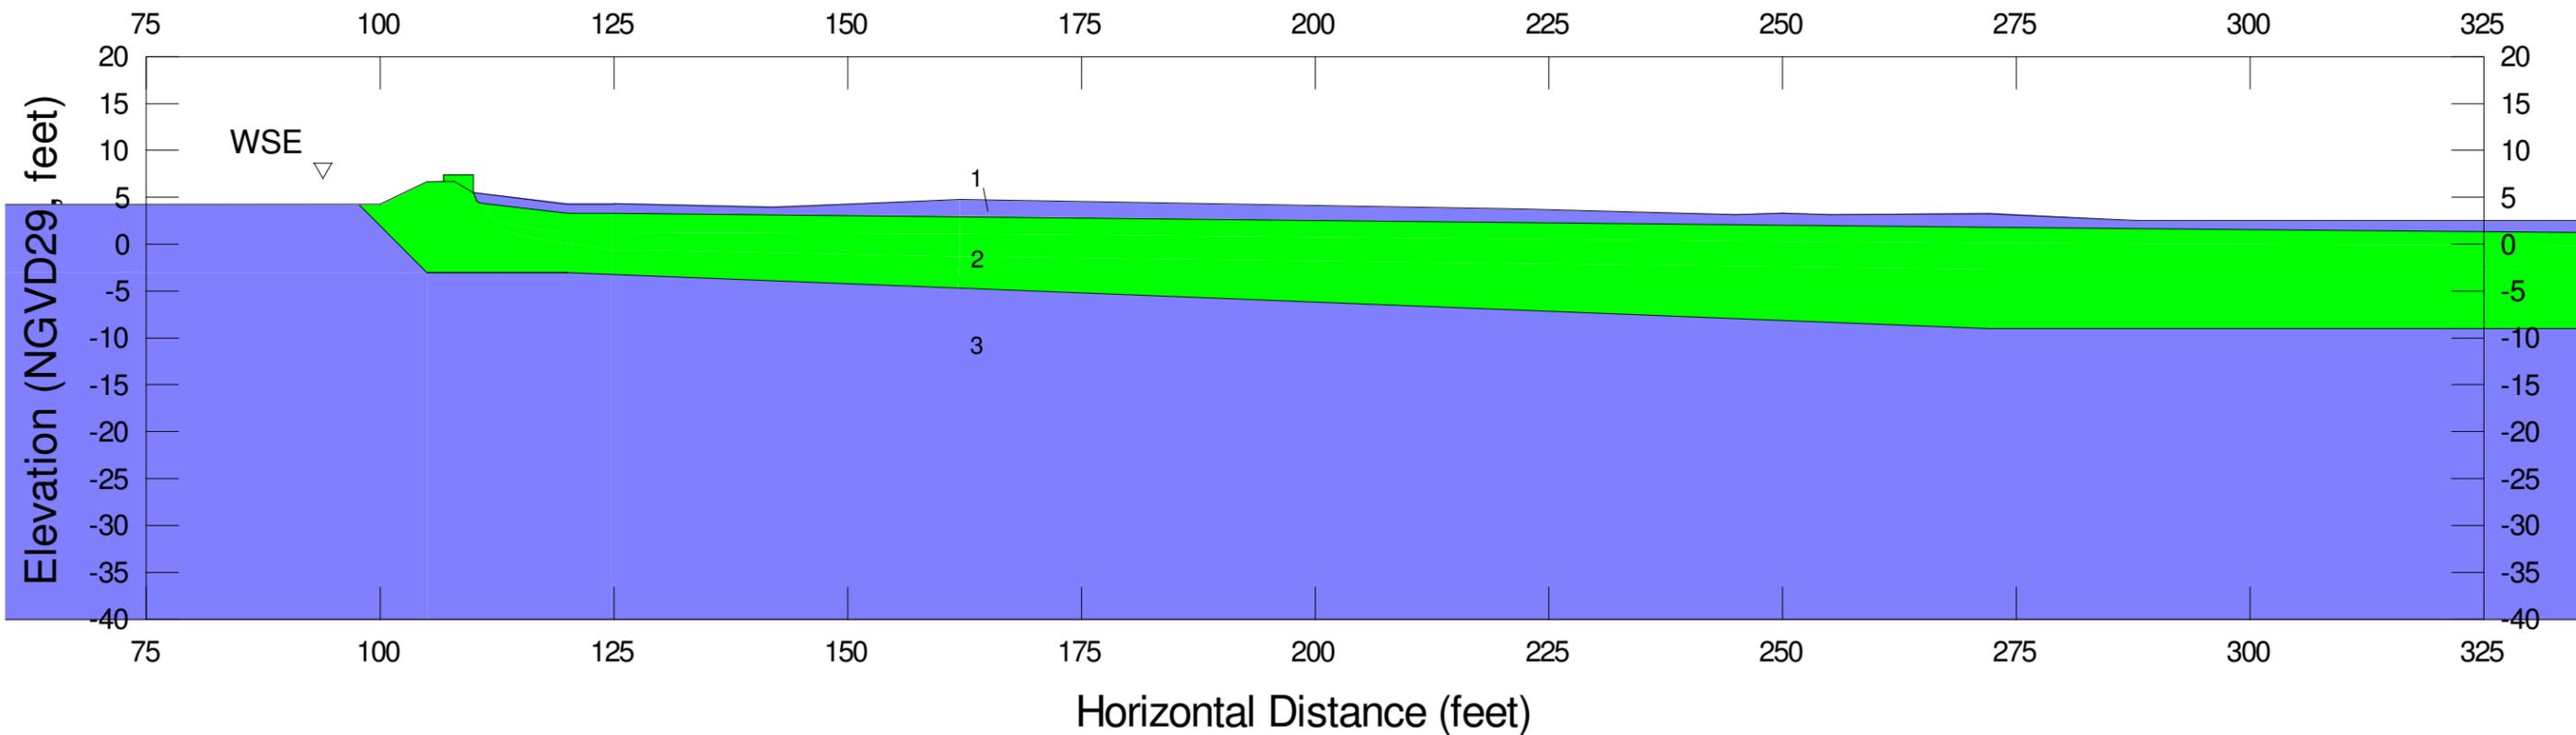
Bright People. Right Solutions. www.kleinfelder.com	PROJECT NO. 96670	SEEPAGE FRAGILITY ANALYSIS EXISTING CONDITIONS: 1 FT. BLANKET	PLATE 7
	DATE: 5.10.2013		
	DRAWN BY: R. Yuen	GEOTECHNICAL DATA REPORT LAS GALLINAS LEVEE SYSTEM SAN RAFAEL, CALIFORNIA	
	CHECKED BY: C. Hall		
FILE NAME:

Approximate Blanket Thickness at Levee Toe: 1 ft

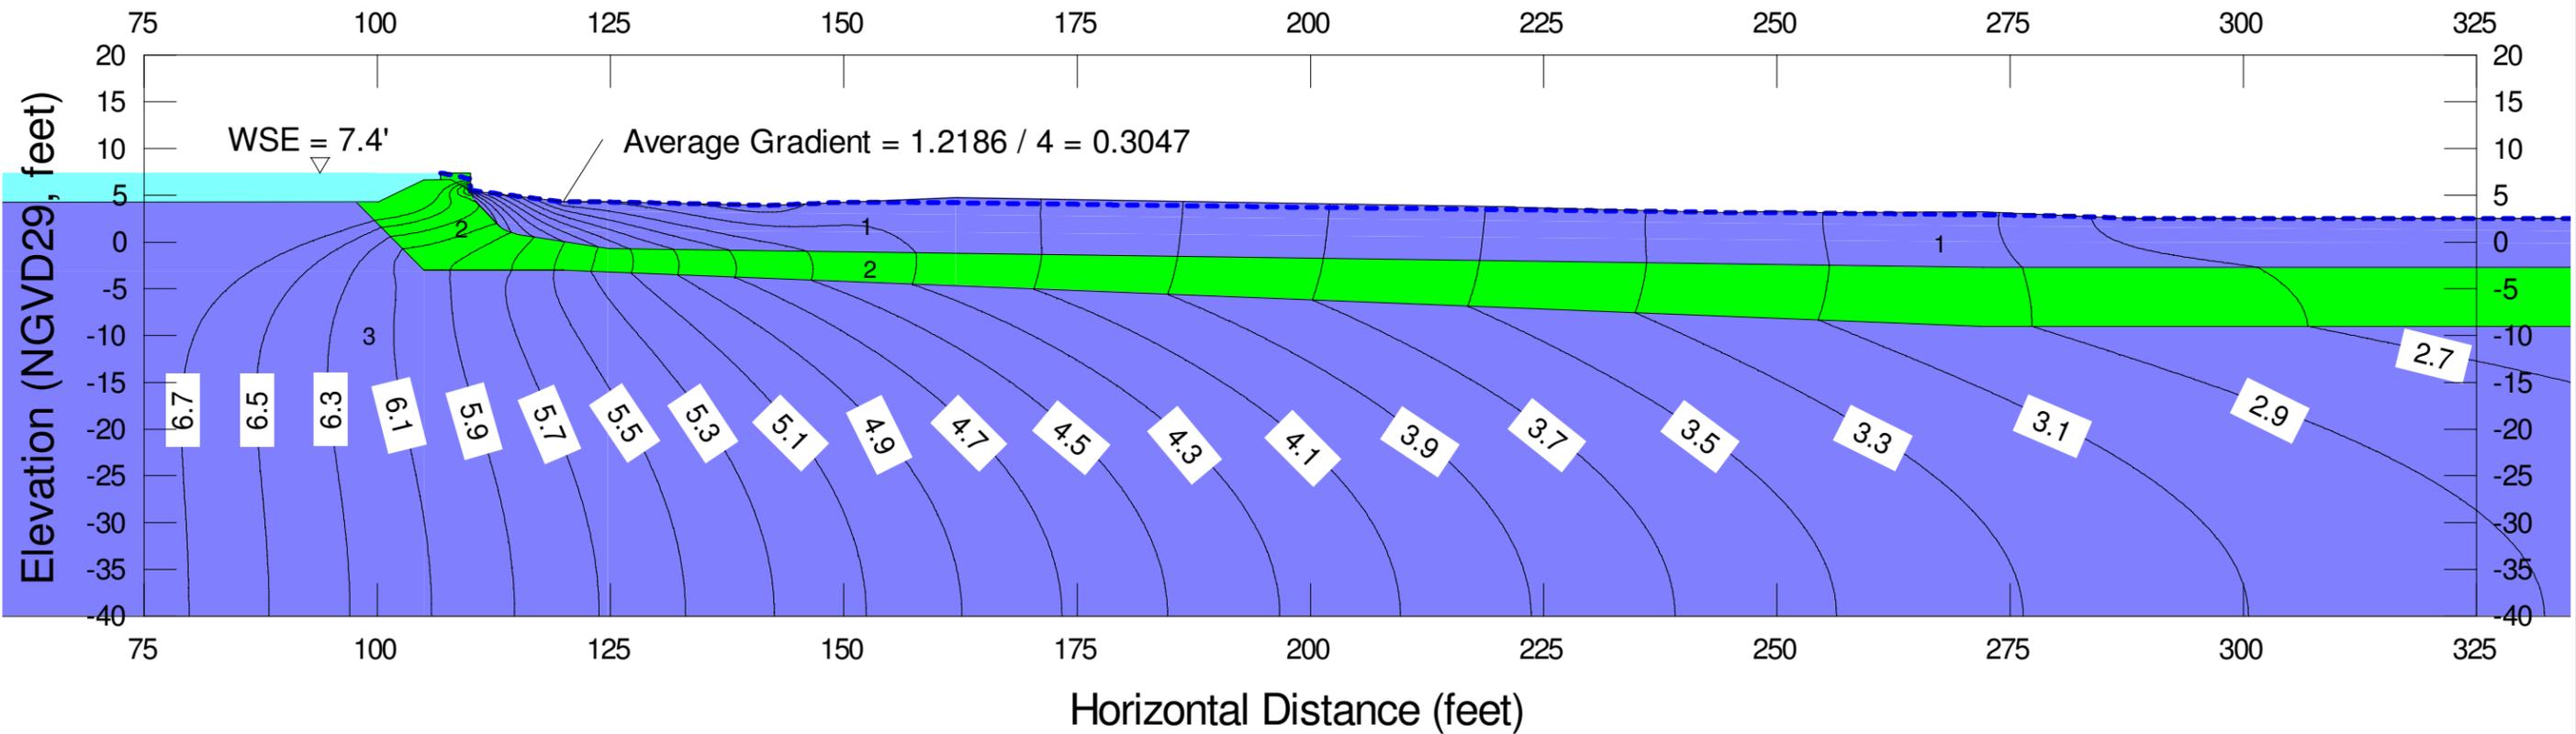
RESULTS OF SEEPAGE ANALYSIS EXISTING CONDITIONS: CASE 1A	GEOTECHNICAL DATA REPORT LAS GALLINAS LEVEE SYSTEM SAN RAFAEL, CALIFORNIA

A baseline seepage analysis, using the “expected” (or anticipated) values, was performed using SEEP/W, the results of which were used in the stability analysis (see Section 11.3). The variables used for seepage analysis input are, as previously described, the blanket thickness, the permeability ratio between the blanket and permeable layers, and the anisotropy of the blanket material. Table 11.1 presents the “expected” values of the soil properties, and the maximum and minimum values used in each of the reliability analyses. The results of the seepage analysis are presented in Table 11.2 below, where each case presented indicates a change in one of the three variables for the various WSEs (Elevations +4.3 through +7.4). Plate 8 presents a graphical result of the analysis for the four-foot blanket assuming a permeability ratio of 10 and a blanket anisotropy (k_v/k_h) of 0.25, assuming a WSE of +7.4.

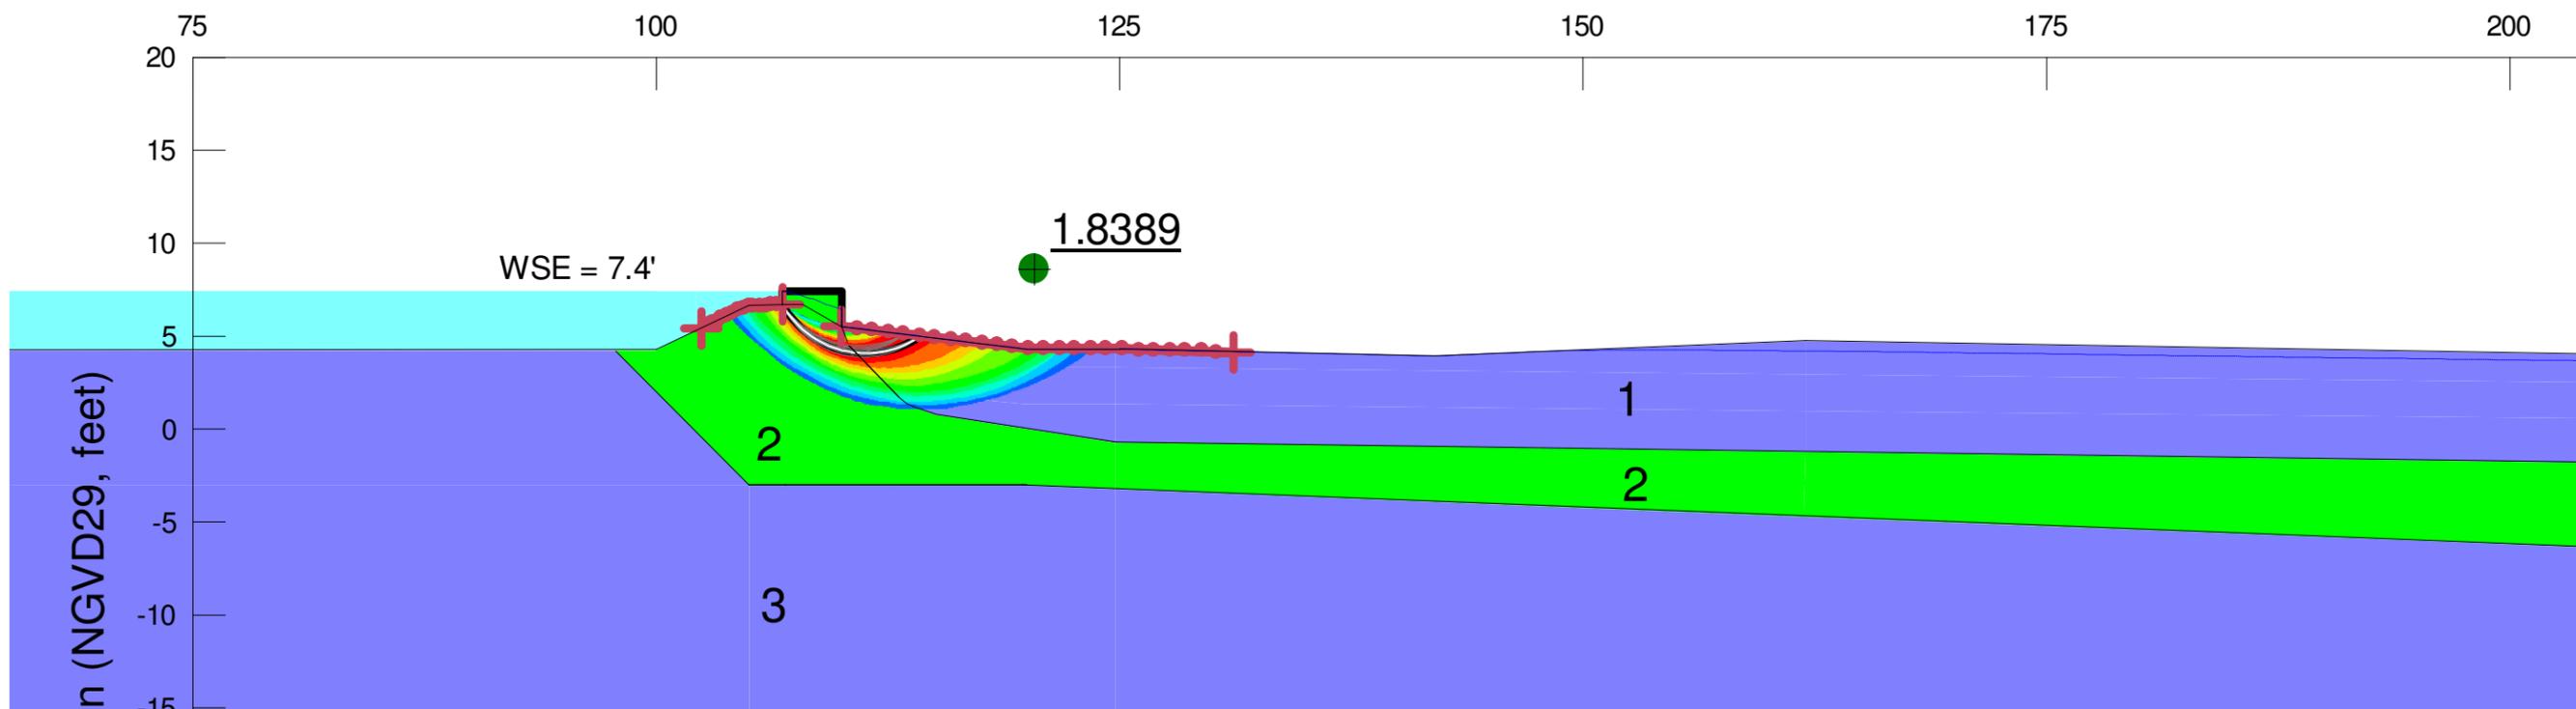
PROJECT NO.	96670	RESULTS OF SLOPE STABILITY ANALYSIS EXISTING CONDITIONS: CASE 1A "EXPECTED"	PLATE 11
	DATE:	5.10.2013		
	DRAWN BY:	R. Yuen	GEOTECHNICAL DATA REPORT LAS GALLINAS LEVEE SYSTEM SAN RAFAEL, CALIFORNIA	
	CHECKED BY:	C. Hall		
FILE NAME:

The results of the stability analysis are presented in Table 11.4. Plate 11 presents a graphical representation of the slope stability results for the “expected” case. Each case analyzed has an associated graphical result. Due to the number of analyses involved, we have not included graphical results of each analysis in this report.

Results:
 Factor of Safety = 1.8389
