**Geotechnical Evaluation of Phoenix Lake**

**PRELIMINARY GEOTECHNICAL EVALUATION  
DB5 – PHOENIX LAKE DAM & RESERVOIR  
WATERSHED FLOOD DAMAGE REDUCTION &  
CREEK MANAGEMENT STUDY  
MARIN COUNTY, CALIFORNIA**

May 6, 2010

Project 960.05

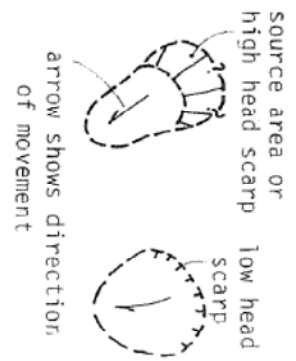
<b>Miller Pacific</b> ENGINEERING GROUP		504 Redwood Blvd. Suite 220 Novato, CA 94947 T 415 / 382,3444 F 415 / 382,3450 www.millerpac.com	
<b>Stetson - MC Flood Protection</b> Phoenix Lake Dam Marin County, California		Project No. 960.05 Date: 2/23/10	
Drawn: JTO Checked:		FIGURE 2

We performed a site inspection on February 17, 2010 to observe existing conditions and identify any significant visual threats that could preclude use of Phoenix Lake as a flood-control detention basin. Our geologic and geotechnical site reconnaissance is summarized below with our observations noted on the attached Figure 2, Geologic Map.

Active and dormant landslides exist around the reservoir as shown on Figure 2. These landslides range in size from small “pop-outs” to large dormant features. There is the potential for re-activation of existing landslides due to seismic shaking or significant saturation. We did not observe any landslide features that could significantly impact the dam. However, surficial sloughing was reported when the reservoir was drained to perform the 1960’s improvements. Based on our preliminary slope stability analyses, Phoenix Lake Dam is most susceptible to slope instability and deformation during large seismic events. The results of our analyses indicate deformation during a strong seismic event would be less than calculated deformation from the previous reports. A more detailed discussion of slope instability of Phoenix Lake Dam is presented later in this report. Given the steep slopes and erosive nature of colluvial soil deposits, the potential for landsliding and slope instability around the reservoir is moderate to high.
