## ADDENDUM NO. 2

### D Street Bridge Electric and System Upgrades City Project No. C16101933

February 04, 2020

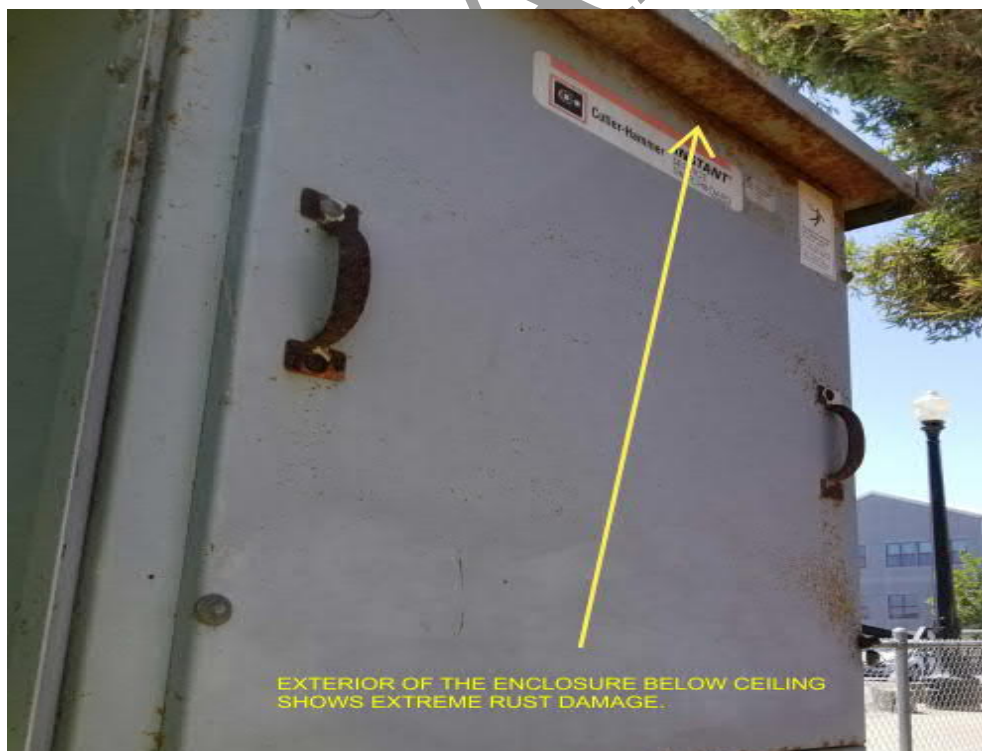
The existing 600A switchboard houses a 400A (200A fused) disconnect which was installed about 18 years ago. It shows signs of metal skin deterioration due to corrosion on portions of the exterior, interior, below the ceiling, and handles of the enclosure. Rust corrosion on the metal skin of the enclosure may indicate internal electrical parts with possible moisture and condensation of water. Circuit breakers and other tripping devices damaged by water condensation may not trip when an electrical overload occurs creating an unsafe condition for personnel. The enclosure was not identified with an Arc Flash Label which is required by NFPA-

Photo E- 2  
Exterior Service Entrance Switchboard Interior of Enclosure

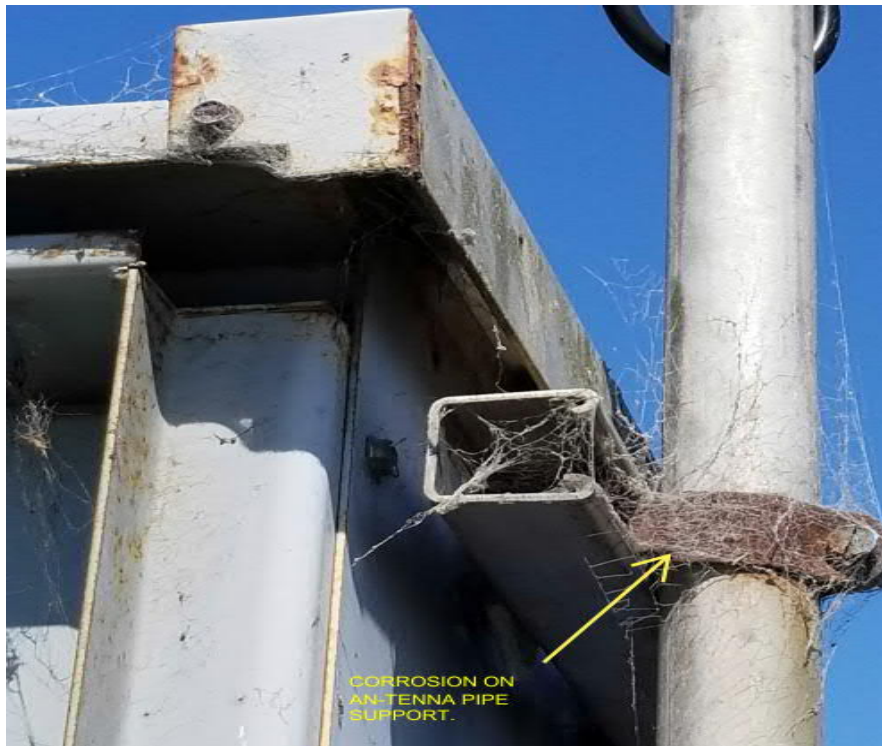
The existing MCC-2 is a 400A service entrance rated MCC located on the South West side of the bridge which was installed about 18-years ago. It shows minor signs of metal skin deterioration below the ceiling of the enclosure. The interior of the enclosure includes heat strips that remove moisture and water condensation and are powered from the interior lighting panel LP2. It was noticeable that the wireless antenna mounting hardware attached on the side of MCC-2 was very corroded and in need of replacement. The enclosure was not identified with an Arc Flash Label. Refer to photos E-5, and E-6.

Photo E- 5  
MCC-2
