**ADDENDUM NO. 4
TO THE
CONTRACT DOCUMENTS
FOR**

**City of Port Orchard, Washington
MCCORMICK WOODS WELL 11 SITE IMPROVEMENT PROJECT**

DIVER INSPECTION REPORT

McCormick #1

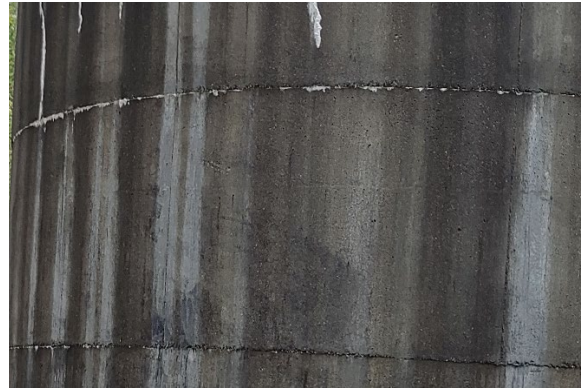
(#4) Exterior Shell Seam

The exterior walls and roof are in fair condition with calcium deposits and residue covering the reservoir. **Recommend pressure washing reservoir exterior to remove residue.** (see pictures #3-8).

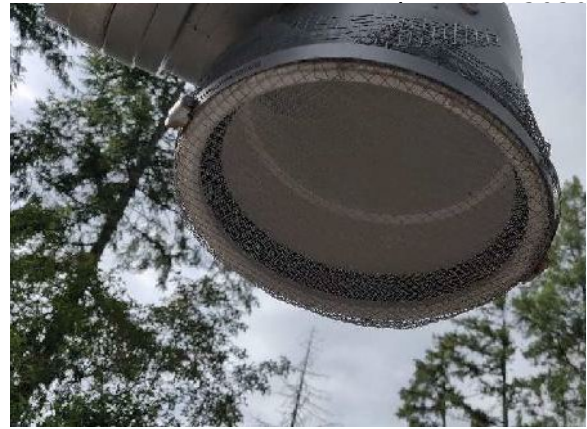
(#10) Roof Vent Screen

Roof vent and screen are in good condition.

Recommend installing a coarse screen on roof vent to protect fine mesh screen from damage. Mild corrosion is present on the interior of the vent.

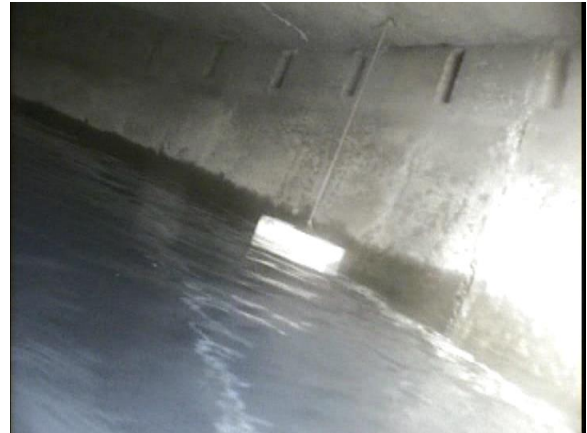
(#16) Ceiling 9 O'clock / Float

The ceiling is in good condition.

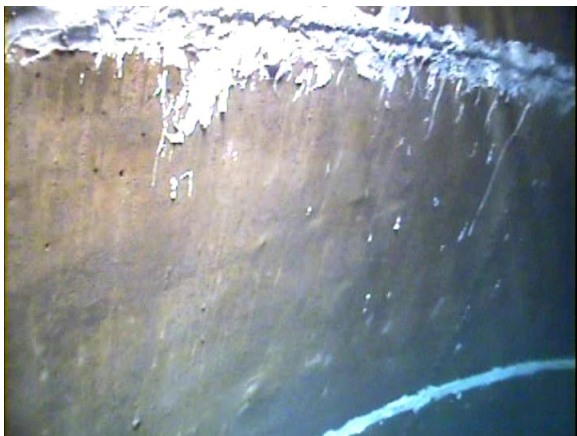
(#21) Wall Course 2 Quadrant 1

The interior walls and epoxy repairs are in good condition. There are cracks on the lower courses of quadrant 3 and 4 but no leakage was observed (see pictures #21-24).

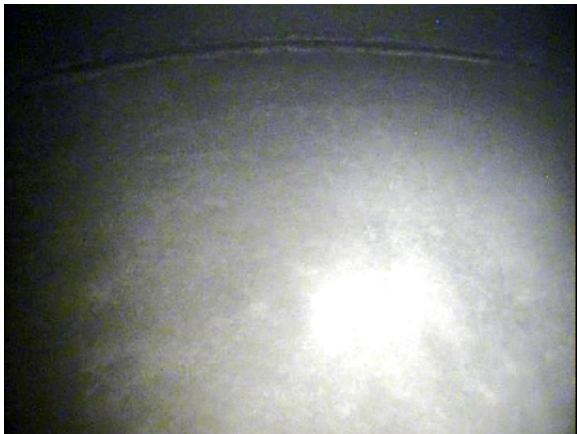
(#26) Floor Quadrant 3

The tank floor was covered with a light coating of sediment prior to cleaning. The floor is in good condition.

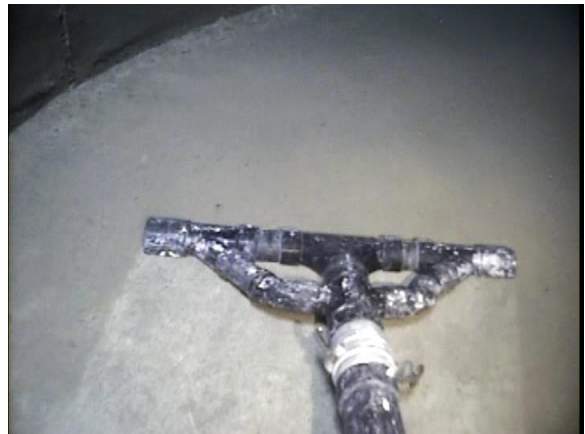
(#29) Sediment Removal

Cleaning/removal of sediment from the reservoir floor and horizontal surfaces was provided. No other maintenance or repairs were provided prior to or at the time of inspection.
