ORACLE OAK, LLC

ARBORIST REPORT

Date: 3/25/24

Re: Dominican Project (APN 015-
163-03)

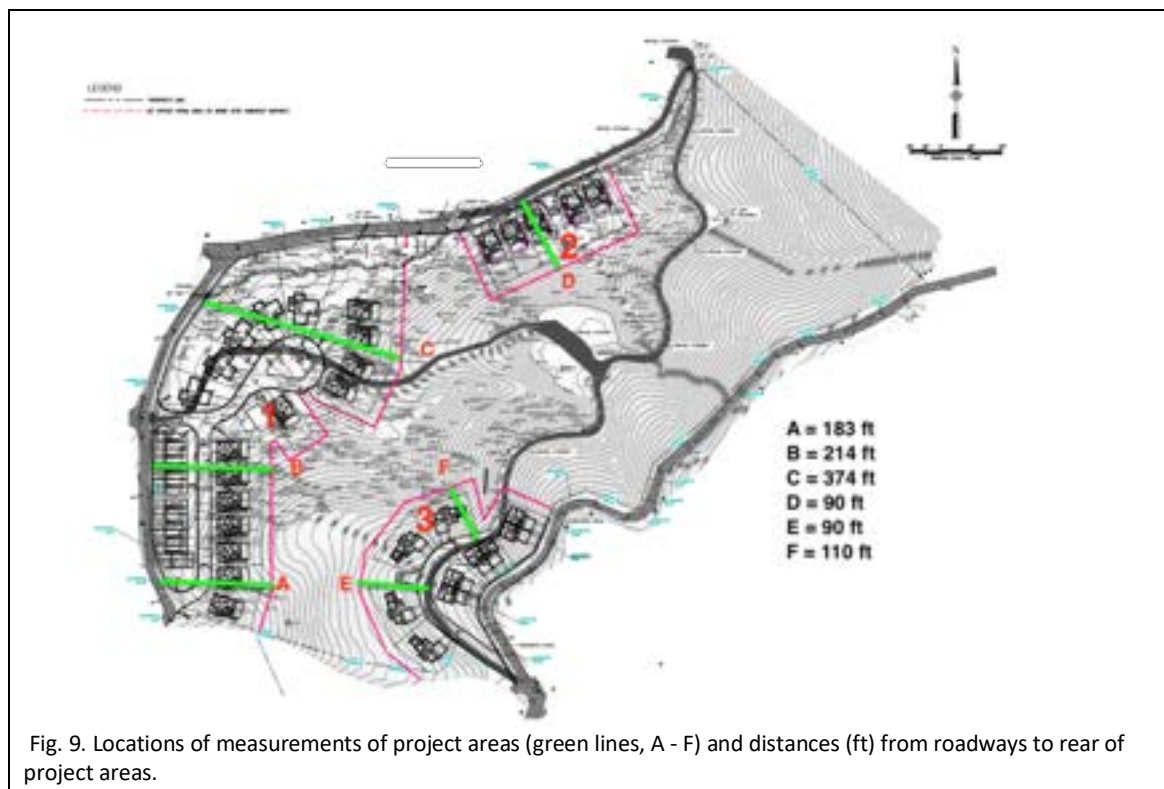
Fig. 9. Locations of measurements of project areas (green lines, A - F) and distances (ft) from roadways to rear of project areas.

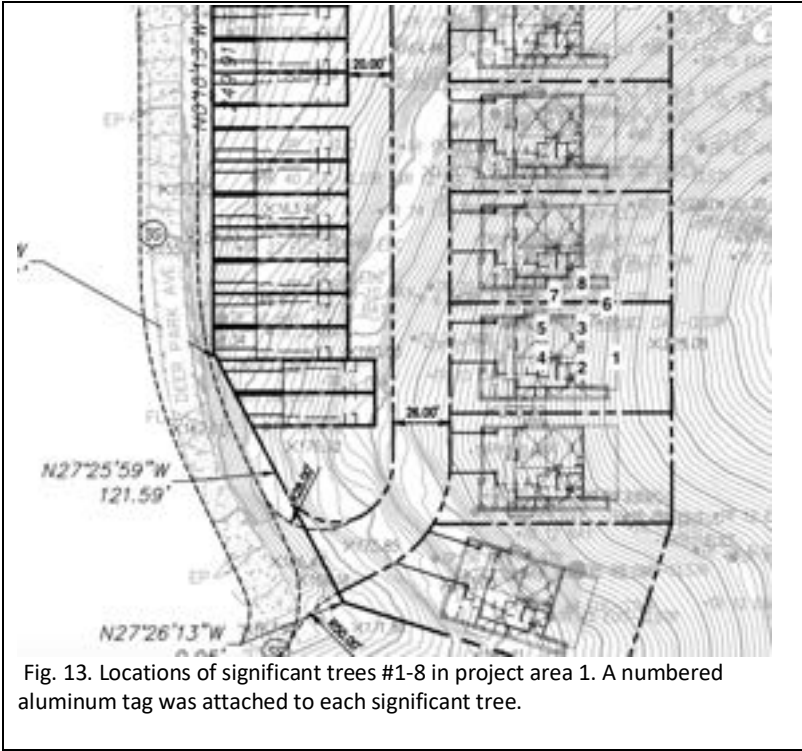
Coast live oaks that qualify as significant trees were located in project areas 1 and 3 (Figs. 12, 13,).

It is recommended that the following oak species be considered as replacement species in project areas: coast live oak (*Q. agrifolia*), island oak (*Q. tomentella*), and Oregon white oak (*Q. garryana*).
