## ARBORIST REPORT

Date: 3/25/24

Submitted to: Comari, Inc.

Re: Dominican Project (APN 015-163-03)

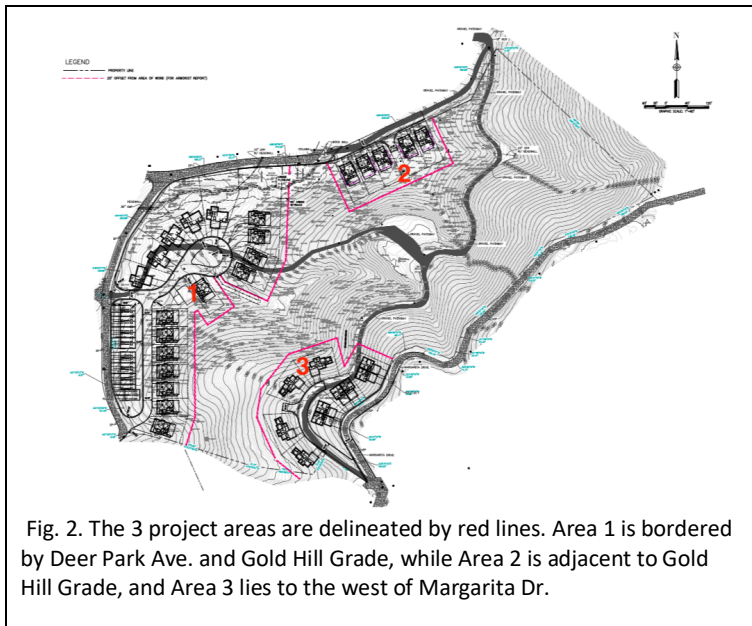
Fig. 2. The 3 project areas are delineated by red lines. Area 1 is bordered by Deer Park Ave. and Gold Hill Grade, while Area 2 is adjacent to Gold Hill Grade, and Area 3 lies to the west of Margarita Dr.

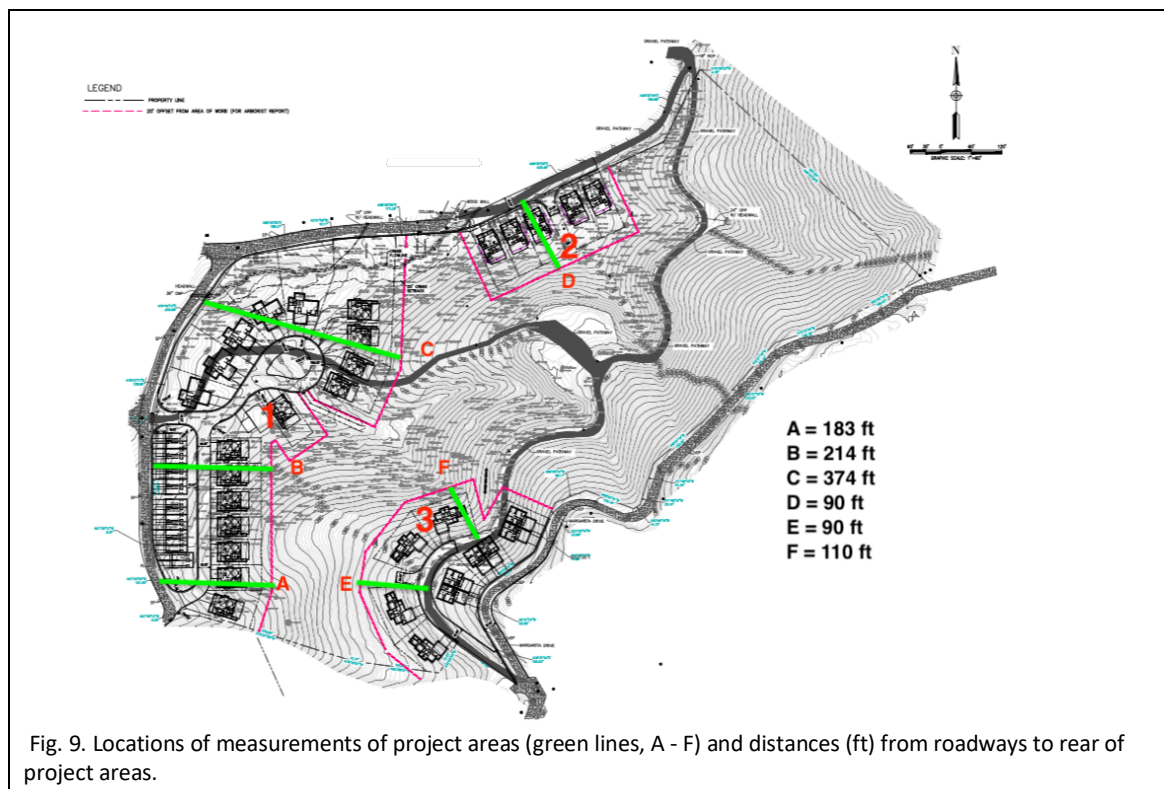
On Feb. 28, 2024, I conducted survey of all CA native trees greater than 12 inches in diameter (DBH) within the project areas (i.e., significant trees as per City of San Rafael). Distances from roadways to rear boundaries of project areas were derived from site map scales. Five measurements were taken (A-F) and marking flags were placed at the rear boundaries (Fig 9).

Fig. 9. Locations of measurements of project areas (green lines, A - F) and distances (ft) from roadways to rear of project areas.

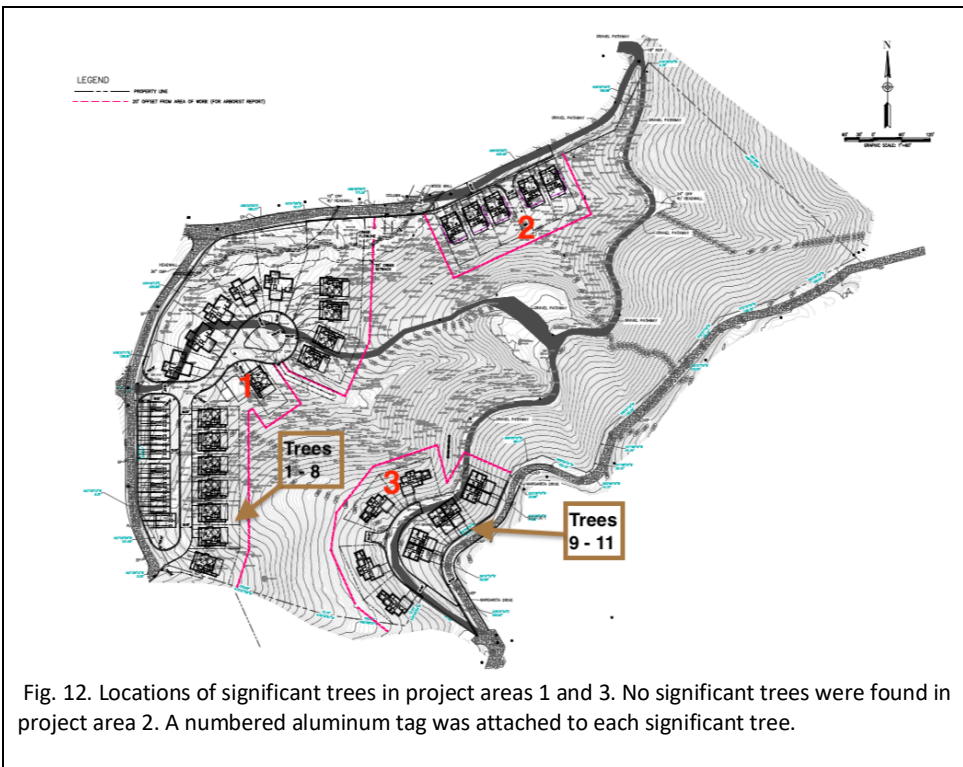
Coast live oaks that qualify as significant trees were located in project areas 1 and 3 (Figs. 12, 13, ).

Fig. 12. Locations of significant trees in project areas 1 and 3. No significant trees were found in project area 2. A numbered aluminum tag was attached to each significant tree.
