**SAN RAFAEL
PUBLIC LIBRARY
FACILITIES PLANNING
PROJECT**

**EXISTING FACILITIES
REPORT**

**City of San Rafael
California**

July 2019

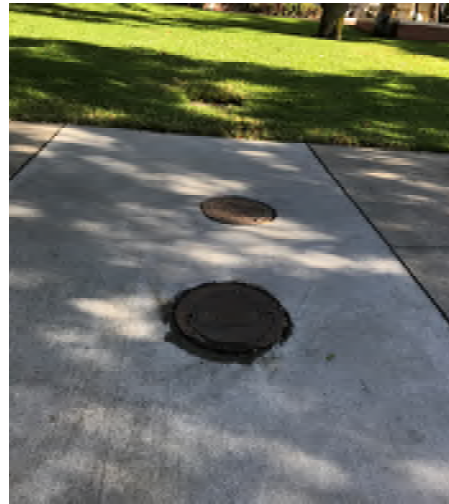
1.2 Sewer cleanouts at Fifth Ave Sidewalk. Entrance to the library can be seen on the background.

As noted from Facility Repair Supervisor, main cleanout is right outside entrance door towards Fifth Street. Cleanout consists of a concrete box with open grate on the top. All sewer running thru pipe gets exposed to rain. Sewer pipe flows towards the South to City sewer at Fifth Avenue, 2 sewer cleanouts can be seen at the side walk, See Pictures 1.1 and 1.2.

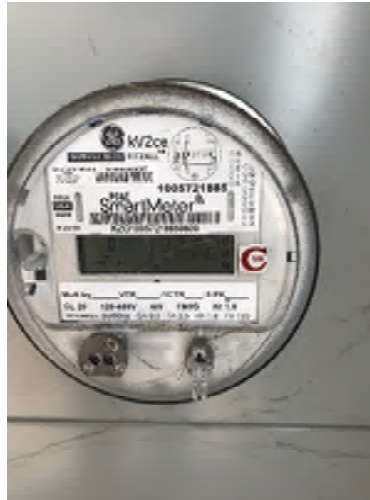
Main Electrical Service Meter

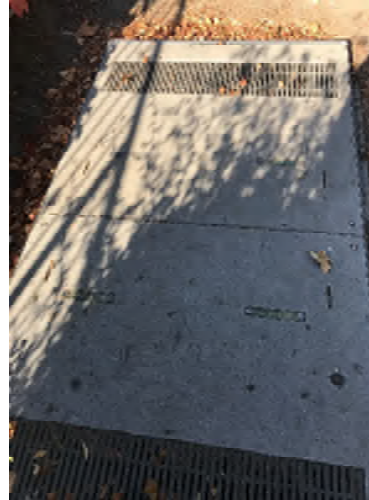
Utility Transformer Vault

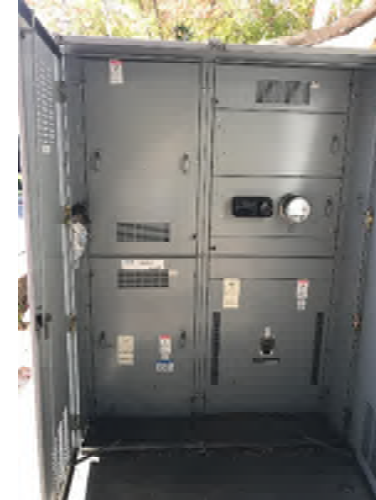
Main Meter / Main Section 1

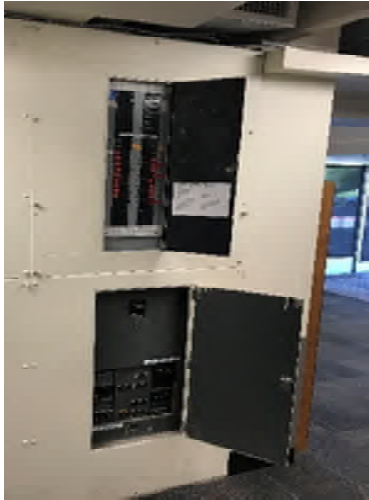
Original Distribution Panel
(At front entry Lobby)

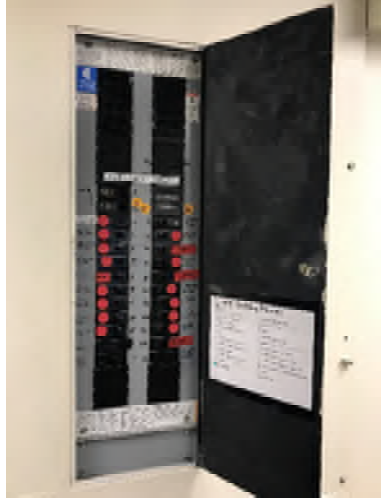
Original Branch Panels

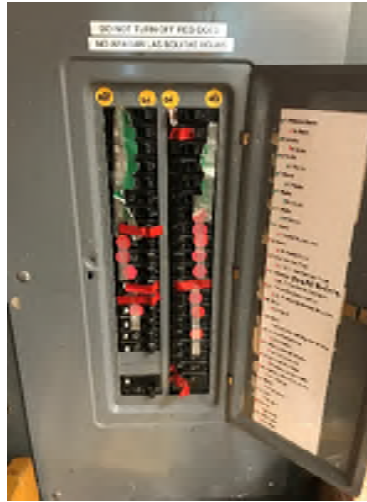
Original Branch Panels

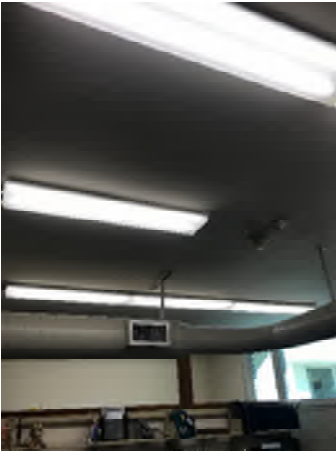
Interior Lensed Lighting

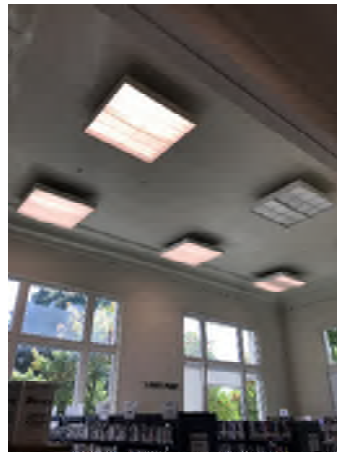
Original Bldg. Lighting

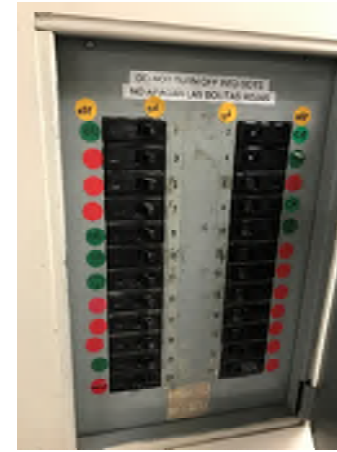
Circuit Breaker Controls

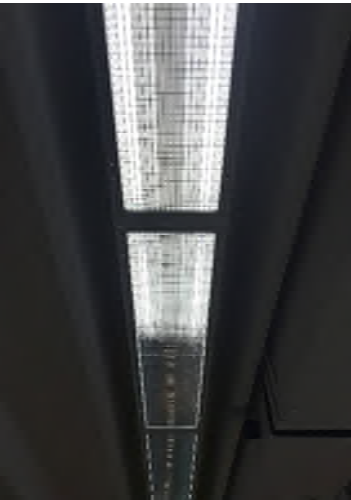
Stack Area Open Lighting

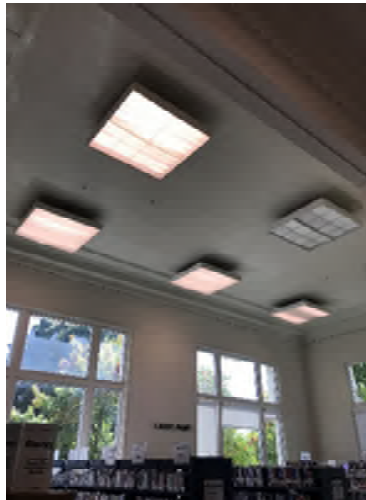
Original Bldg. Lighting

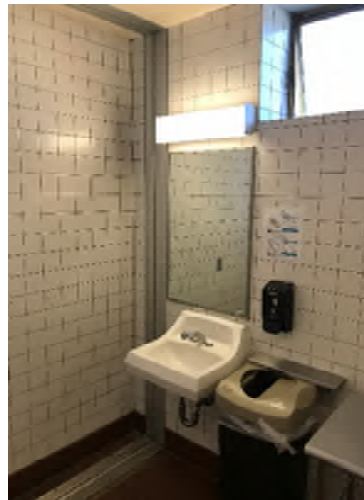
Surface Mounted Lighting

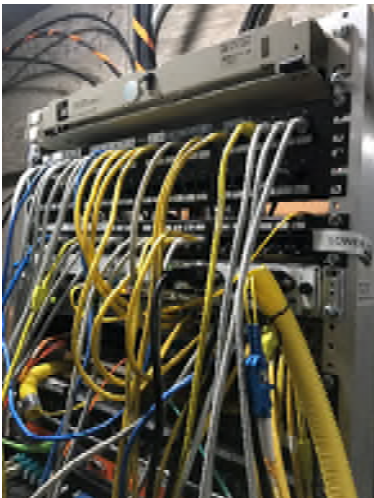
Older Cat 5 Cabling
