Historic Resource Evaluation

196 Spain Street East,

Sonoma, California

27 December 2023

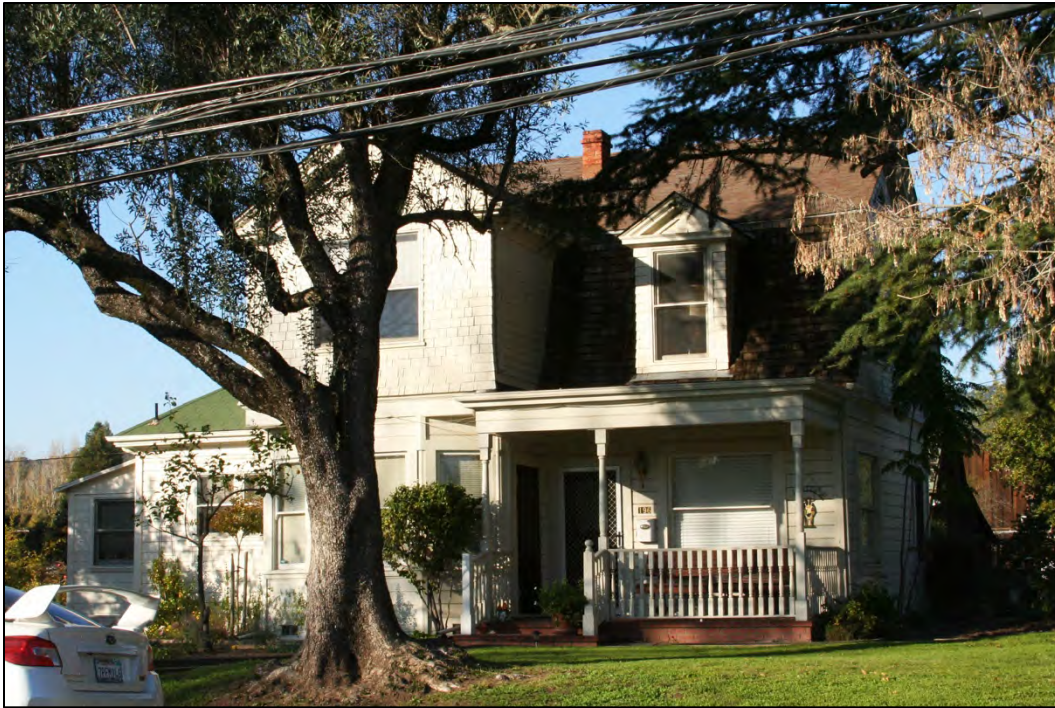
Figure 1: South facade (Spain Street)

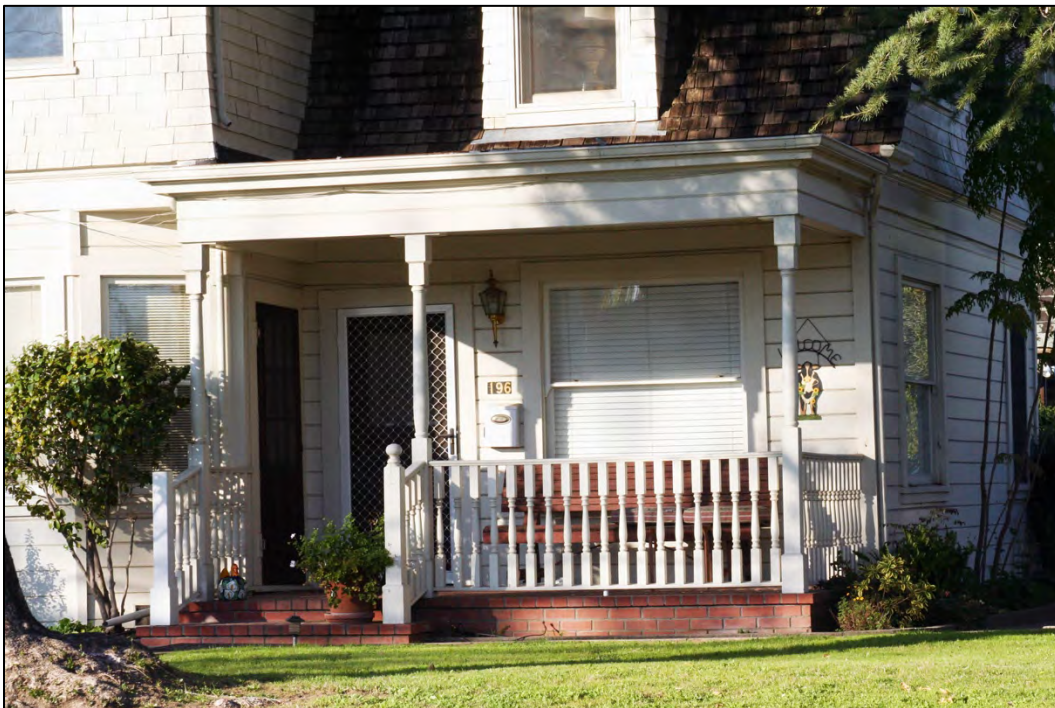
Figure 2: South facade, porch at southeast corner

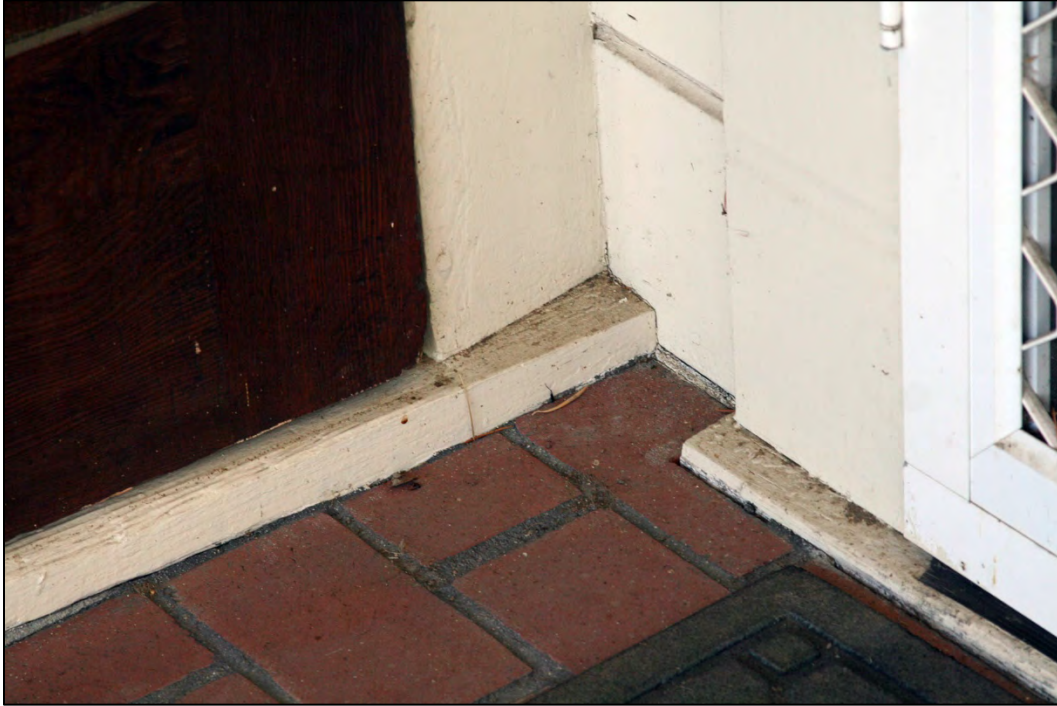
Figure 5: South facade, porch floor

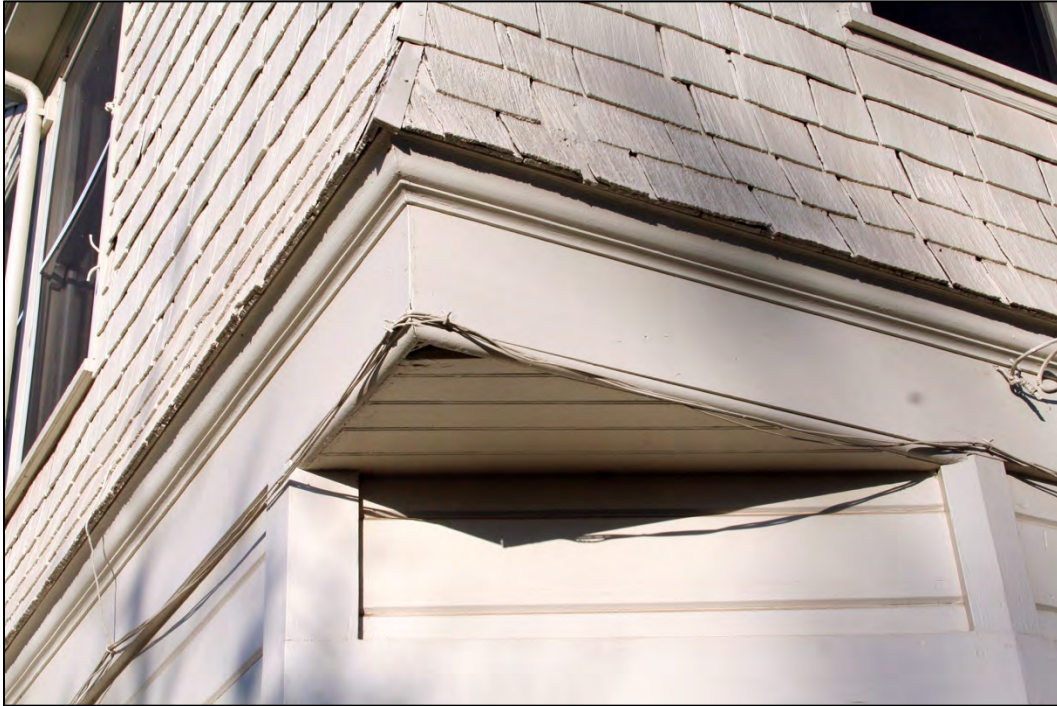
A 3-sided bay window extends across the first floor of this projected cross gable on the south façade. Each face of the bay windows has a double-hung, one-over-one, wood sash window set in chamfered trim. Beadboard encloses the projecting corners of the second story (see figure 7). Vertical trim delineates the corners of the bay.

Figure 7: South facade, bay window eave detail

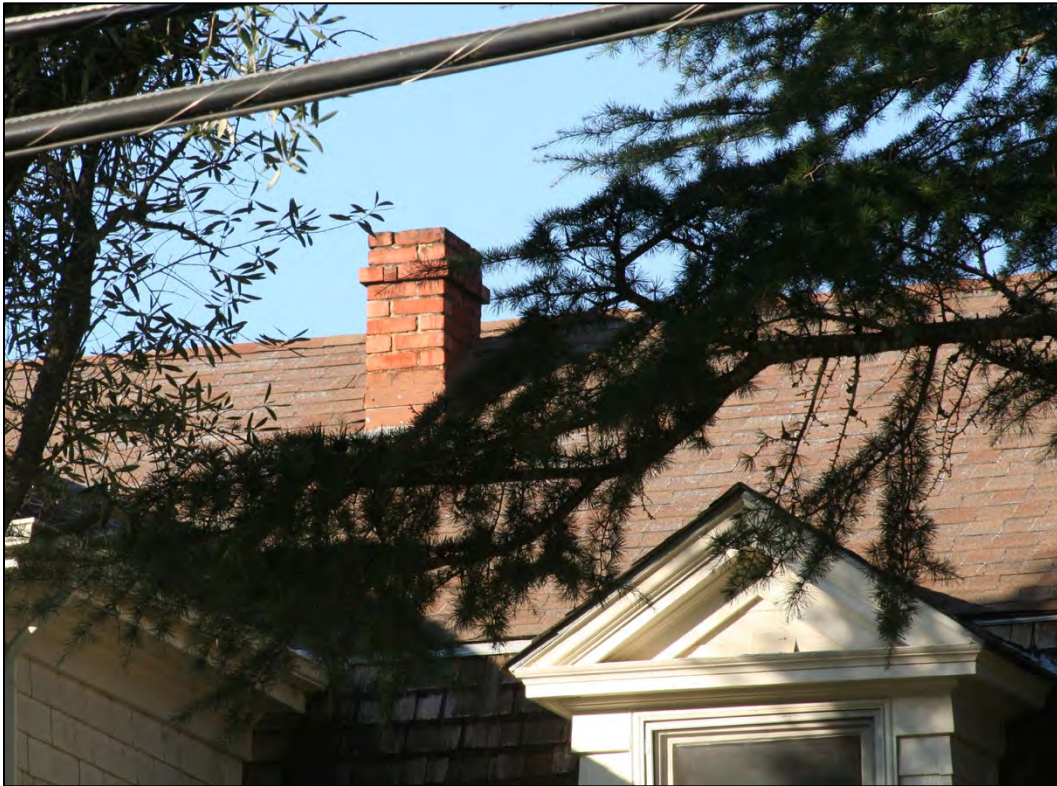
A brick chimney with a simple brick crown projects from the south slope of the roof (see figure 9).

Figure 9: South facade, brick chimney

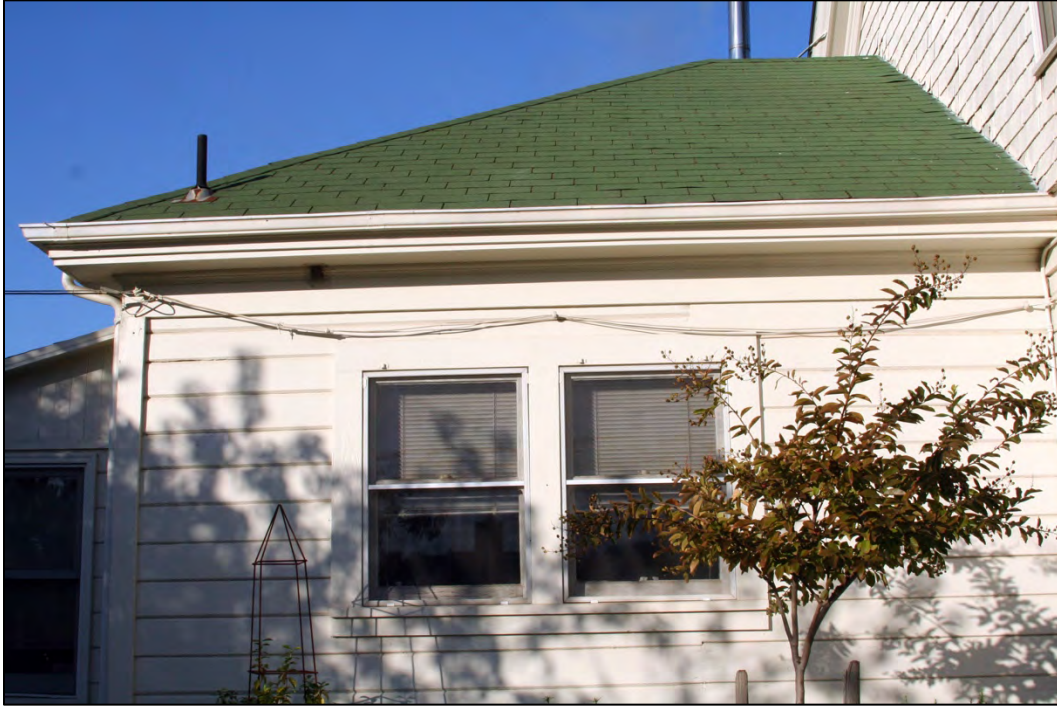
double-hung, one-over-one, wood sash windows are framed as a single unit. An unadorned fascia extends across the face of the wing, while plain wood boards delineate the corner (see figure 11).

Figure 11: South facade, west wing, pair of windows
