FACILITY CONDITION ASSESSMENT

SACRAMENTO CITY UNIFIED SCHOOL DISTRICT
5735 47th Avenue
Sacramento, California 95824

PACIFIC ELEMENTARY SCHOOL
6201 41st Street
Sacramento, California 95824

June 10, 2020

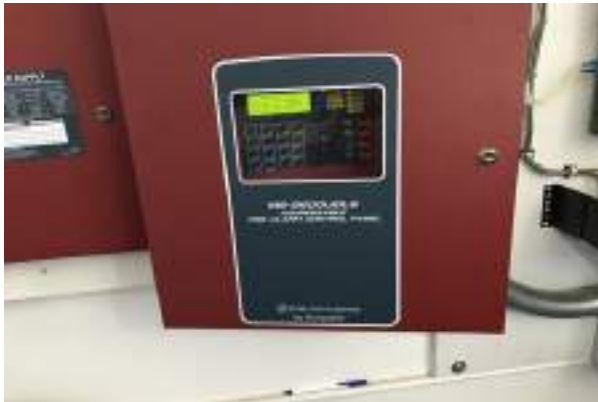
#21	FIRE ALARM CONTROL PANEL, BASIC/ZONED, REPLACE
-----	---
