FACILITY CONDITION ASSESSMENT

SACRAMENTO CITY UNIFIED SCHOOL DISTRICT
5735 47th Avenue
Sacramento, California 95824

JOHN STILL MIDDLE (EAST CAMPUS)
2250 John Still Drive
Sacramento, California 95832

June 11, 2020

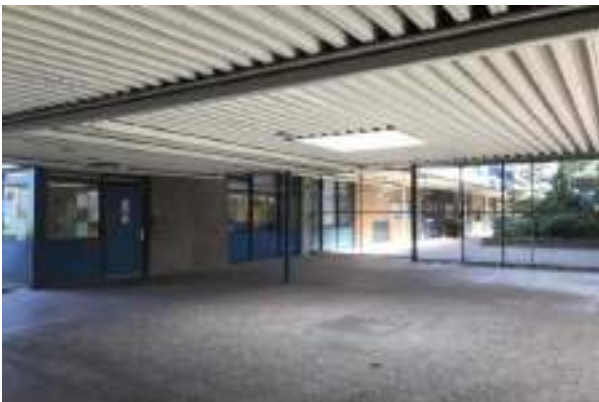
#5	BUILDING B AT OFFICES
----	-----------------------

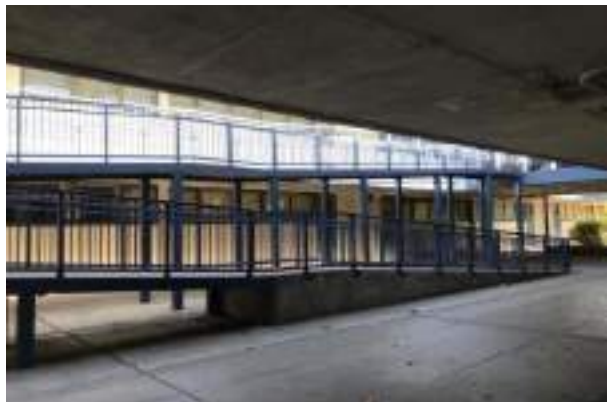
#6	BUILDING B RAMP
----	-----------------

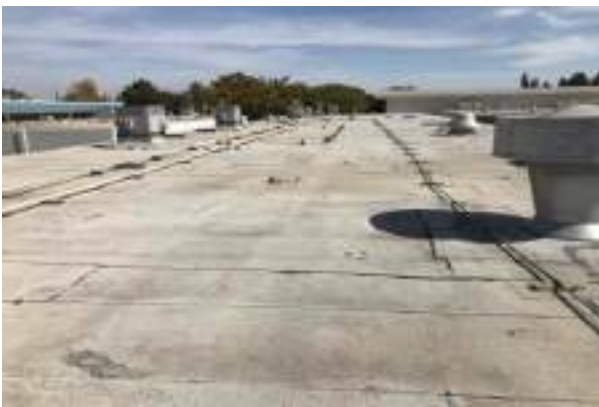
#15	BUILDING E ROOF, TYPICAL ROOFING FINISH
-----	---

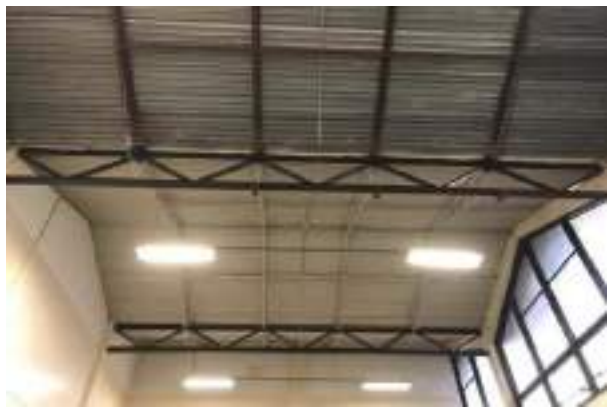
#16	BUILDING D STRUCTURE
-----	----------------------

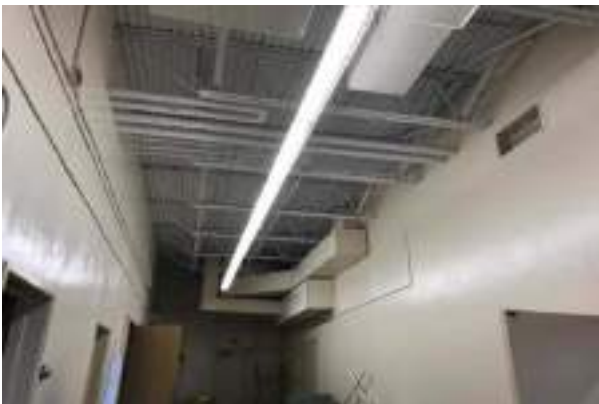
#17	BUILDING E STRUCTURE
-----	----------------------

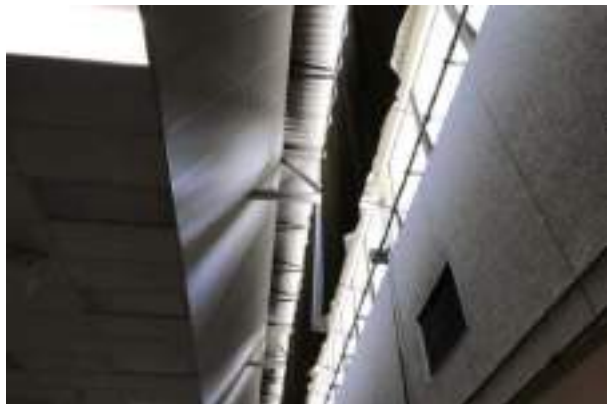
#18	BUILDING F STRUCTURE
-----	----------------------

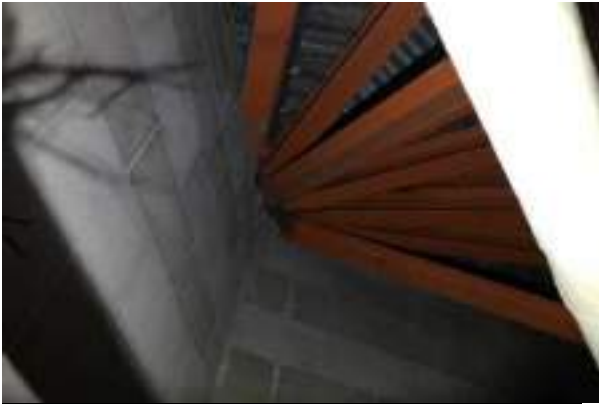
#19	BUILDING G STRUCTURE
-----	----------------------

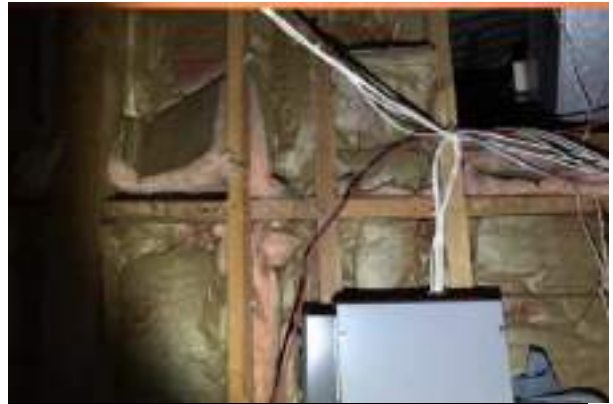
#20	BUILDING G INSULATION 3 1/2 INCH BATT
-----	---------------------------------------

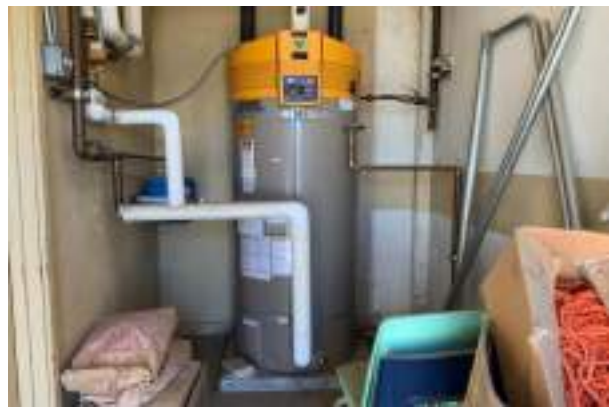
#22	GYM WATER HEATER
-----	------------------
