FACILITY CONDITION ASSESSMENT

SACRAMENTO CITY UNIFIED SCHOOL DISTRICT
5735 47th Avenue
Sacramento, California 95824

ALBERT EINSTEIN MIDDLE SCHOOL
9325 Mirandy Drive
Sacramento, California 95826

June 10, 2020

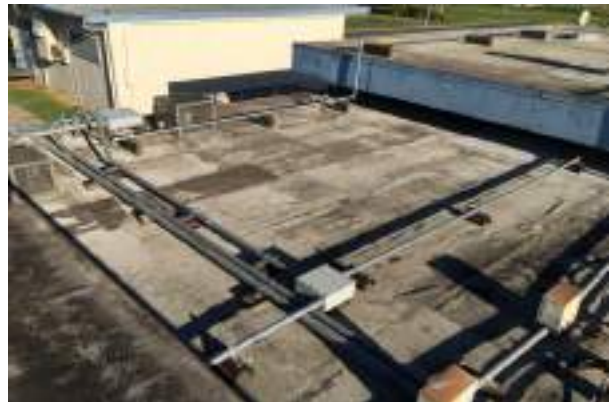
#12	MODIFIED BITUMINOUS ROOF MEMBRANE
-----	-----------------------------------

Roof in Poor condition.

Roof has problems with seals cracking and blisters in the bituminous material. - AssetCALC ID: 1482944

Uniformat Code: B3011
Recommendation: **Replace in 2020**

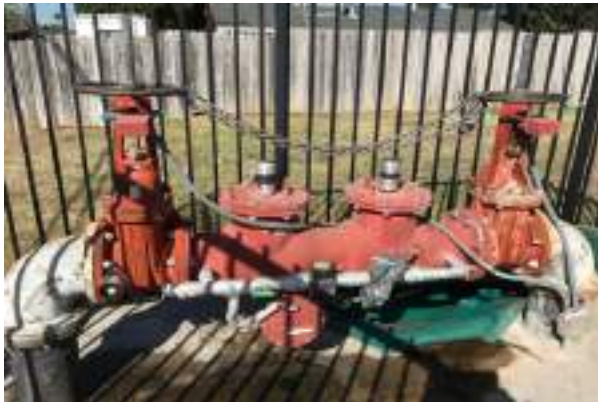
#26	BACKFLOW PREVENTER, DOMESTIC, 4"
-----	----------------------------------

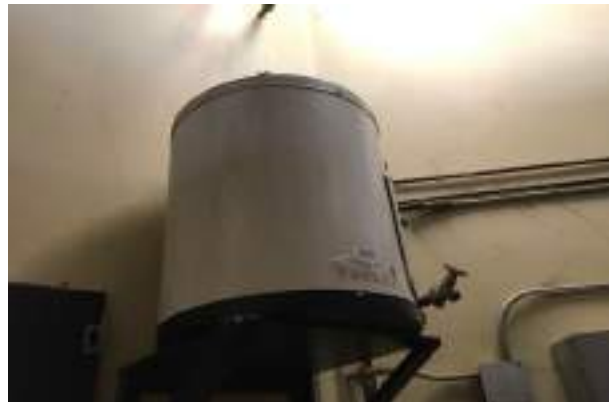
#29	DOMESTIC BOILER, GAS
-----	----------------------
