Inspection Detail

Client:	CloudStore		
	Inspected by:			
	Location of Inspection:	1116 MN-23, Pipestone, MN 56164		
	Phone No / Email:	+1 507 820 1720 / nonapplicable@gmail.com		
	Date of Inspection:	6/19/2024	Job#:	8688u58jk
	Year:	2019	Make:	Komatsu
	Model:	PC138US	VIN:	KMTPC261JJA052547

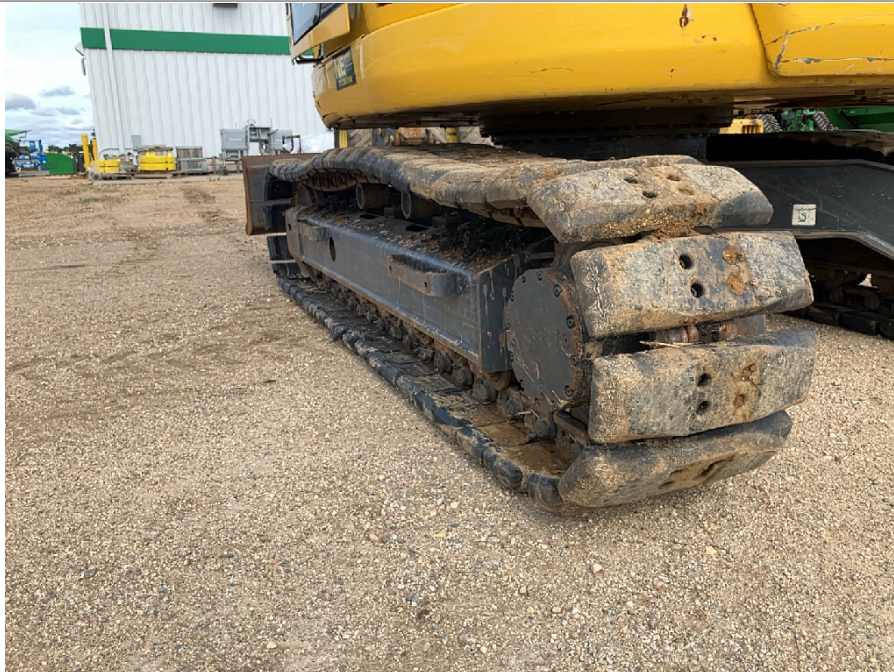
Left Track Condition / Left Track Rollers

The Front and Rear Lights are not operational. The bucket is missing. The rear counterweight has paint scratches on it. Both of the tracks appear to be loose. The unit is showing a warning for the fan control system abnormality on the dash at the time of inspection. The headliner and roof panel are stained. The armrests on the operator seat are worn. The bottom aftermarket seat cover is coming off. The left foot pedal pad cover is missing. The front right sheet metal panel is dented and the paint is missing. The right center sheet metal cover is bent and dented. The rear right compartment door panel is bent and dented. The front right step is bent. The engine coolers appear to be dirty. The tie-down loops on the sides of the blade appear to be broken off. The blade lift cylinder shields appear to be missing on top of the cylinders. The rubber track shoes have cuts and gouges in them. Some of the track link pins are starting to show wear. The coolant is low in the reservoir. The front right grab handle appears to be bent. The front left lower sheet metal below the cab appears to be bent.

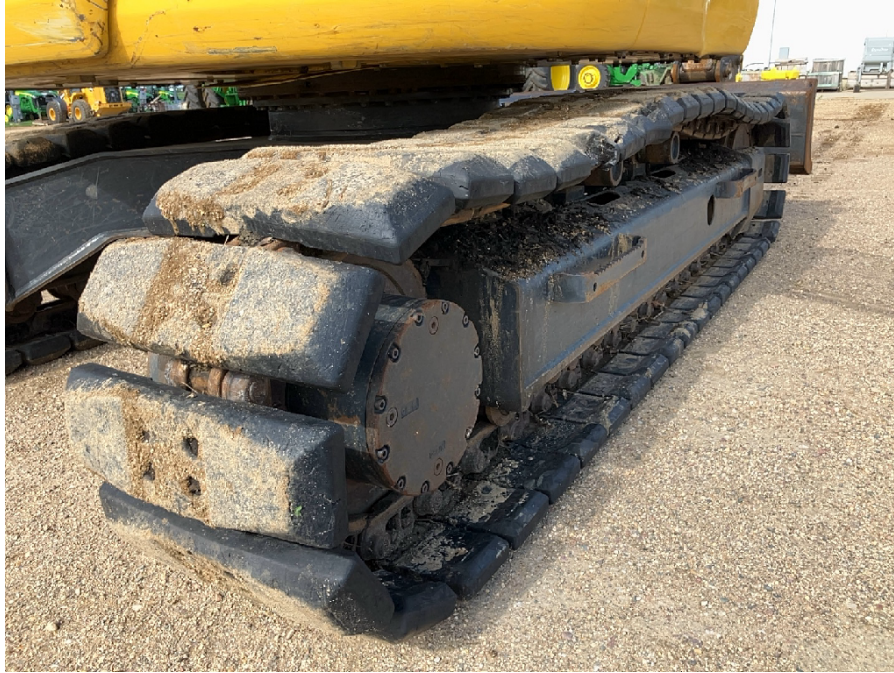
Right Track Condition

Right Track Condition:	See Notes	Right Track Brand:	Obstructed	Right Track Size:	Obstructed
Right Track Tread Depth Measurement:	2.75"	Right Track-Idler:	No Damages Observed	Right Track-Sprocket:	No Damages Observed
Right Track Rollers:	No Damages Observed				
Left Track Condition:	No Damages Observed	Left Track Brand:	Bridgestone	Left Track Size:	Obstructed
Left Track Tread Depth Measurement:	2.75"	Left Track-Idler:	No Damages Observed	Left Track-Sprocket:	No Damages Observed
Left Track Rollers:	No Damages Observed
