FACILITY CONDITION ASSESSMENT

Oakley Elementary
1120 West Harding Avenue
Santa Maria, California 93458

158764.22R000-016.017

February 23, 2023

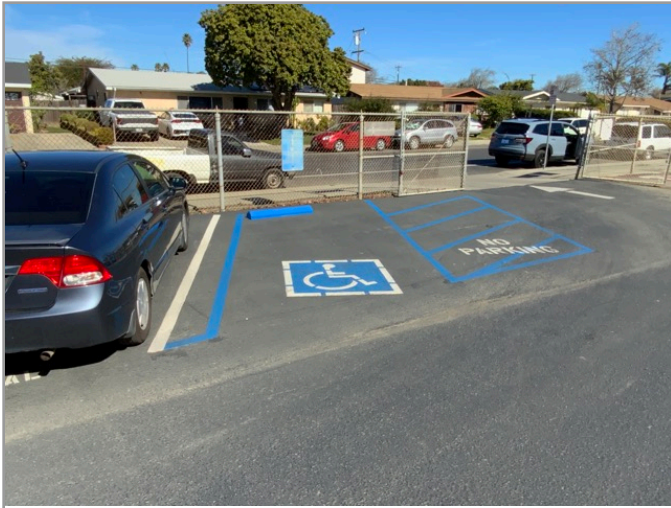
OVERVIEW OF ACCESSIBLE PARKING AREA

Question		Yes	No	NA	Comments
1	Does the required number of standard ADA designated spaces appear to be provided ?	✘			
2	Does the required number of van-accessible designated spaces appear to be provided ?		✘		No Van Parking signage
3	Are accessible spaces on the shortest accessible route to an accessible building entrance ?	✘			
4	Does parking signage include the International Symbol of Accessibility ?	✘			
5	Does each accessible space have an adjacent access aisle ?	✘			
6	Do parking spaces and access aisles appear to be relatively level and without obstruction ?	✘
