FACILITY CONDITION ASSESSMENT

Bonita Elementary
2715 West Main Street
Santa Maria, California 93458

158764.22R000-007.017

February 20, 2023

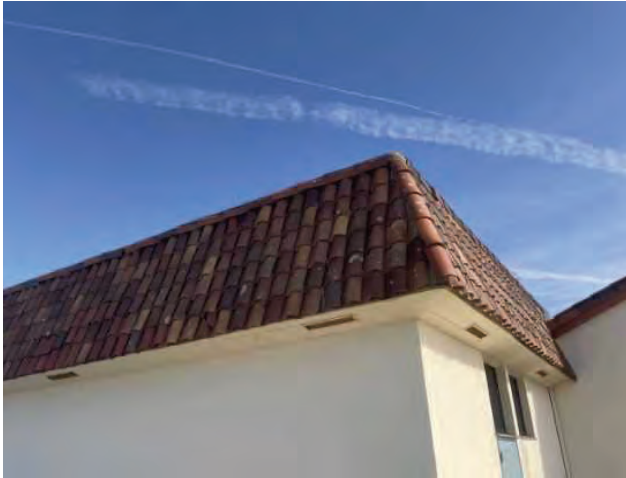
7 - TILE ROOFING

Roofing in Poor condition.

Clay tiles have passed usable life with visible broken and cracked sections - AssetCALC ID: 5145157

Uniformat Code: B3010
Recommendation: **Replace in 2025**
