# FACILITY CONDITION ASSESSMENT

## **DLR Group**

Bruce Elementary  
601 West Alvin Avenue  
Santa Maria, California 93458

*February 21, 2023*

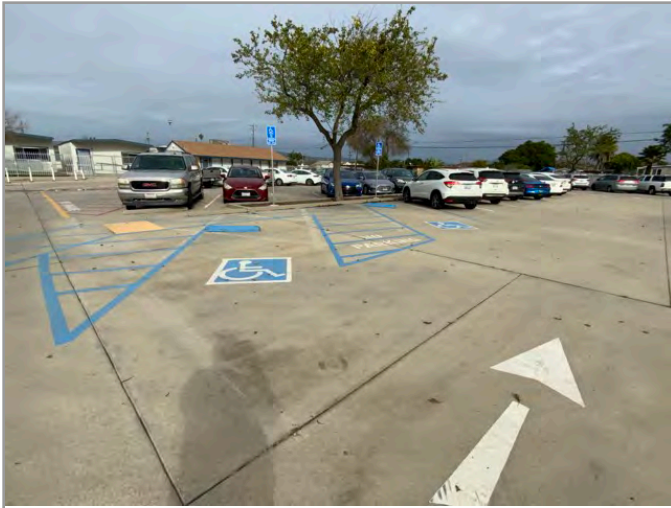
OVERVIEW OF ACCESSIBLE PARKING AREA
