**Grand Valley State University
Stormwater Management Plan
Allendale Campus**

EGLE SAW Grant No. 1143-01

**Project No. 191361
February 6, 2023**

**Prepared For:
Grand Valley State University
Allendale, Michigan**

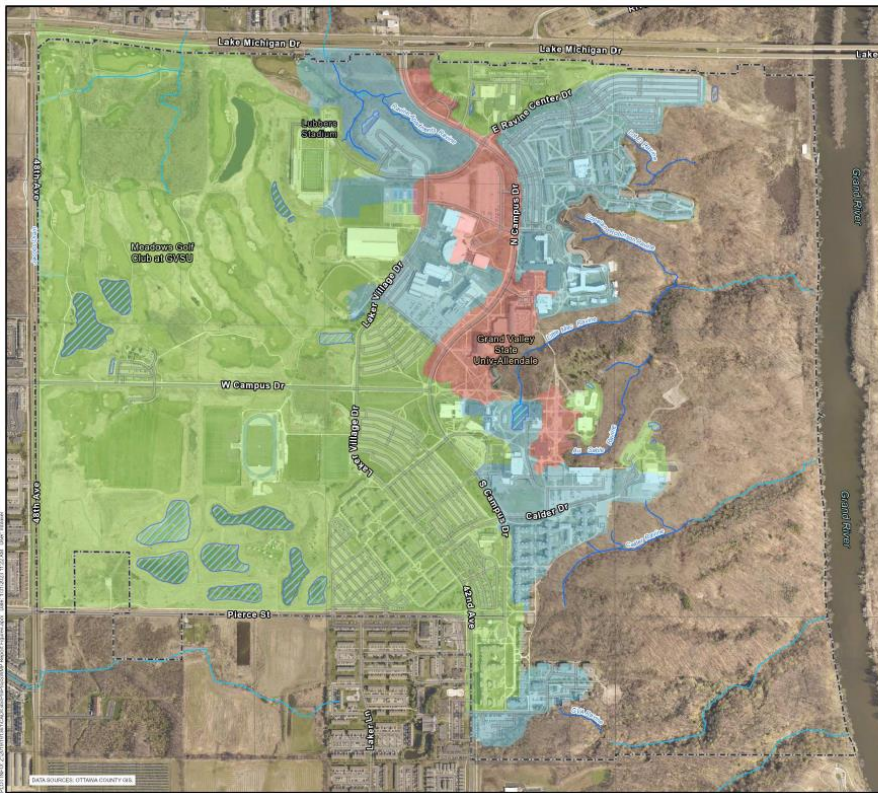
PROJECT NO. 191361
FIGURE NO. 14

Assessment of the stormwater system consisted of delineating and prioritizing stormwater drainage areas. Drainage areas were prioritized as high, medium, or low based on the type and capacity of existing stormwater BMPs, as shown in Figure 14. Drainage Areas rated "high" priority are those lacking adequate stormwater BMPs.

Uncontrolled discharge of stormwater is generally associated with high priority areas. A "medium" priority drainage area has some stormwater BMPs, but improvements could be realized thru implementation of additional BMPs. Lastly, a "low" priority drainage area has sufficient stormwater BMPs. Evaluation of the stormwater wetland complexes was conducted to determine if design intent is being maintained. Assessment of Zumberge Pond was conducted to evaluate overall function and determine impacts from potential addition to Kirkhof Center. Ravines, which are situated primarily on the east side of campus and convey stormwater to the Grand River, were inspected to evaluate ravine erosion and identify areas of concern. Location and overall function (above ground BMPs only) of existing storm water BMPs was also conducted. Lastly, site-specific areas of known concerns were inspected. Corrective measures identified as a result of the stormwater system assessment are discussed in the Recommendation section of this report. Representative photos of site inspection are provided in Appendix 1.
