# FACILITY CONDITION ASSESSMENT

## **DLR Group**

Temecula Middle  
42075 Meadows Parkway  
Temecula, California 92592

*September 8, 2021*

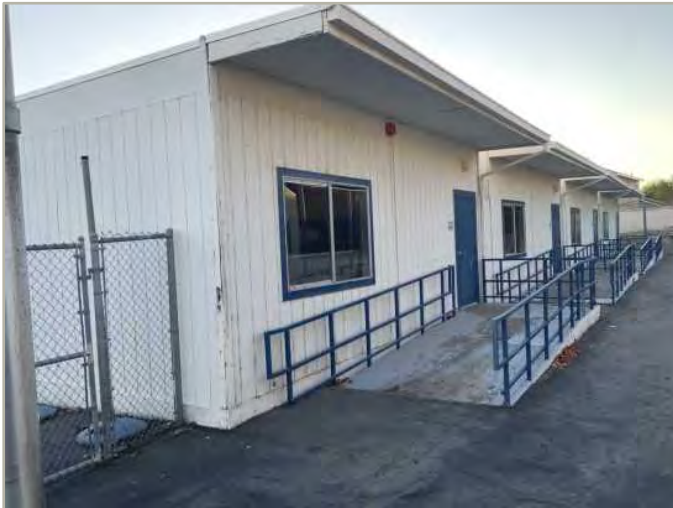
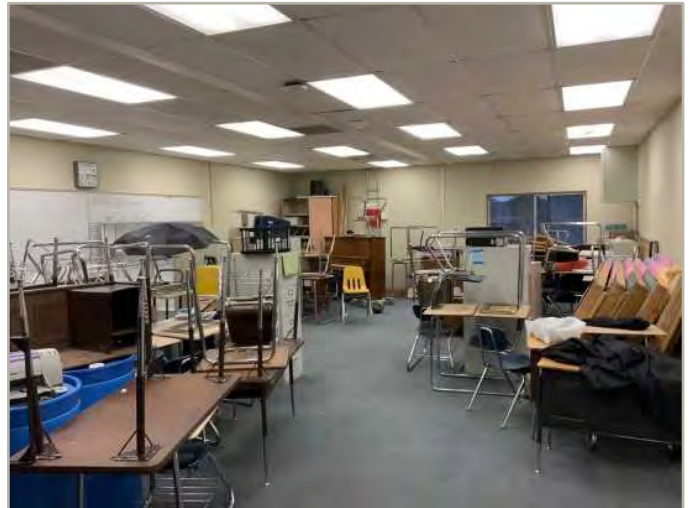
## 11. Portables 700 - Classrooms

Portables 700 appears to be used for storage only, the wood ramps and trim are in a state of deterioration, with the ramps creating a safety hazard if put back in use. The trim and ramps are also in a state of deterioration on the portable ramps 901-905 though four of the ramps have been repaired while the fifth is likely slated for repair soon.

<b>Electrical</b>	Source and Distribution: Circuit breaker panels fed from main switchgear with copper wiring Interior Lighting: LED Emergency Power: None	Fair
<b>Fire Alarm</b>	Smoke detectors, alarms, and strobes	Good
<b>Equipment/Special</b>	None	--
<b>Accessibility</b>	Presently it does not appear an accessibility study is needed for this building. See Appendix D.	
<b>Key Issues and Findings</b>	Exterior trim is cracked, splintering, and deteriorating. Access ramps are cracked, splintering, and deteriorating creating trip hazards.

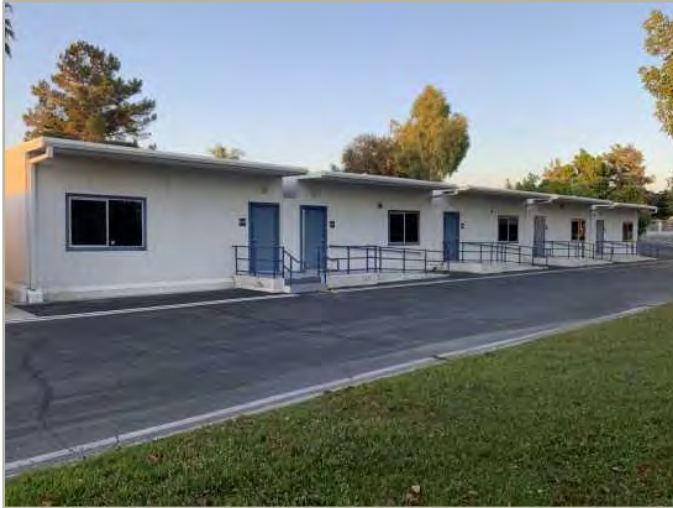
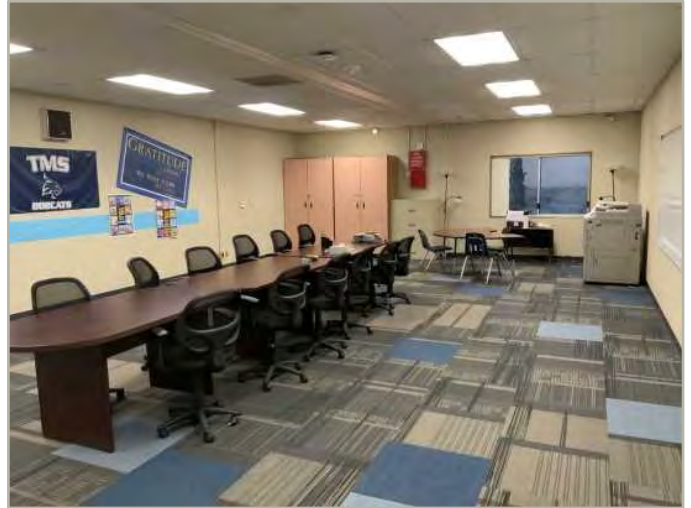
## 12. Portables 901-905 - Classrooms

<b>Electrical</b>	Source and Distribution: Circuit breaker panels fed from main switchgear with copper wiring Interior Lighting: LED Emergency Power: None	Fair
<b>Fire Alarm</b>	Smoke detectors, alarms, and strobes	Good
<b>Equipment/Special</b>	None	--
<b>Accessibility</b>	Presently it does not appear an accessibility study is needed for this building. See Appendix D.	
<b>Key Issues and Findings</b>	Exterior trim is cracked, splintering, and deteriorating. Access ramp is cracked, splintering, and deteriorating creating trip hazards (in the process of being repaired).
