120 Volt Household Current Testing on Corrugated Stainless-Steel Tubing Types and Schedule 40 Black Iron Gas Piping.

Prepared For: National Association of State Fire Marshals
PO Box 948238
Maitland, FL 32794

February 16, 2018

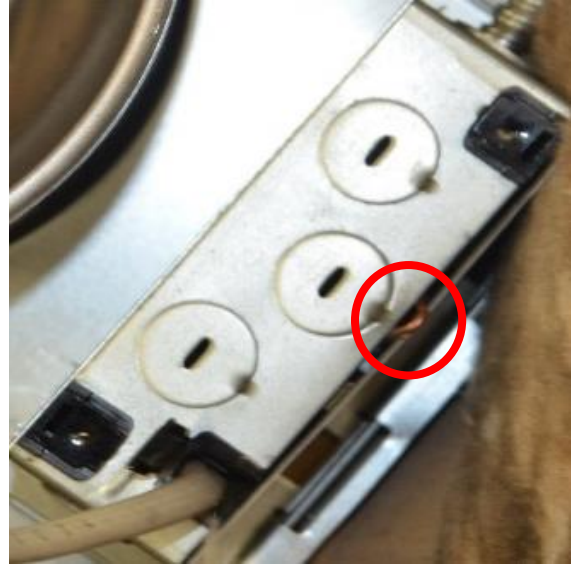
An ungrounded recessed light fixture was installed so that the hot conductor (black wire) was shorted to the light fixture housing (see Figure 1). Turning on the switch to the light energized the casing to the light fixture. Without an equipment ground wire, the casing on the light fixture becomes energized. Depending on the type of gas pipe, a potential path to ground may then be introduced via contact between the light fixture and the grounded gas pipe.

Figure 1 Electrical Short to Light Fixture Housing.

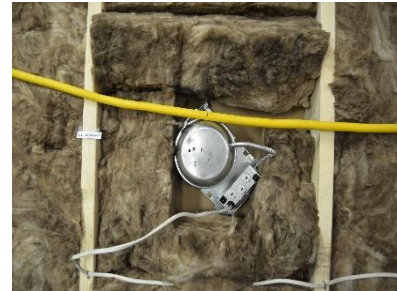
Neither the recessed light fixture’s housing nor the yellow jacketed WARDFlex® CSST sustained any damage.

Figure 10 WARDFlex® in contact with recessed light.

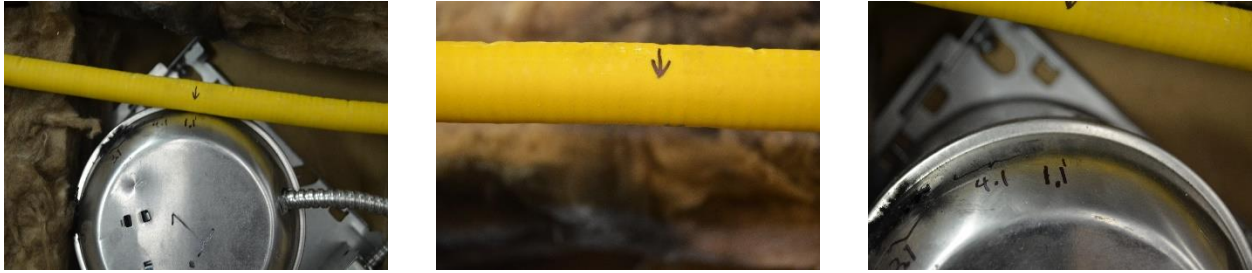
Figure 12 Test 1.1 in place (left). Undamaged WARDFlex® (center) and light fixture (right) post-test.

When the light switch was turned ON, the light came on, but there was no electrical activity. The circuit breaker did not trip. Neither the recessed lighting fixture nor the yellow jacketed WARDFlex® CSST sustained any damage.

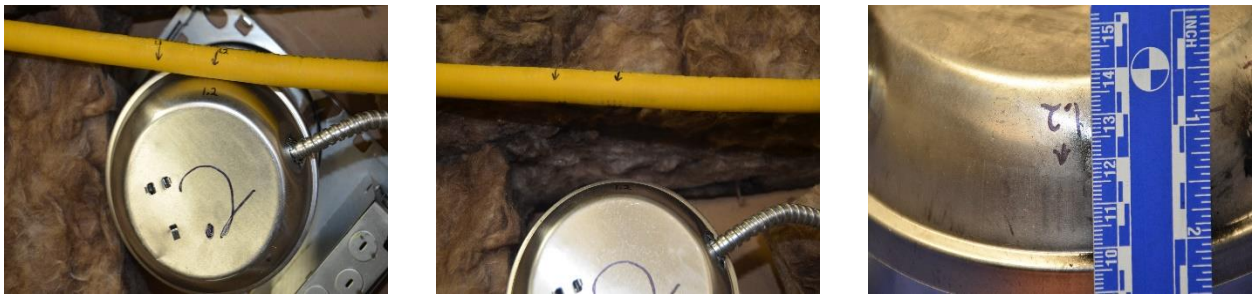
Figure 13 Test 1.2 in place (left). Undamaged WARDFlex® (center) and light fixture (right) post-test.

When the light switch was turned ON, the light came on, but there was no electrical activity. The circuit breaker did not trip. Neither the recessed lighting fixture nor the yellow jacketed WARDFlex® CSST sustained any damage.

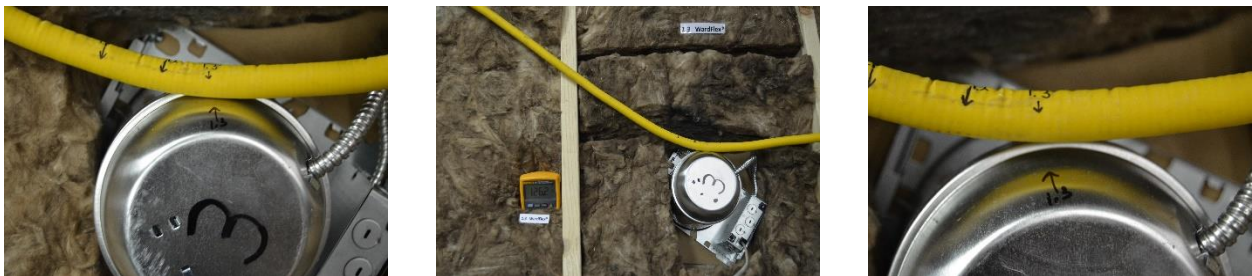
Figure 14 Test 1.3 in place (left & center). Undamaged WARDFlex® and light fixture (right) post-test.

When the light switch was turned ON, the light came on, but there was no electrical activity. The circuit breaker did not trip. Neither the recessed lighting fixture nor the yellow jacketed WARDFlex® CSST sustained any damage.

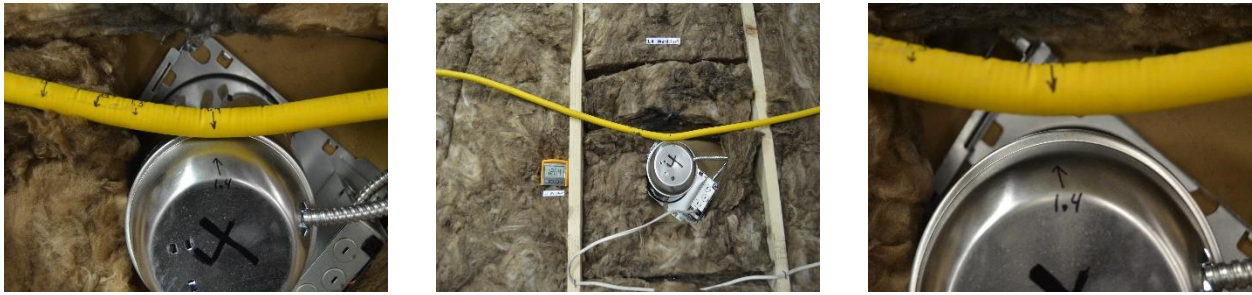
Figure 15 Test 1.4 in place (left & center). Undamaged WARDFlex® and light fixture (right) post-test.

When the light switch was turned ON, the light came on, but there was no electrical activity. The circuit breaker did not trip. Neither the recessed lighting fixture housing nor the yellow jacketed WARDFlex® CSST sustained any damage.

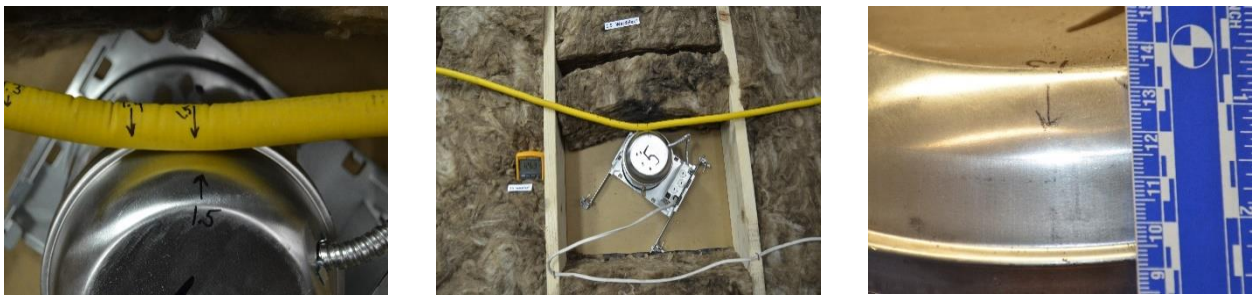
Figure 16 Test 1.5 in place (left & center). Undamaged light fixture post-test (right).

When the light switch was turned ON, the light came on, but there was no electrical activity. The circuit breaker did not trip the breaker. Neither the recessed light fixture's housing nor the yellow jacketed WARDFlex® CSST sustained any damage.

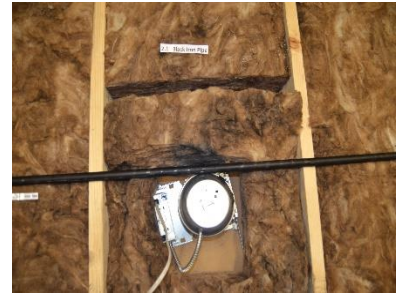
When energized, the circuit faulted and tripped the circuit breaker. Both the recessed light fixture’s housing and the BIP sustained minor surface damage at the point of contact.

No perforations occurred in either the recessed light fixture or the BIP throughout this series of testing.

Figure 17 Test 2 layout.

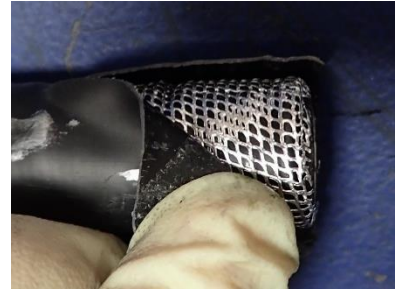
FlashShield™ possesses a 3-layer outer jacket. The bottom layer, or layer closest to the CSST, is a semi-conductive polymer (plastic). The middle layer is a conductive aluminum mesh. The top layer, or outermost layer, is an insulative polymer (plastic). Each of the 5 tests used a new 10-foot section. When energized, the circuit did not fault. The circuit breaker did not trip. The recessed light fixture’s metal housing remained energized at the circuit potential until manually de-energized after an approximate 30 second wait.

Figure 41 FlashShield™ CSST aluminum mesh layer visible.

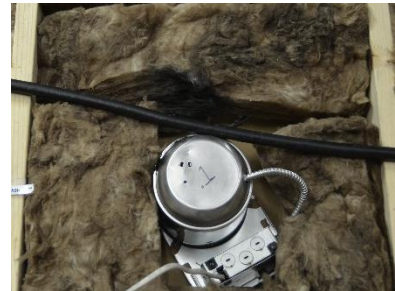
Neither the recessed light fixture’s housing nor the FlashShield™ CSST sustained any damage.

Figure 42 FlashShield™ CSST in contact with recessed light fixture.

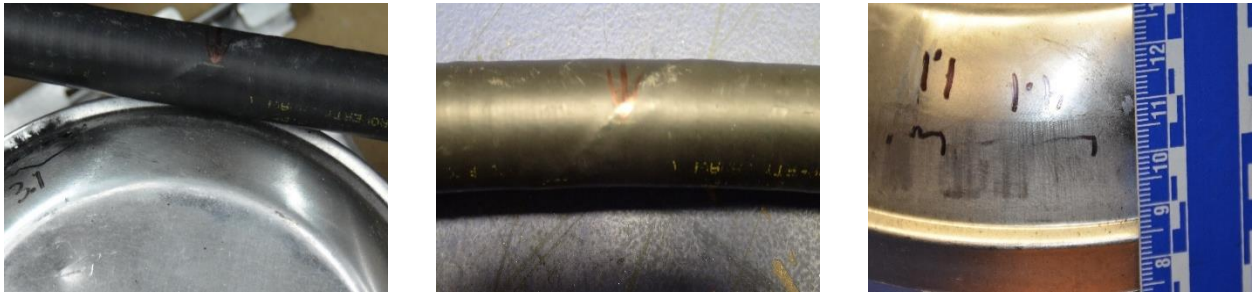
Figure 43 Test 4.1 in place (left). Undamaged FlashShield™ (center) and light fixture (right) post-test.

When the light switch was turned ON, the light came on, but there was no electrical activity. The circuit breaker did not trip. Neither the recessed light fixture's housing nor the FlashShield™ CSST sustained any damage.

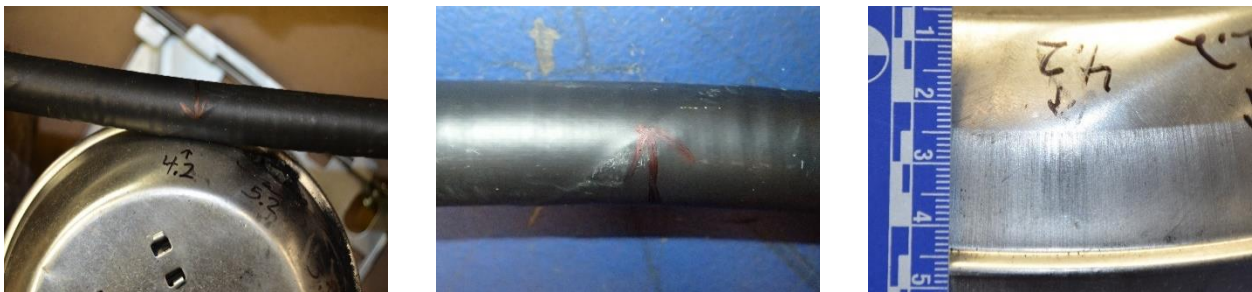
Figure 44 Test 4.2 in place (left). Undamaged FlashShield™ (center) & light fixture (right) post-test.

When the light switch was turned ON, the light came on, but there was no electrical activity. The circuit breaker did not trip. Neither the recessed light fixture's housing nor the FlashShield™ CSST sustained any damage.

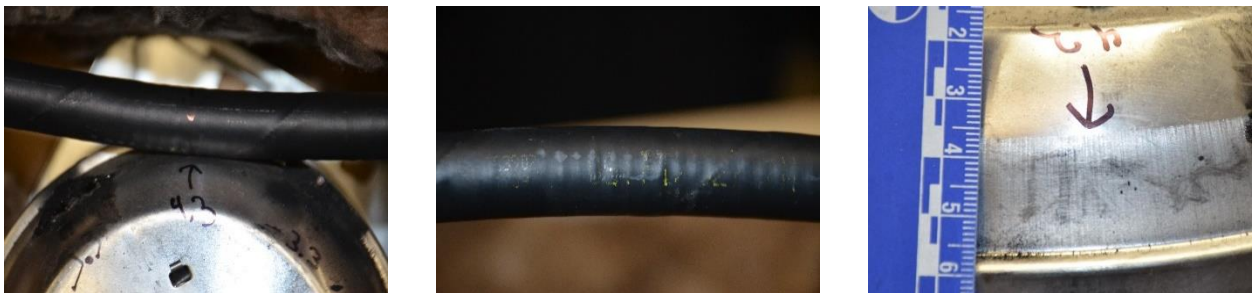
Figure 45 Test 4.3 in place (left). Undamaged FlashShield™ (center) & light fixture (right) post-test.

When the light switch was turned ON, the light came on, but there was no electrical activity. The circuit breaker did not trip. Neither the recessed light fixture's housing nor the FlashShield™ CSST sustained any damage.

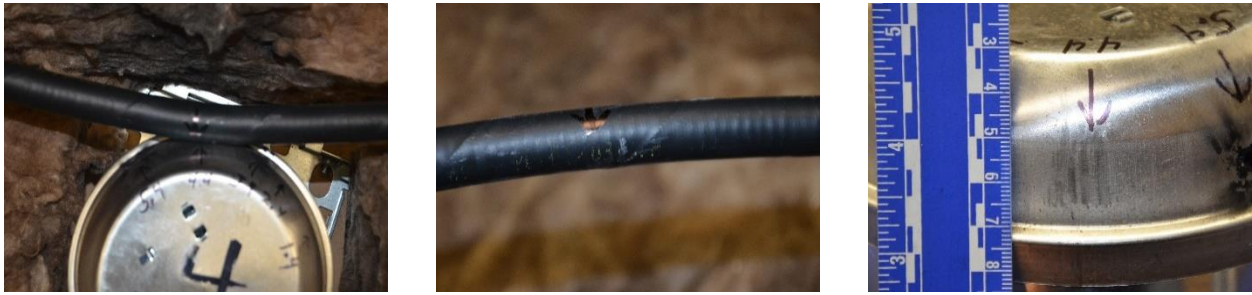
Figure 46 Test 4.4 in place (left). Undamaged FlashShield™ CSST (center) & light fixture (right) post-test.

When the light switch was turned ON, the light came on, but there was no electrical activity. The circuit breaker did not trip. Neither the recessed light fixture's housing nor the FlashShield™ CSST sustained any damage.

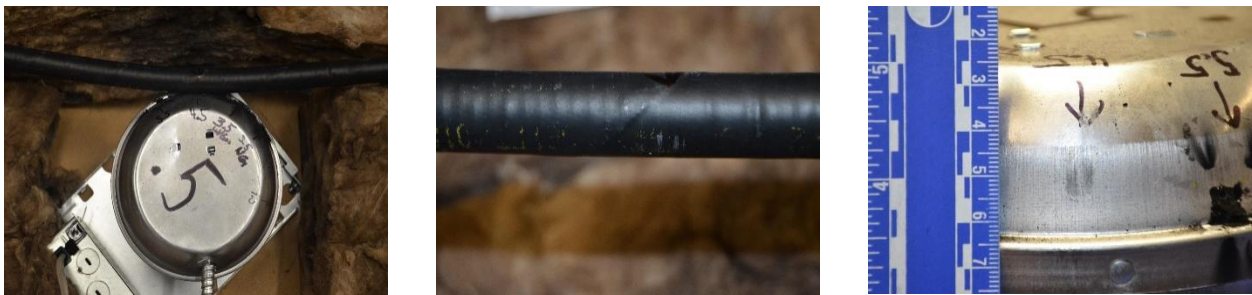
Figure 47 Test 4.5 in place (left). Undamaged FlashShield™ (center) & light fixture (right) post-test.

When the light switch was turned ON, the light came on, but there was no electrical activity. The circuit breaker did not trip. Neither the recessed light fixture's housing nor the FlashShield™ CSST sustained any damage.
