### TECHNICAL REPORT – FIRE INVESTIGATION

<b>VEHICLE MAKE:</b>	XXXXXXXX	<b>REPORT DATE:</b>	13 <sup>th</sup> September 2015
<b>VEHICLE REG:</b>	XXXXXXXX	<b>DATE OF LOSS:</b>	XXXXXXXX
<b>INSURED:</b>	XXXXXXXXXXXX	<b>LOCATION:</b>	XXXXXXXXXXXX
<b>INSURER:</b>	XXXXXX	<b>CONTACT:</b>	XXXXXXXXXX
<b>CLAIM / POL No:</b>	XXXXXXXX	<b>DATE OF APP:</b>	XXXXXXXX

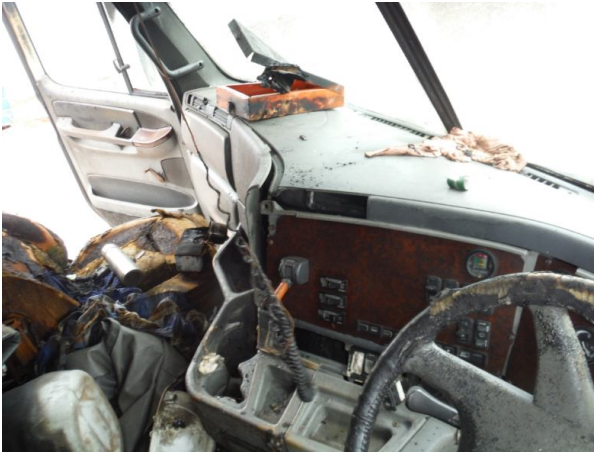
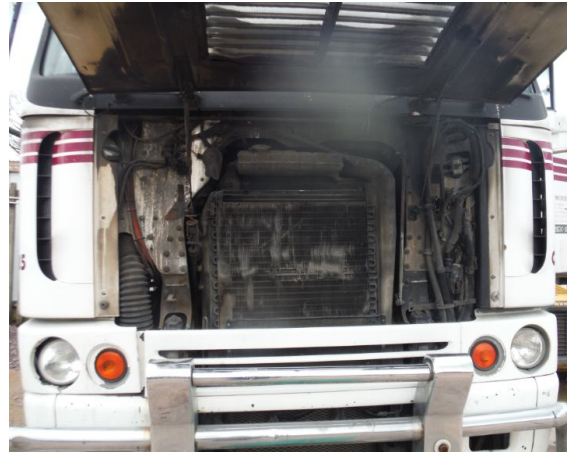
I agree with the Assessor's report that this vehicle is a write off and that the fire started on the left hand side of the engine, however, one of the vehicle's ECM's (Electronic Control Module) was not to blame. this will be elaborated on later in this report.

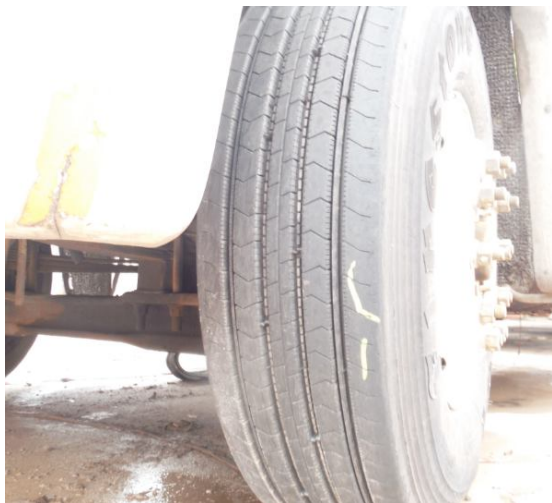
Axle 1 left

None of the tyres on the vehicle presented any problems with regards to roadworthiness; all had adequate tread life remaining and were free from any cuts or abrasions.

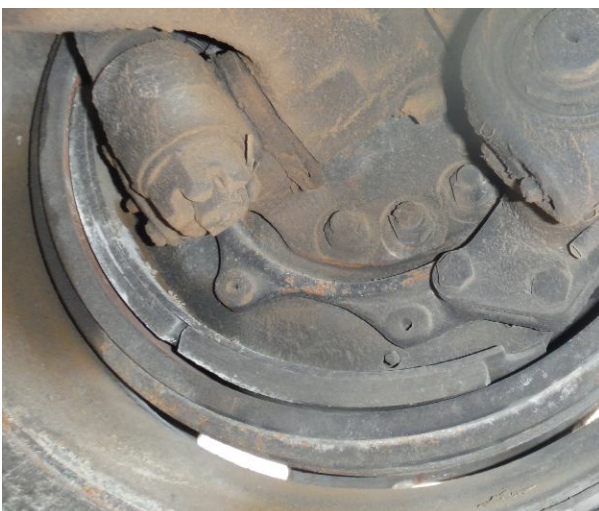
Axle 1 left

On the brake paths seen below you can see evidence of surface oxidization, there is no issue with this, as it is commonly known surface rust which can develop quickly in certain conditions. This vehicle has been standing for some time as the accident occurred in March 2015.

I found no technical issues with the brakes.
