TECHNICAL REPORT – ACCIDENT DAMAGE

VEHICLE MAKE:	Volvo	REPORT DATE:	29 th JuNE 2014
VEHICLE REG:	XXXXXXXXXX	TRAILER:	XXXXXXXXXX
INSURED:	XXXXXXXXXX	LOCATION:	XXXXXXXXXX
INSURER:	XXXXXXXXXX	CONTACT:	XXXXXXXXXX
CLAIM / POL No:	XXXXXXXXXX	DATE OF APP:	XXXXXXXXXX

To inspect the above mentioned three vehicle combination and to offer expert opinion on the condition of the vehicles, in particular, the components of the brake system and any influence they had in the overall roadworthiness in terms of complying to SANS 10047 – “The testing of motor vehicles for roadworthiness” of the individual vehicles as well as my views as to vehicle braking and handling dynamics immediately prior to and during the incident in which they were damaged.

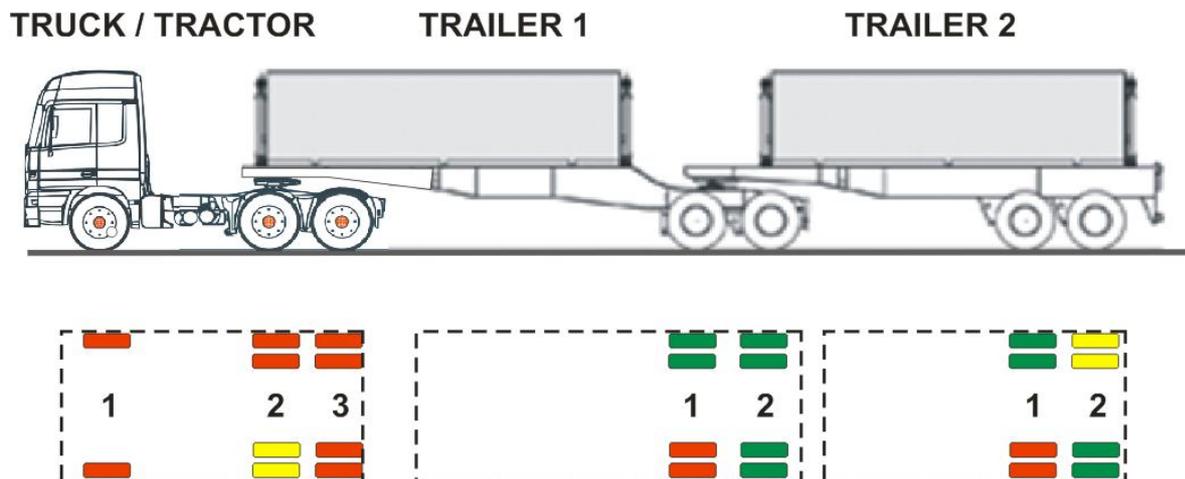
Fig 1

Through my report, references will be made to the wheel position of certain components, below I have included a sketch “Fig 1” of the layout of the combination of vehicles in order to ensure no confusion exists as to which ones I am referring to. The colours are representative of my opinions regarding the braking ability of each wheel, green being adequate, yellow being impaired braking and red being totally unacceptable in terms of roadworthiness and safety.

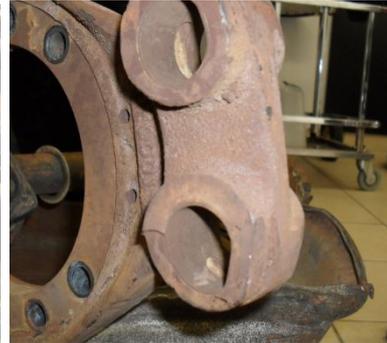
Photo no.3

Photo No.1 highlights the piece worn out, not damaged, of the “S” camshaft on the outer edge which correlates with how the rollers would be sitting at an angle due to the bend in the brake spider that can be seen in Photo No.2. Also all four edges of the spider where the brake pins should have been are worn in the same manner (Photo No.3) where the brakes shoes would normally be sitting perpendicular to the pins and have plenty of clearance from the spider bracket.

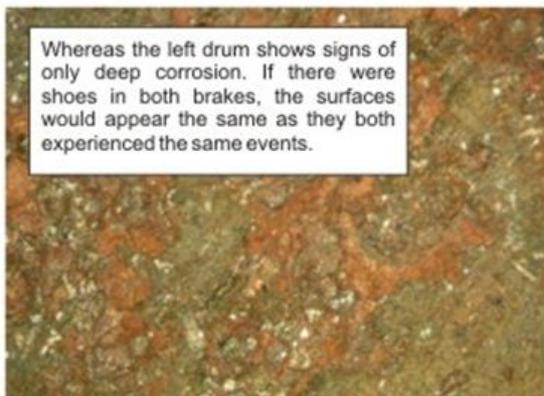
The surface of the left drum magnified

The report from Metserve is easy to understand. It shows that the huge difference between surfaces of the brake paths on the two brake drums tested are the result of one of them (the right drum) is clearly abraded by the contact with a brake shoe, whereas the left one shows no sign of such abrasion.

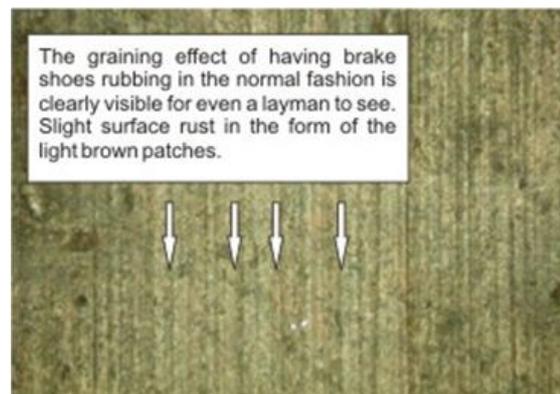
The surface of the right drum magnified

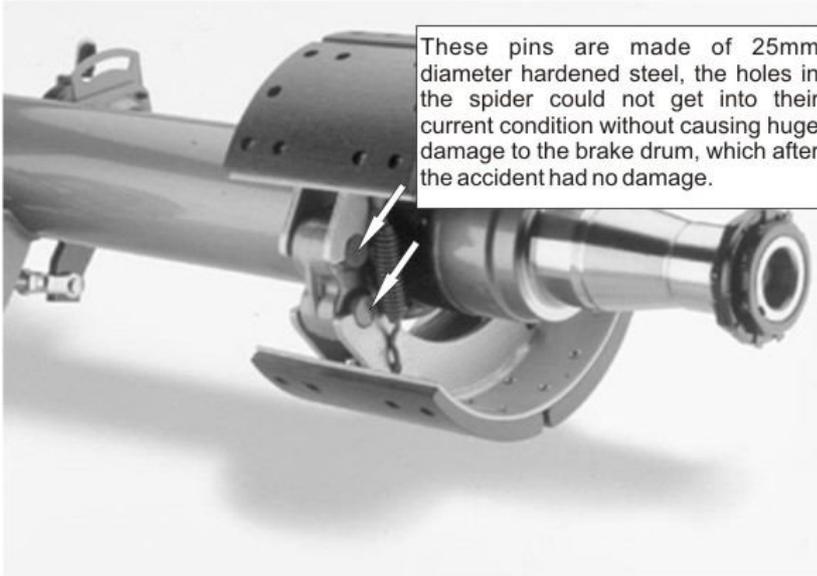
To show this, I have included illustration Fig. 1 and Photo 3 from the front link trailer report that show that the damage to the hole on the brake spider could not be caused while a brake anchor pin and brakes shoes are present, which would be necessary for the brake to be operating.

The brake shoe anchor pins are mounted in the center of the brake shoes, which obviously run in the centre of the brake path of the drum.

As confirmed in Metserve's report, the drum is made of a cast iron which properties would not allow it to deflect and cause the damage to the spider without breaking itself. There was no damage or internal marks on the brake drum of the front left axle.

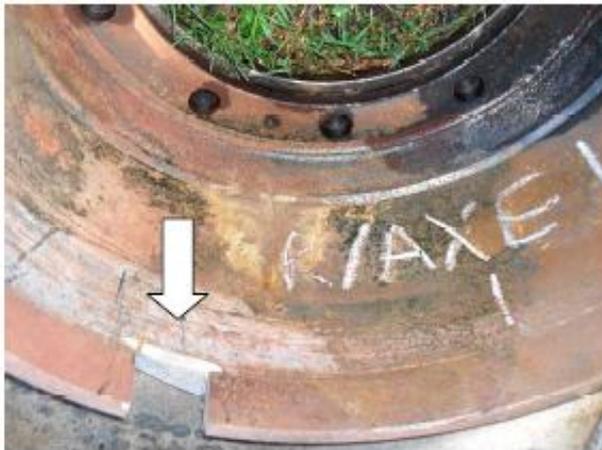
Illustrate the section removed from the brake drum hereafter named sample 6616B

The hand written identification of the drum "R/AXE"

Illustrate the section removed from the brake drum hereafter named sample 6616G

The hand written identification of the drum = "Axel one left"

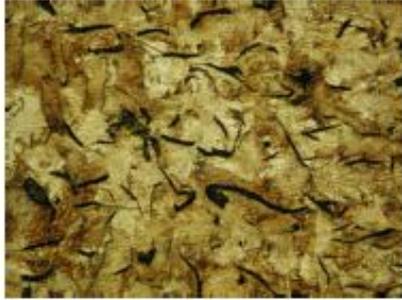
The microstructure of the core section of sample 6616G exhibited a characteristic pearlitic graphite flake cast iron structure.

Core structure At 150X Mag 2% Nital

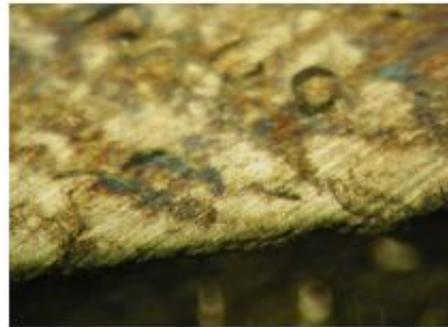
Microscopic examination of the break surface did not reveal any abnormalities on the sample examined.

Brake surface sample 6616G at 250x mag
2% Nital Etch

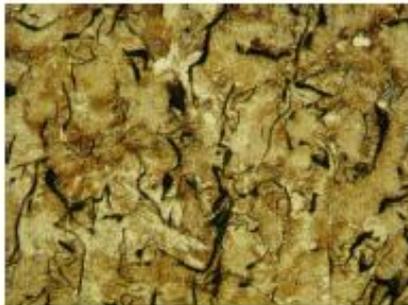
The microstructure of the core section of sample 6616B exhibited a characteristic pearlitic graphite flake cast iron structure similar to sample 6616G. Examination of the brake surface did reveal evidence of pitting corrosion refer RHS photomicrograph.

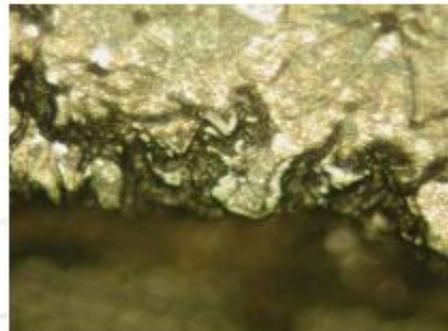
Brake surface sample 6616b at 250x mag
2% Nital Etch

Graphite Form = Type One
Graphite SA = A
Graphite Size = 3

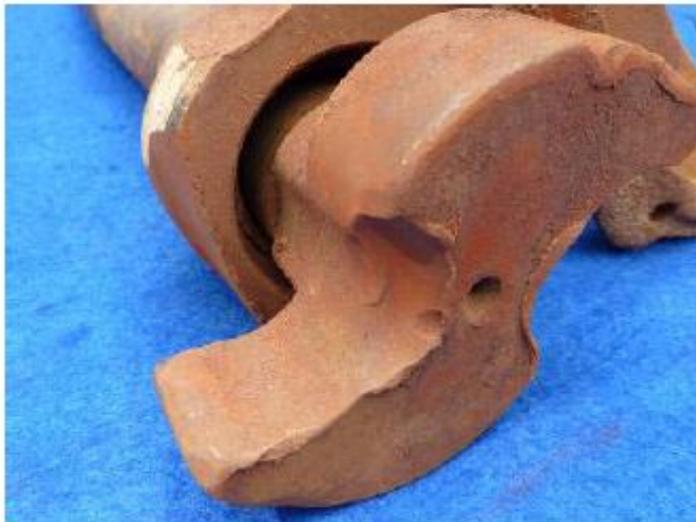
Illustrate sample in the "5 cam" in the condition received

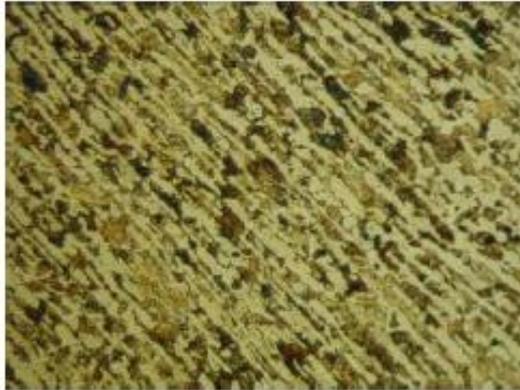
The microstructure of the core section of the "S Camshaft" exhibited a characteristic ferrite - pearlite structure typical for low carbon steel in the as normalized condition.

Core structure At 150X Mag. 2%Nital
