**Residential Recon Home Inspection Company**

# Inspection Table of Contents

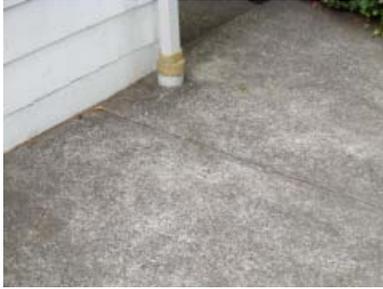
Downspout' s empty into an underground peripheral drainage system.

**Disclaimer: Underground peripheral drainage systems are not tested and may be clogged. Further Evaluation required.**

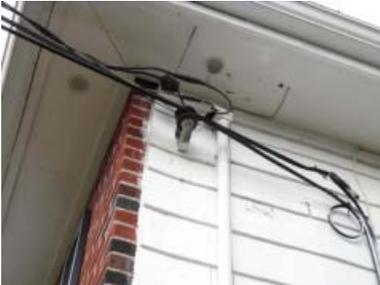
Overhead.

Satisfactory.
