# Your Inspection Report

1234 My Street  
Boise, ID 83702

**INSPECTION DATE:**  
Thursday, October 22, 2015

RE: Report No. 1006  
1234 My Street  
Boise, ID  
83702

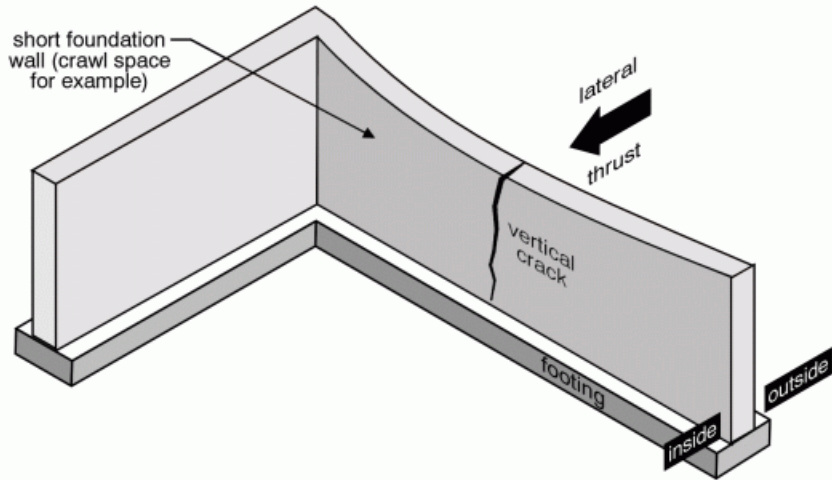
## Vertical foundation cracks

**10. Condition:** • [Cracked](#)

**Implication(s):** Chance of water damage to contents, finishes and/or structure | Weakened structure

in short foundation walls,  
horizontal forces can also  
cause vertical cracks (typically  
at the midpoint of the walls)
