Right Angle Inspections, LLC

Property Inspection Report

123 Any St, Everytown, CO 80123
Inspection prepared for: Will Buy
Real Estate Agent: Goode Sell - ABC Real Estate

Date of Inspection: 11/7/2015 Time: 11:00
Age of Home: 1979 Size: 1850'
Weather: Sunny

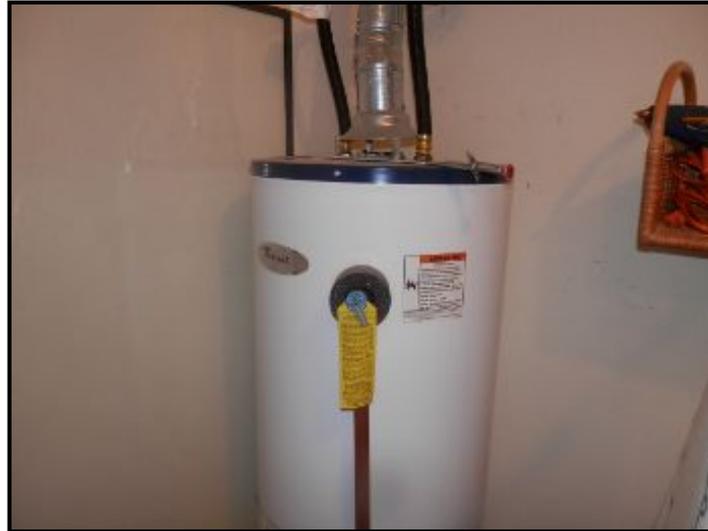
- Brand Name or Manufacture: US Craftmaster.
- Fuel or Energy Source: Natural Gas
- Capacity: Approximately 40 Gallons
- Year of Manufacture: 2012

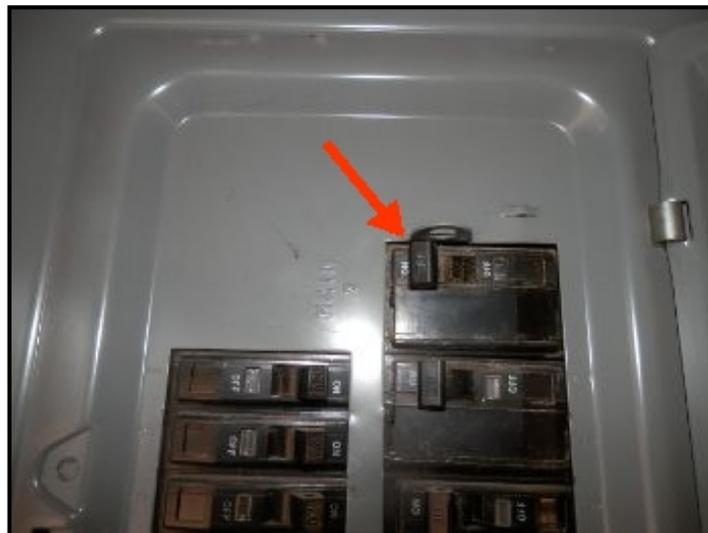
Main shut off

- Main Shut OFF location: at the mail panel.
- No major system safety or function concerns noted at time of inspection at main panel box.

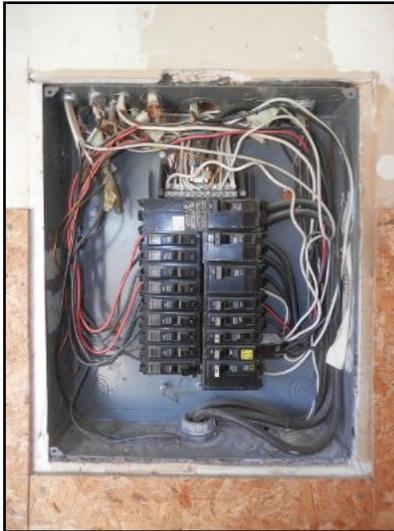
Panel wiring

- Service Conductors: Aluminum service conductors. Aluminum is acceptable for service conductor applications
- Wiring Method(s): The observed cable system(s) installed are non-metallic sheathed cables, commonly known as "Romex".
- Grounding: This wire system is grounded.
- Branch Circuit Conductors: Combination of copper and aluminum at 220 volt circuits. Aluminum wiring at 220 volt applications is known to be safe and still used today all types of modern construction. Conductor materials confirmed in the service panel only

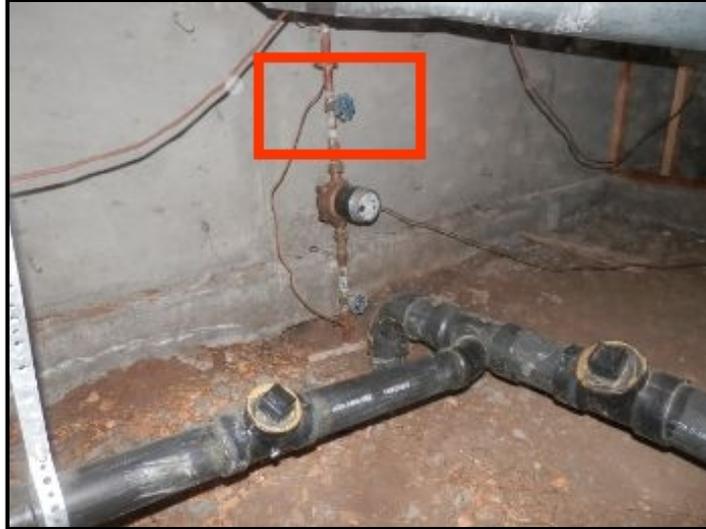
Plumbing Main Shut Off

- Main Water Shut Off Location: Crawl space.
