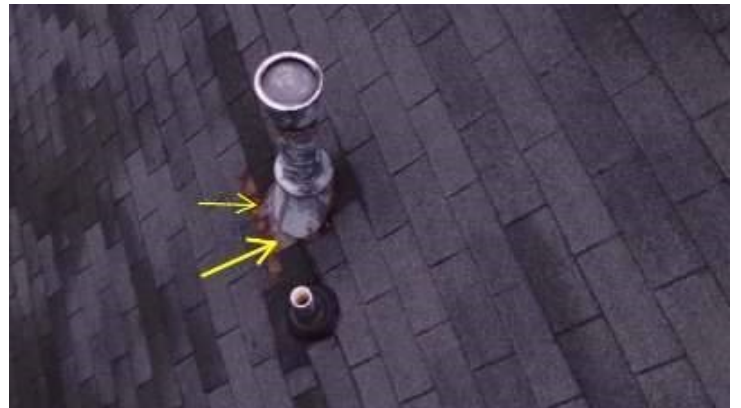
Photo 14-4
Required repair, replacement and/or evaluation

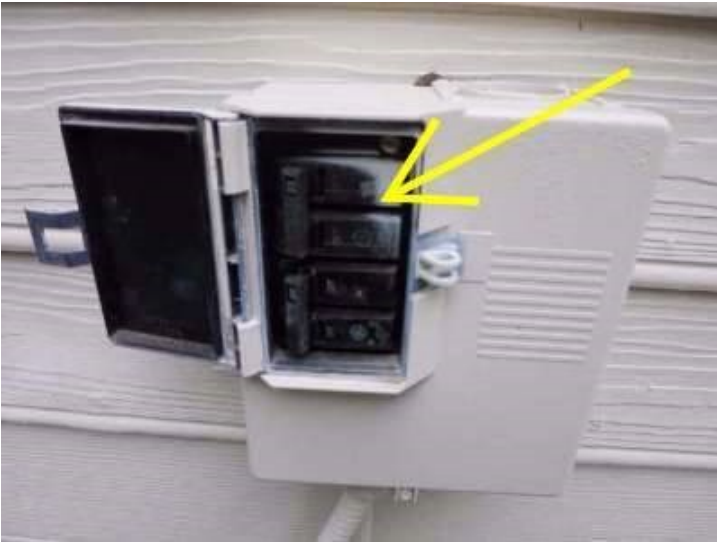
Photo 35-1
Paint on breakers!

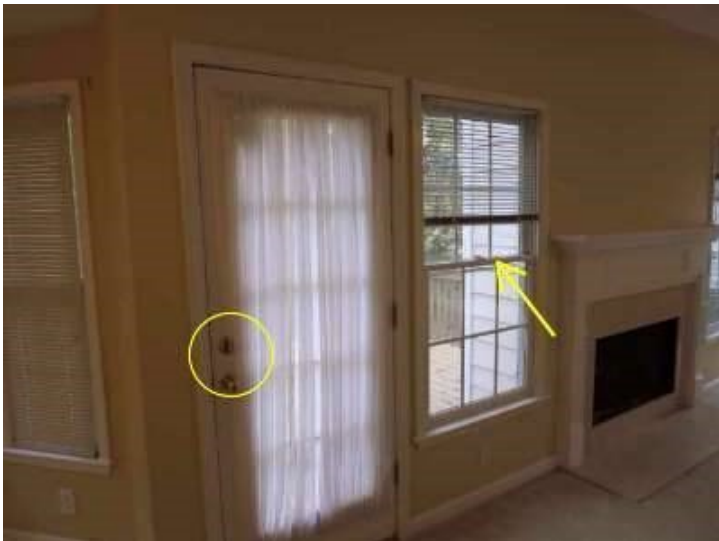
Photo 52-3
Dead bolt not latching, Window does not open freely

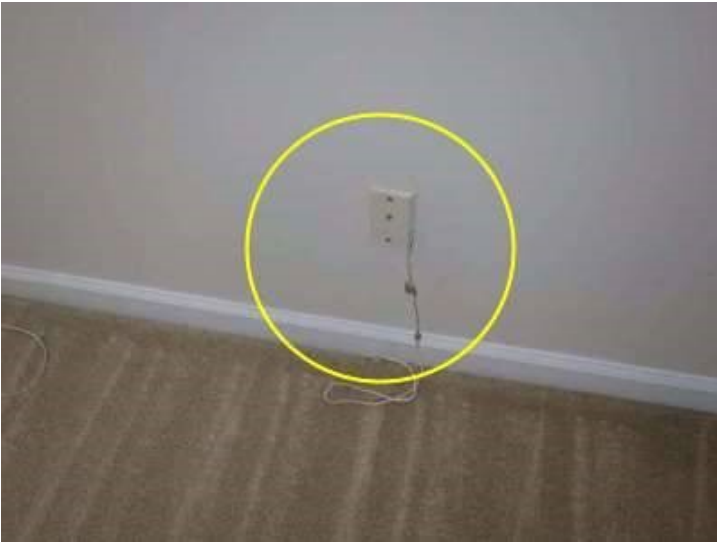
Photo X-15
Recommend that a qualified person repair as necessary

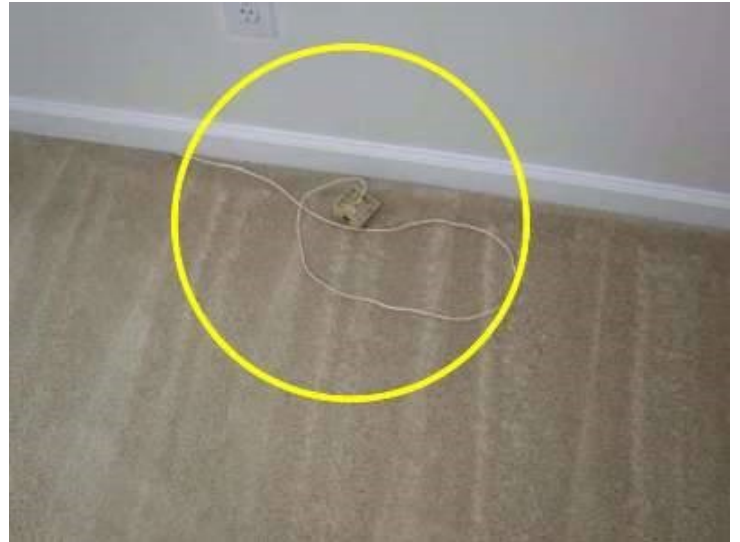
Photo X-16
Recommend that a qualified person repair as necessary

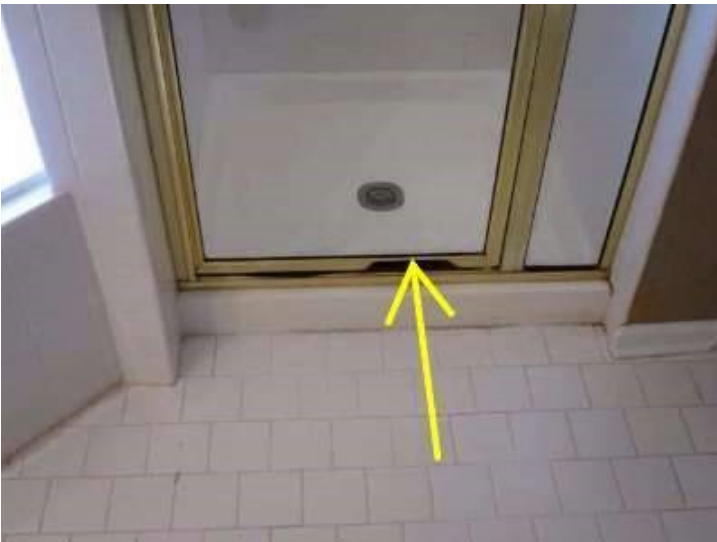
Photo X-17
Recommend that a qualified person repair as necessary
