Your Inspection Report

11554 136 Street
Surrey, BC V3R 3C2

Thursday, July 21, 2016

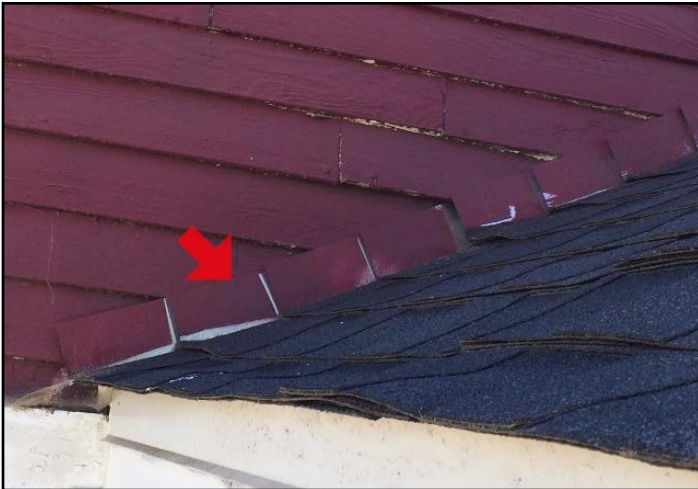
4. Flashings not properly installed

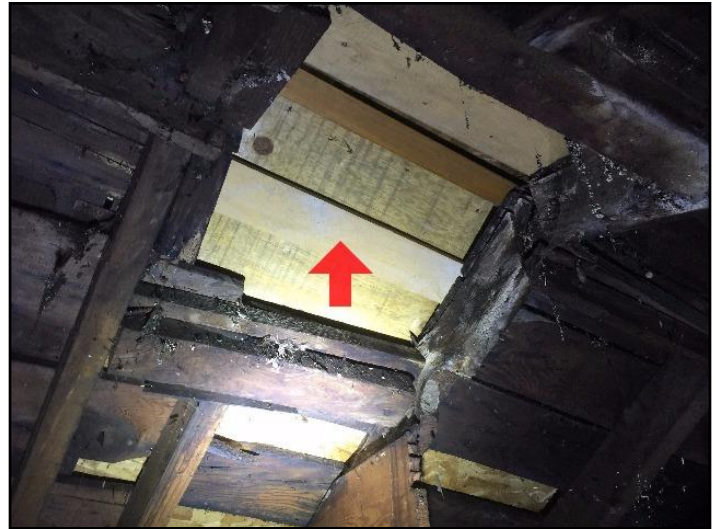
1. • There has been a new asphalt shingle roof installed fairly recently. As seen from the attic, the roof has been patched where the old chimney came through and where the extension was added. The rafters and ridge boards in these areas have been weakened. This patchwork in conjunction with the weakened structure will impact life of the new roof. The step flashings on the lower section of roof, over the porch, have not been tucked under the siding or tucked under the shingles. These need to be fixed as soon as possible as it poses an immediate water ingress problem. The siding should have been cut back to allow the flashings to tuck underneath. There are no drip edge flashings, gutters or downspouts installed. In the winter months the water will simply pour over the edge, create a puddle where it hits the ground, and splash onto the wall. This will be an annoyance as it will splash on the walls and anything close to the house and could deteriorate the siding and structure over time. There are no penetrations through the roof for plumbing vents. After the plumbing vents have been installed a qualified roofing contractor should be brought in, to install boots around the vents, fix the flashings and install gutters and downpipes.

5. Patched where chimney used to come through

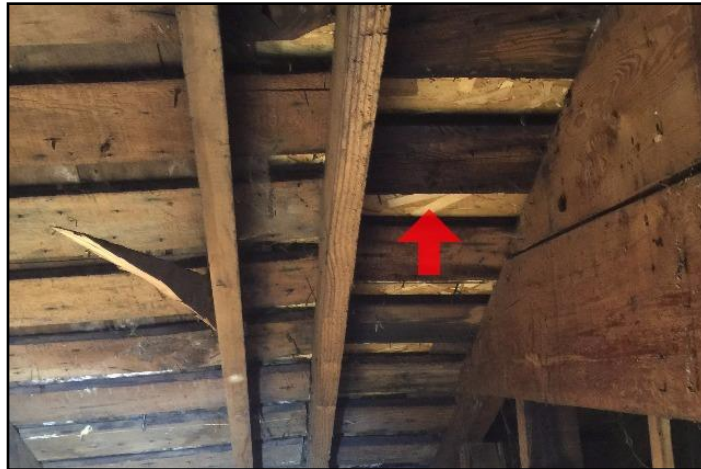
6. Patched at addition

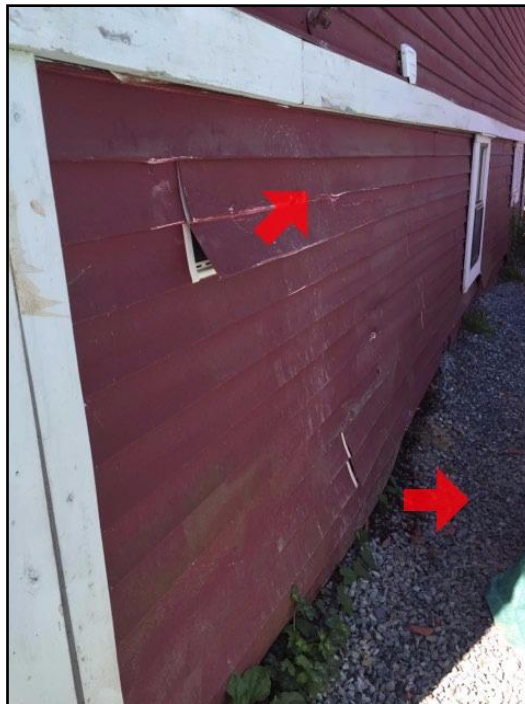
12. Condition: • [Buckled or wavy](#)

22. Vinyl siding buckling and pulling away

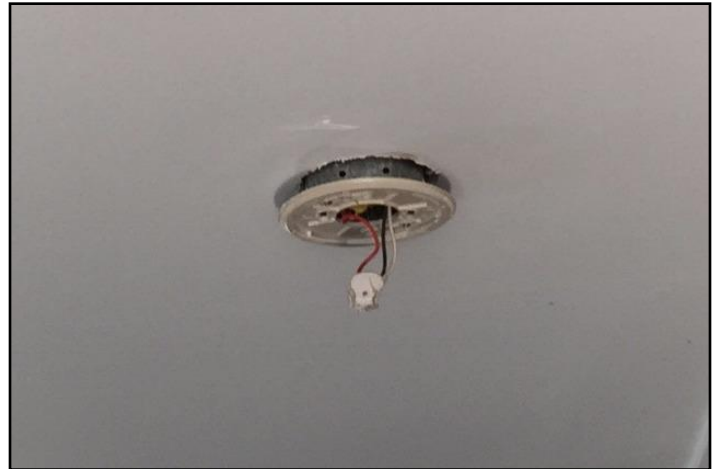
62. *Removed smoke detector*

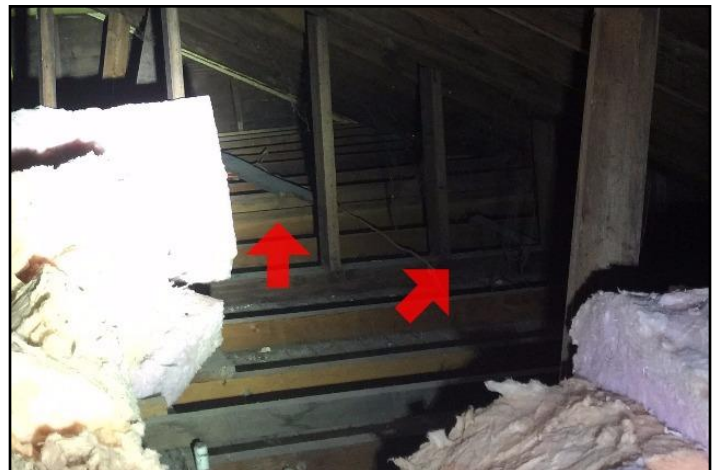
68. Gaps or voids
