**Inspection reference: 1235**

**Confidential Inspection Report**  
**43 Somewhere Ave.**  
**Any Town, MD 12345**

**April 24, 2018**

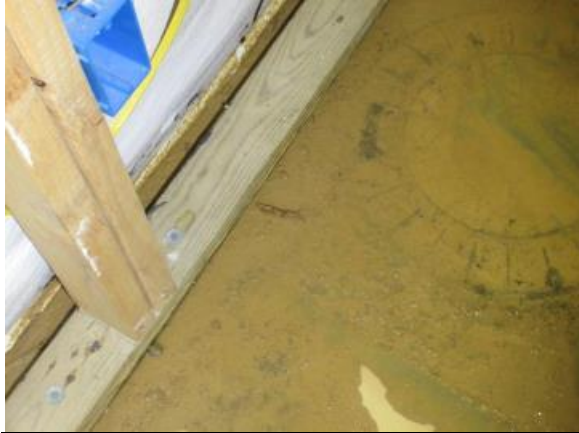
There's insulation on the walls around perimeter of the basement. There is an active leak coming from underneath the insulation and appears to be the exterior wall. It is unknown the source of the leak, but with evidence of dirt and water I am assuming that there is a crack in the wall. The insulation will have to be removed to verify where the leak is coming from. Recommend repair by license concrete contractor.

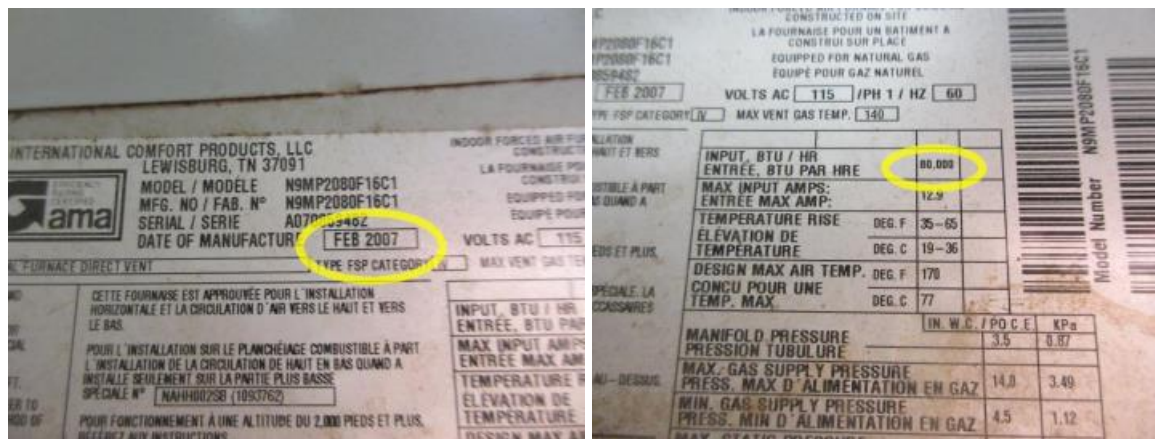
6.4 General Operation & Cabinet: OK RM RR SC NI Unit was operational at the time of inspection.

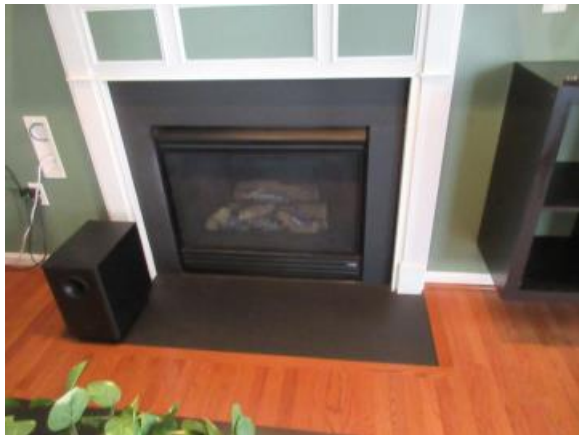
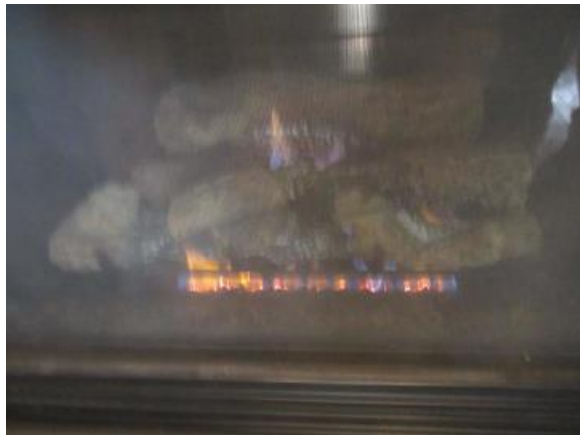
6.6 Living Room:

Gas - The fireplace is designed to use gas fuel only. There is a log set installed.

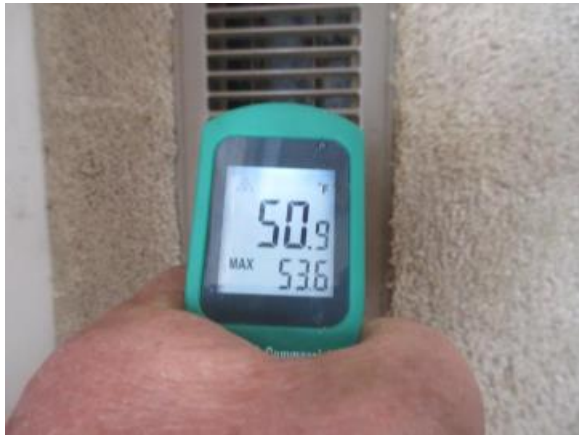
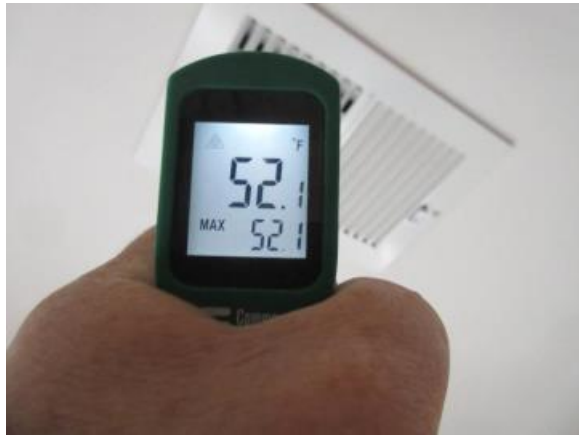
6.23 System Condition: 2nd Floor

System condition is not working properly. Temperature drop should be within 15-20 degrees, 1st Floor temperature drop is 2 degrees after running for over 1 hour, 2nd Floor temperature drop is 0 degrees. Recommend repair by a licensed HVAC contractor.

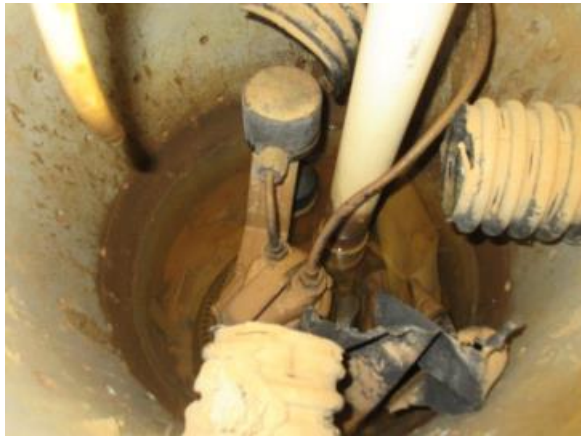
7.14 Basement:	<input checked="" type="radio"/>	<input type="radio"/>	<input type="radio"/>	<input type="radio"/>	<input type="radio"/>	The pump appears functional.
----------------	----------------------------------	-----------------------	-----------------------	-----------------------	-----------------------	------------------------------

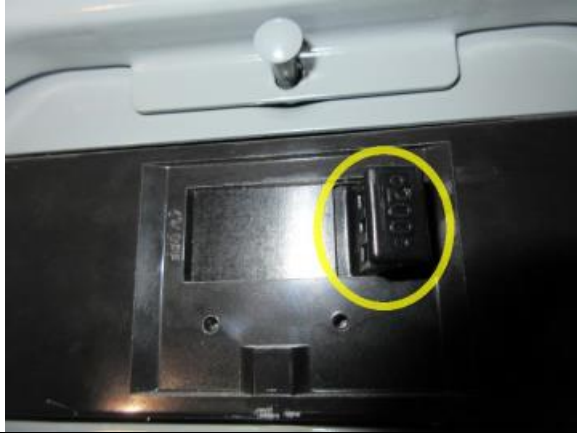
8.4 Main Circuit Rating: 200 amps.

Basement, There should be three feet of clearance in front of the panel. There is a wall that has been installed directly in front of the electric panel. This wall is not finished, but when it is finished it will not have the 3 feet of clearance. I recommend rearranging the wall to be able to have three feet of space before it is finished.
