Brick By Brick Inspections, Inc.

Home Inspection Report

123

Inspected on Sat, Feb 11 2017 at 8:35 AM

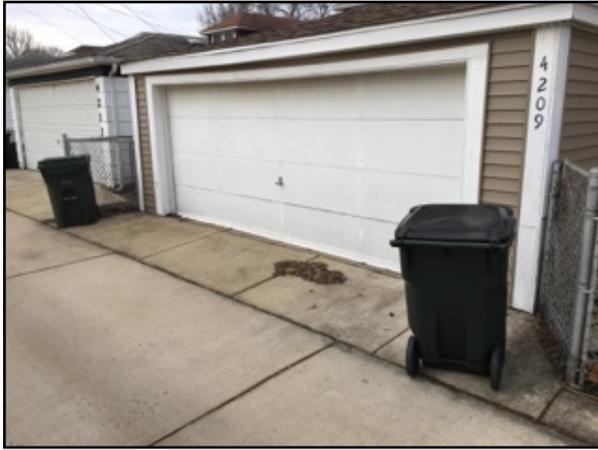
Figure 1-1

Comment 1:
Garage facing ally.

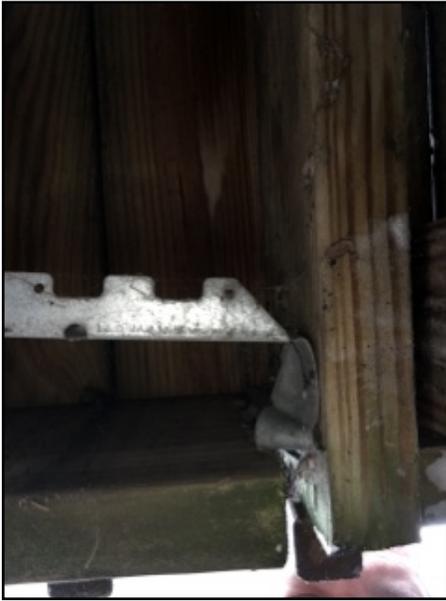
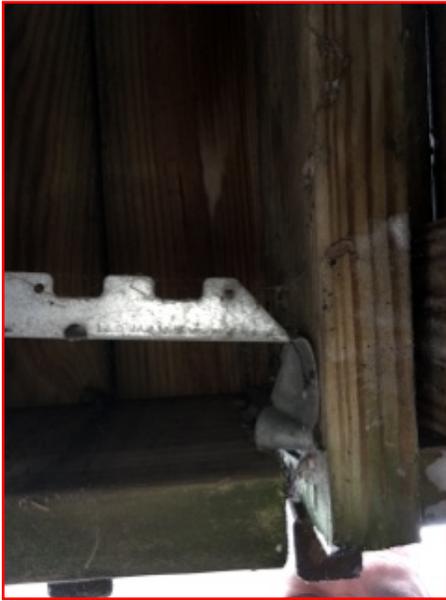
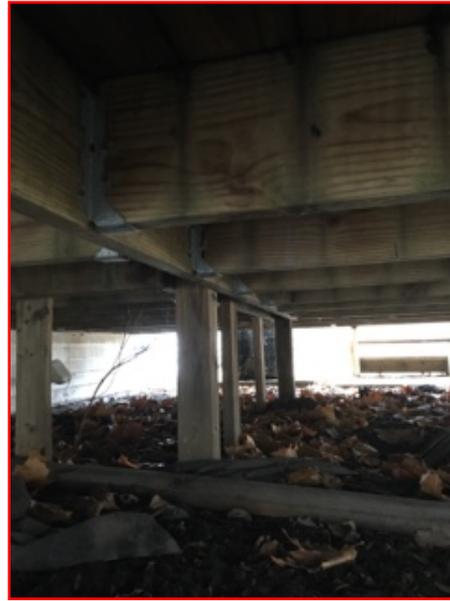
Figure 4-1

2) Joint hangers pulling away from support beams.

Some bracing needs further evaluation by a professional contractor.

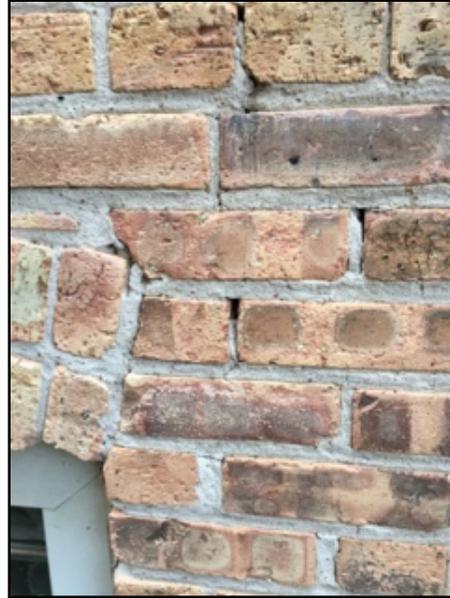
Figure 9-2

Some minor, small sections with loose or missing mortar between the bricks. These should be monitored and evaluated by a professional if the condition worsens.

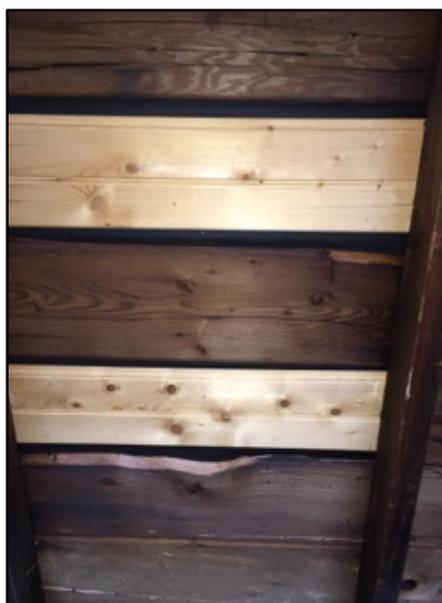
Figure 13-2

Roof appears to have been recently repaired and replaced. Some of the decking material appears to be undersized leaving gaps

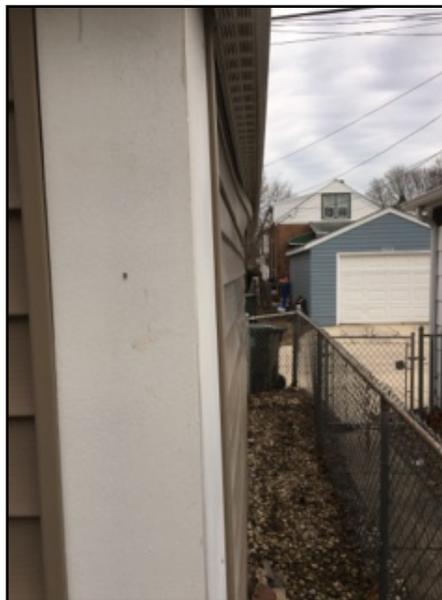
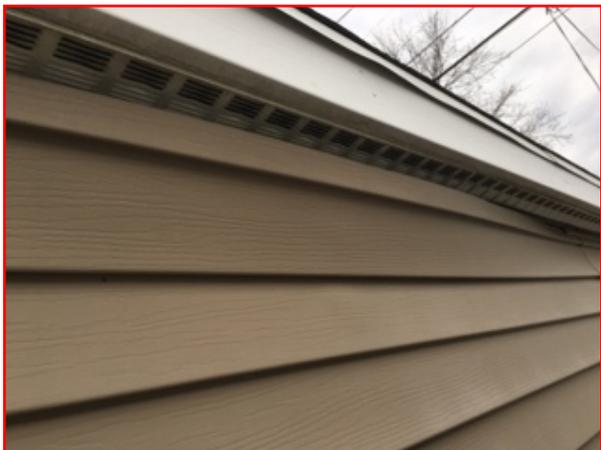
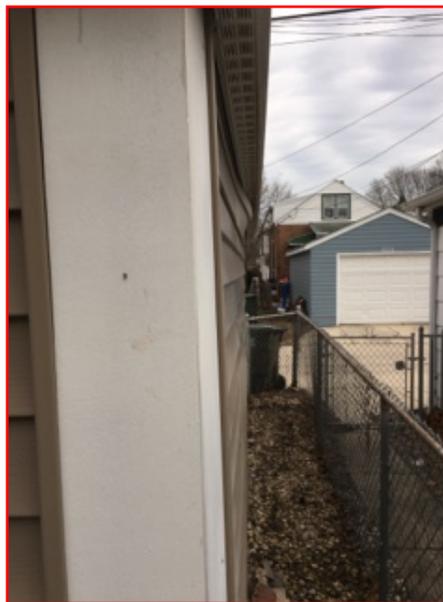
**Comment 14:**
Siding on garage is not properly attached. Recommend having a vinyl siding professional evaluate and repair.

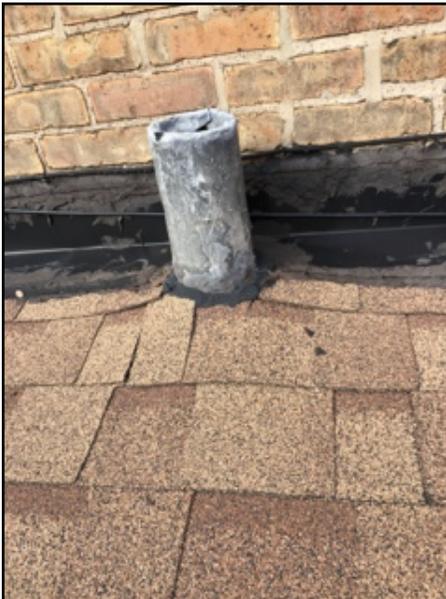
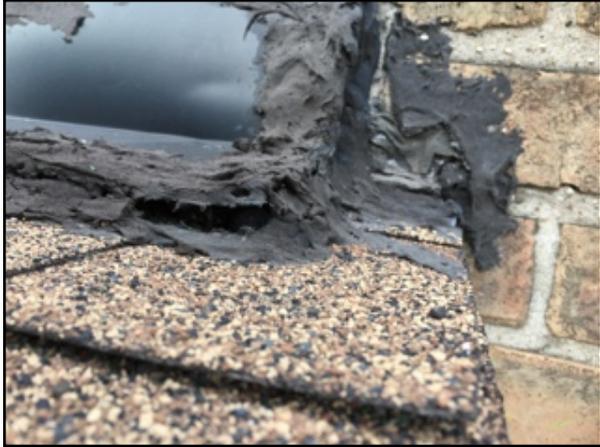
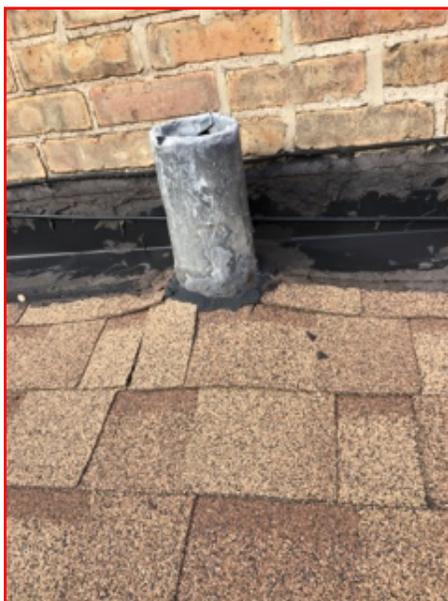
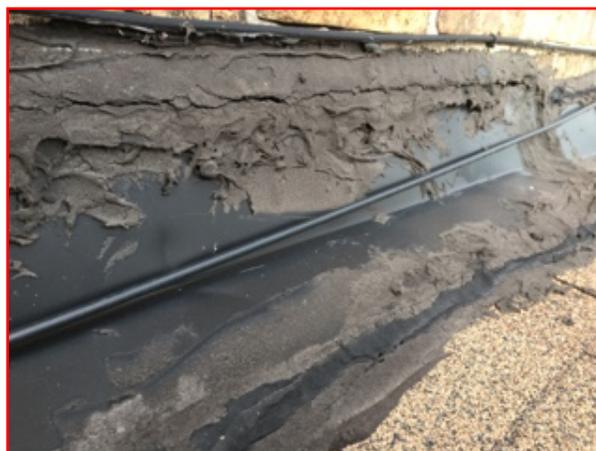
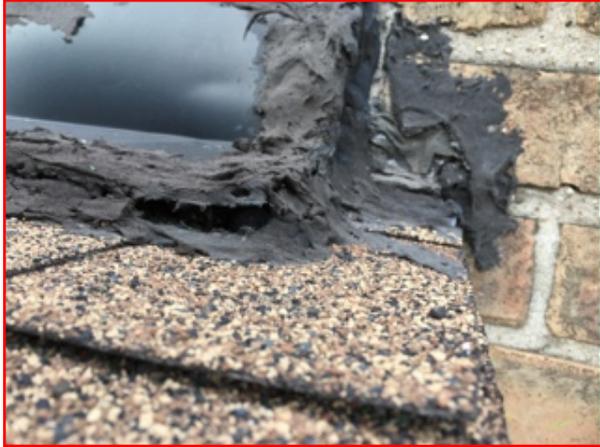
Lower level of roof not properly flashed around vent pipe or along transition from brick to the roof. This should be evaluated by a roofing professional.

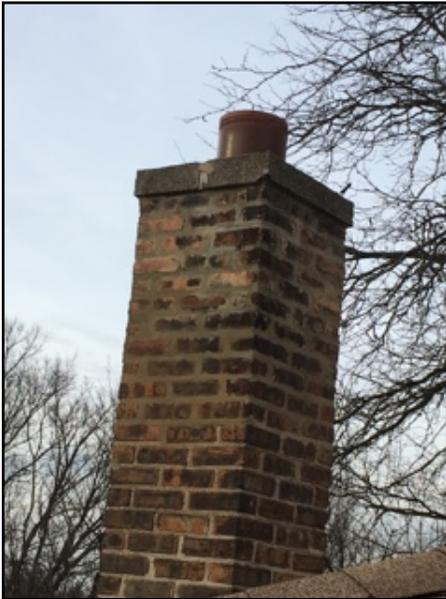
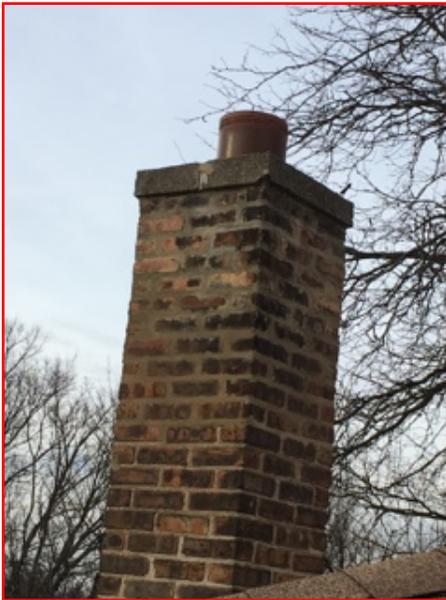
Chimney should have a cap installed to prevent debris or animals from entering the flue.

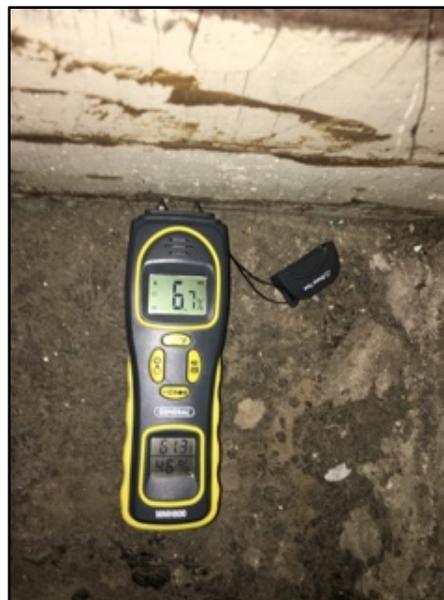
Figure 20-2

Comment 20:
Moisture readings in basement.

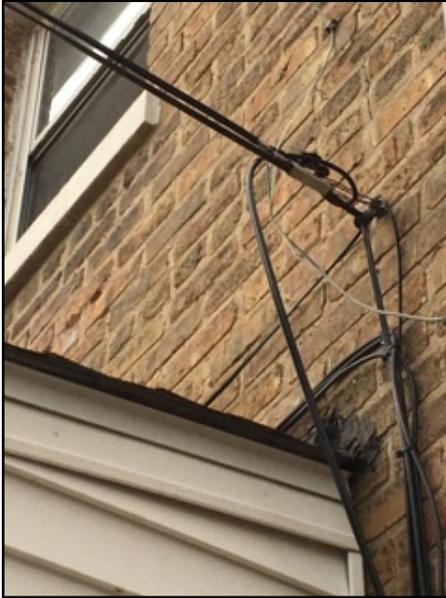
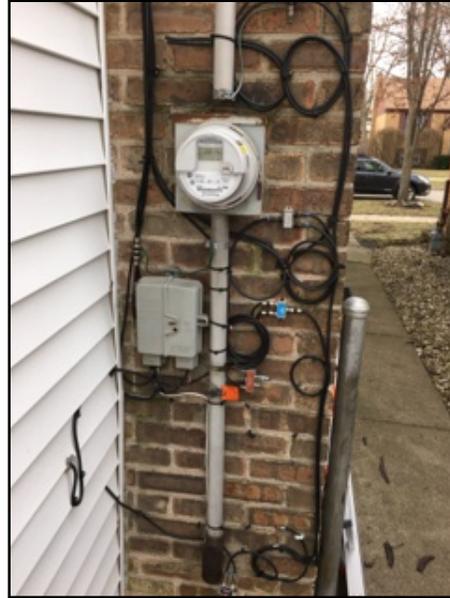
Comment 23:
Electrical supply line and meter.

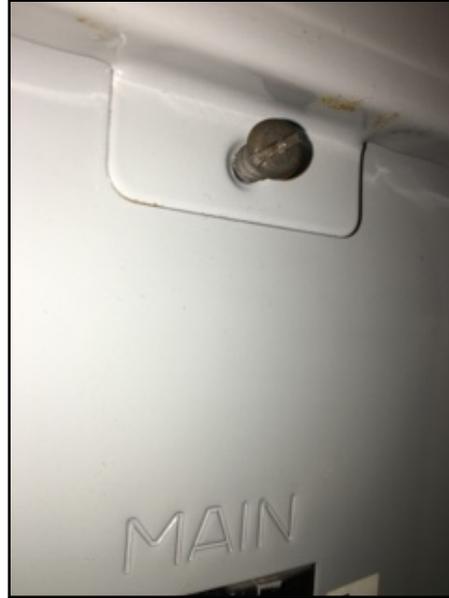
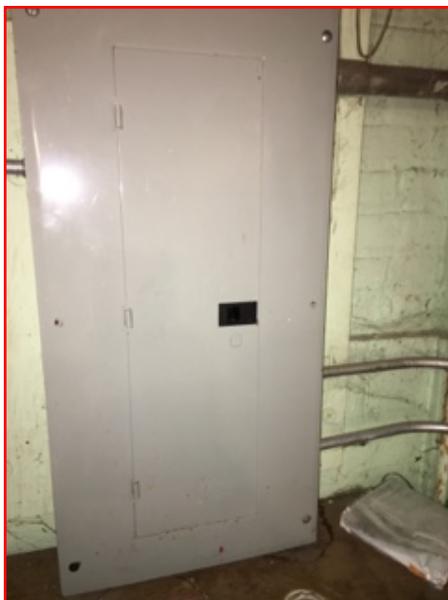
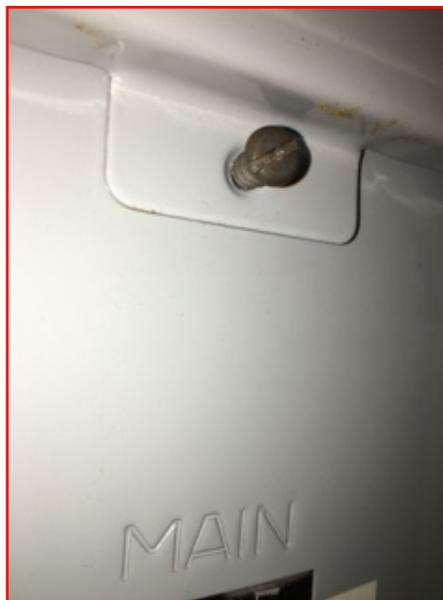
14) Missing screws in electrical panel. Interior screws not right size. Recommend replacing with the correct hardware to keep the panel sealed.

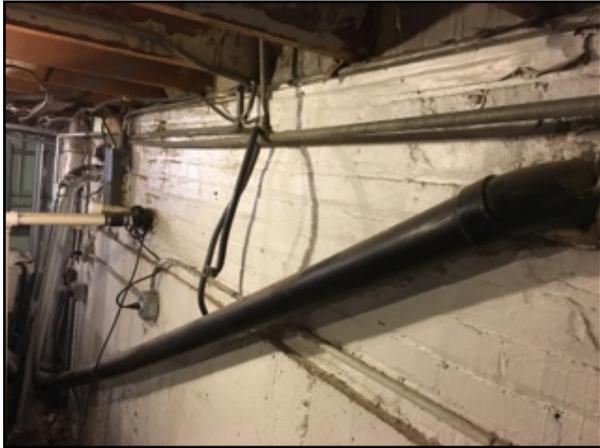
Figure 34-1

Waste pipe from main level bathroom appears to be at a slope of 3 inches for foot which is acceptable for waste drainage.

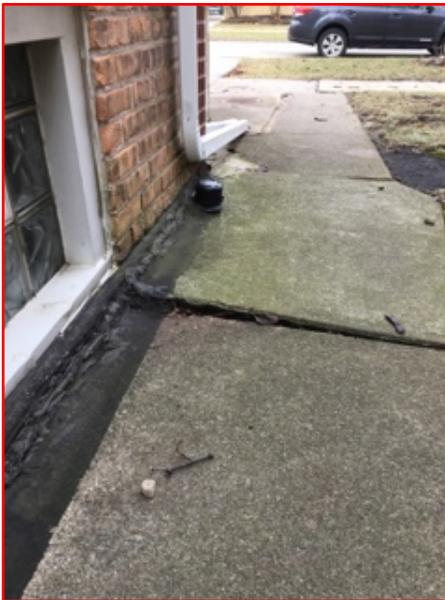
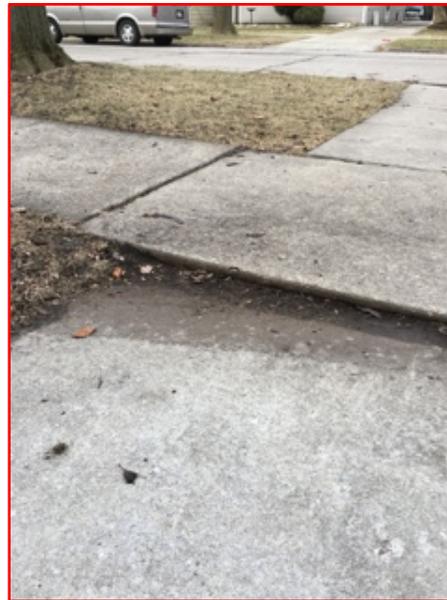
1) Some sections of the side entrance walkway and entryway have raised edges which could be a tripping hazard.

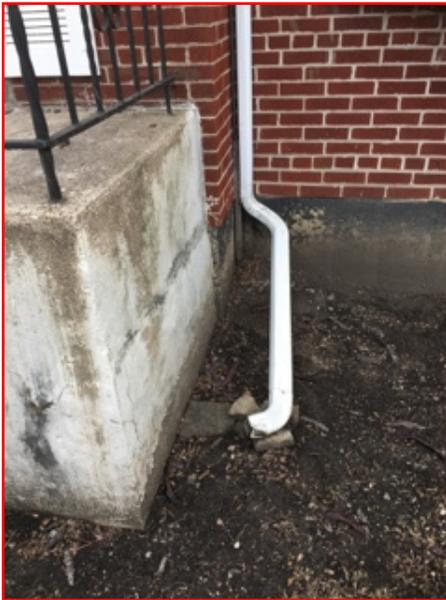
Figure 7-1

3) Gutters should direct water away from the house, recommended removing the end and extending this gutter away from the foundation or stairs.

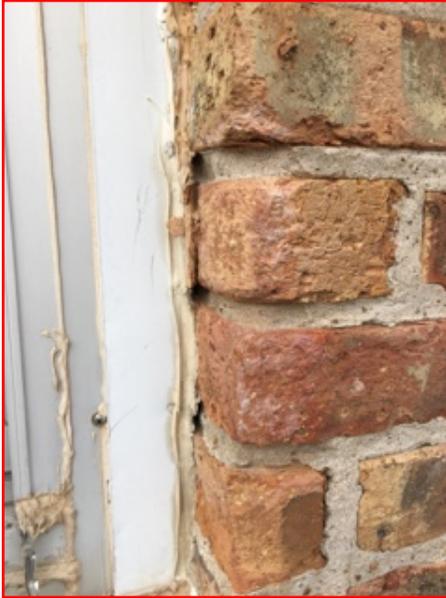
Figure 8-1

4) Sealing around rear 2nd floor window has failed. Recommend caulking open areas.

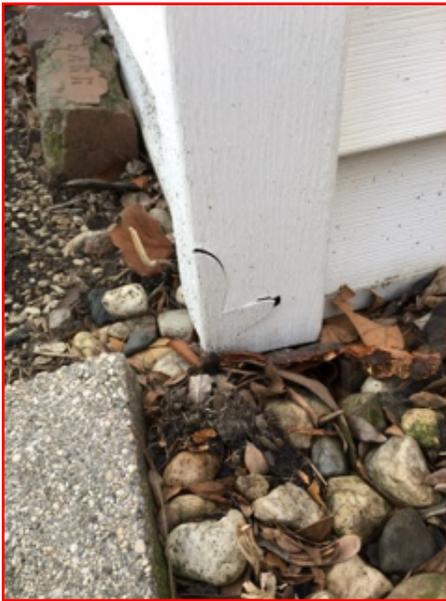
Figure 10-1

5) Crack in vinyl corner NE corner.

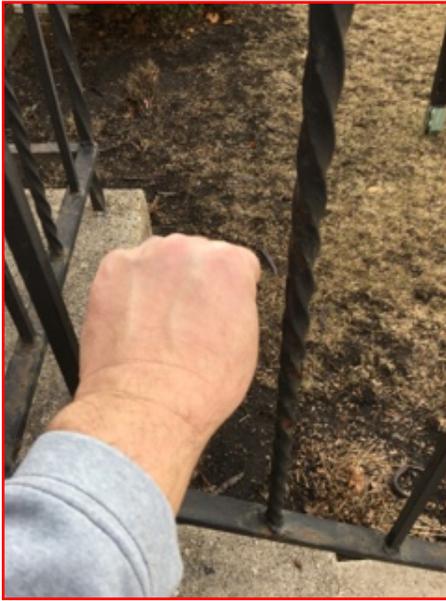
Figure 11-1

6) Distance between ballistas is more than 4 inches which is a safety hazard.

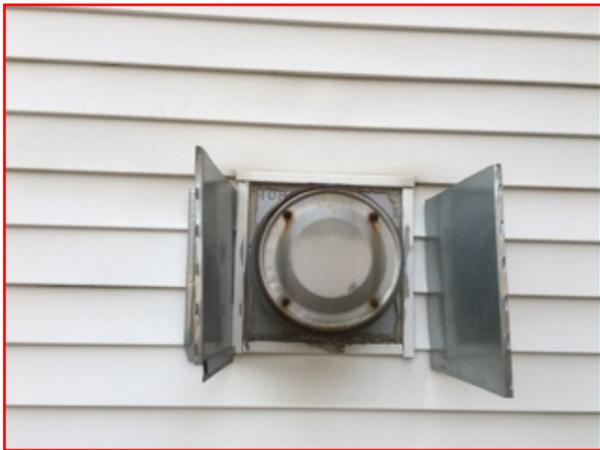
Figure 12-1

7) Exhaust vent for the heater in the rear addition/family room appears to be missing parts or requires repair.

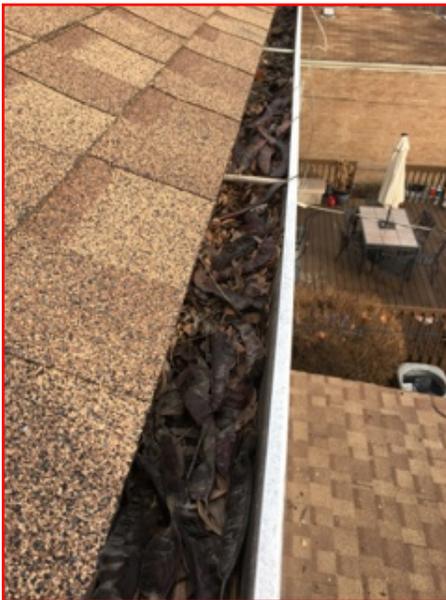
Figure 17-1

10) Gutters are clogged with leaves and debris. Recommend having them cleaned immediately.

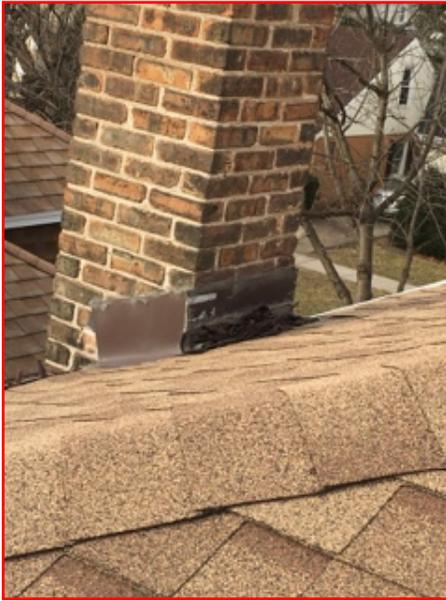
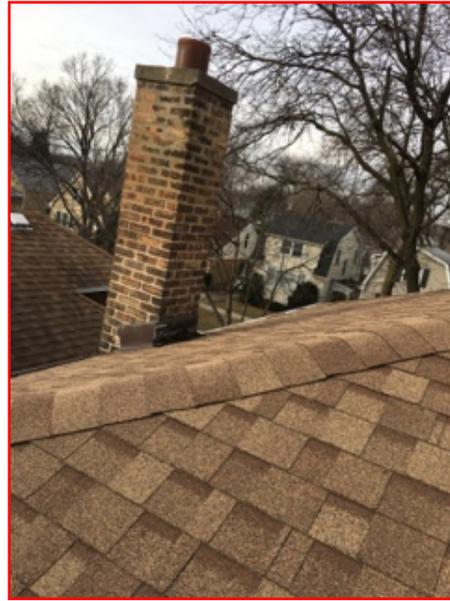
11) Chimney does not have a "cricket" installed. Flashing around chimney may be inadequate and allow moisture to penetrate around the chimney. Recommend having a roofing professional further evaluate and repair as needed.

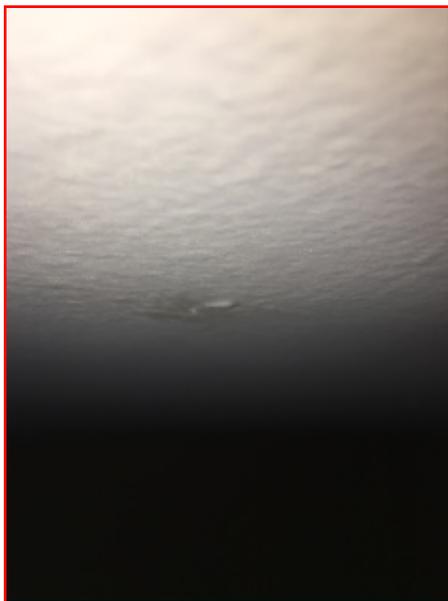
Figure 21-1

13) Possible moisture in ceiling in bathroom possibly due to lack of ventilation.

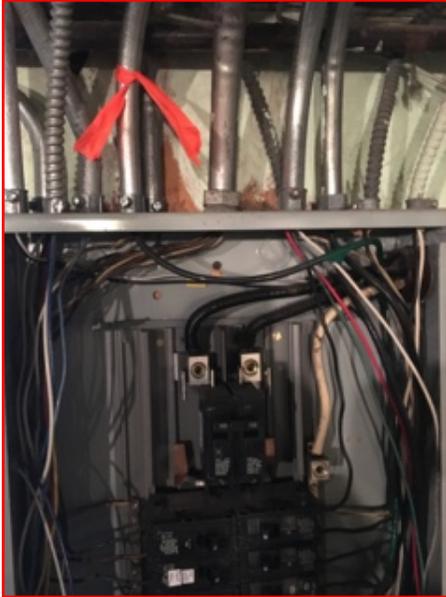
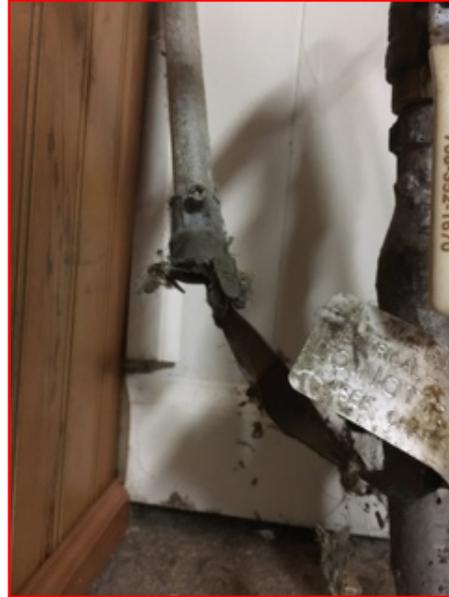
15) Ground wire is fed into conduit from the panel to the water main however there is no wire tied to the water pipe to ground the electrical system. Recommend having a professional electrician evaluate and repair the ground as needed.

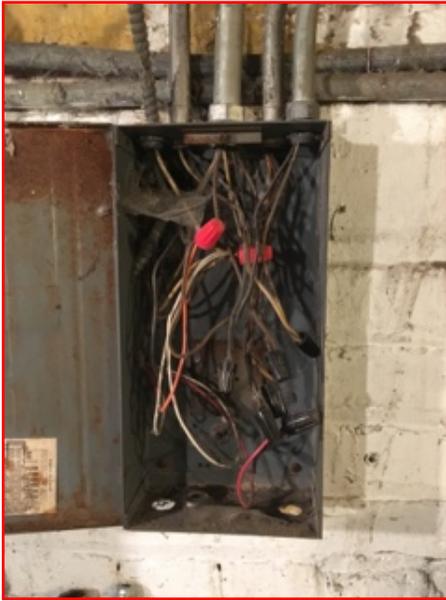
Figure 27-1

16) Original panel box which is not in use is housing several electrical connections. These should be placed in a junction box. Further evaluation from a professional electrician is recommended.

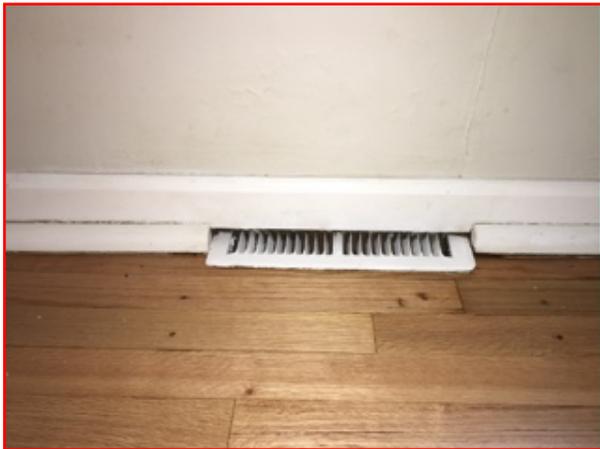
Figure 29-1

17) Vents are overlapped by moldings not allowing the heat to distribute properly.

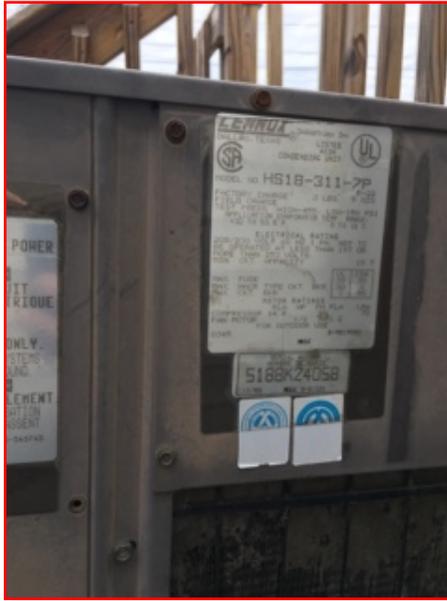
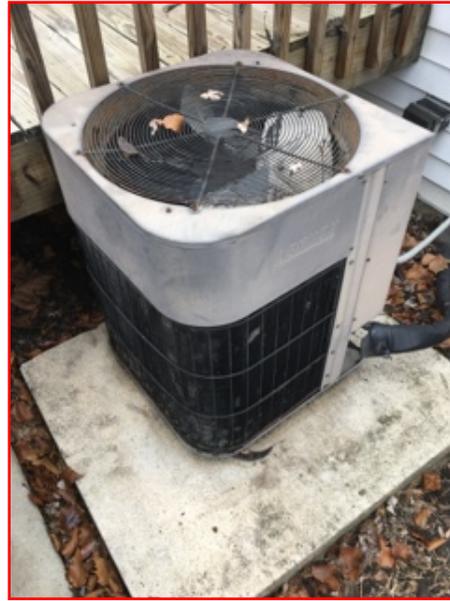
18) Could not test air conditioning unit. Unit was produced in October or 1988 and is beyond its expected useful life.

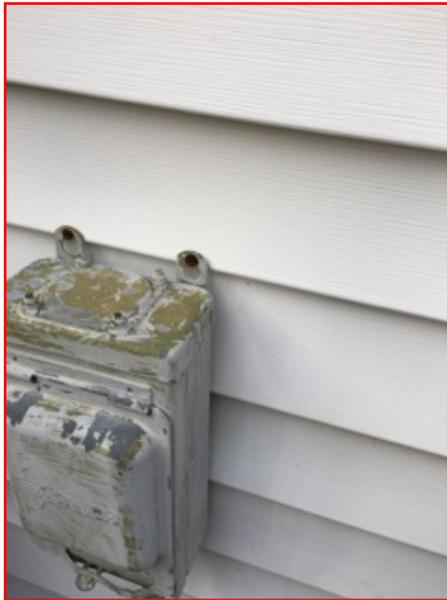
Figure 32-1

19) Disconnect box for air conditioning condenser is not properly secured to house and is loose. This should be checked by a professional electrician.

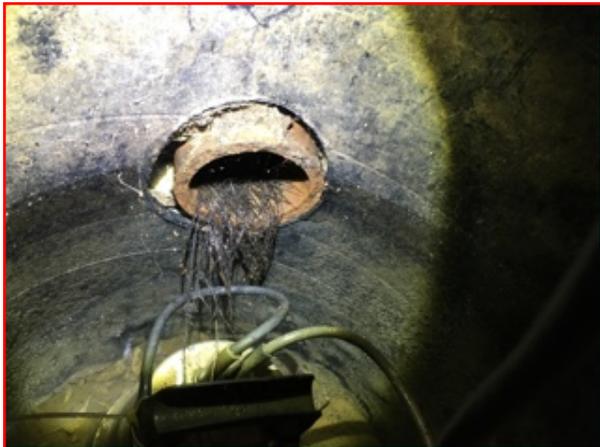
Figure 35-1

21) Roots entering the sump pit in the basement. Roots can clog drain lines and should be cleaned and inspected by a professional plumber periodically. Also noted the upstairs bathtub was draining slowly. Could not determine where the sump pump is ejecting water inside the crawl space area which was sealed at time of the inspection. Recommend a professional plumber inspect further.

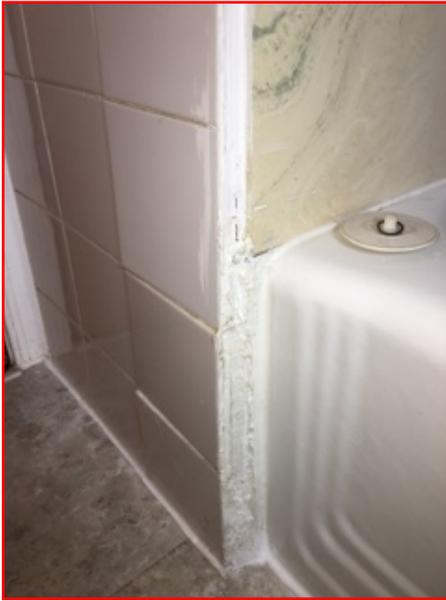
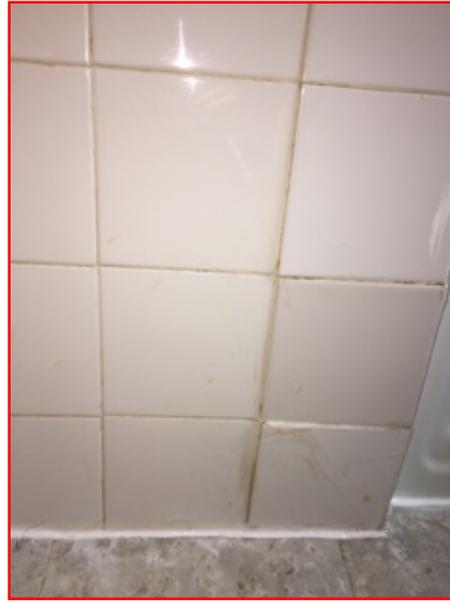
22) Moisture intrusion around tub. Tiles are coming loose from wall next to tub. Recommend replacing and resealing.

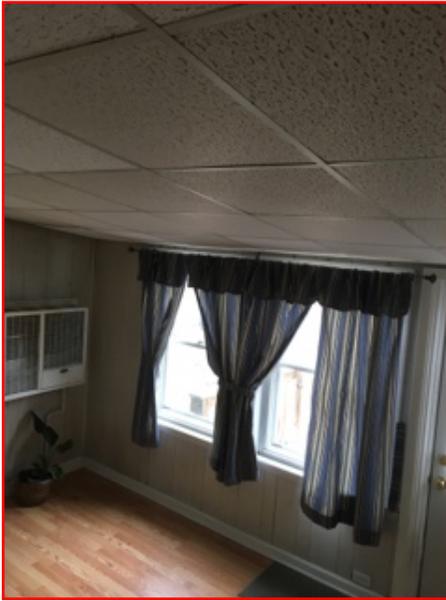
Figure 40-1

24) Sloping floor and brick in the entry to the room indicates that this is an addition or a finished porch area. Heating has been installed separately in the north wall. Could not inspect the area underneath this room to determine if it has a proper foundation. There were no apparent issues noted during the inspection. Further evaluation by a professional contractor or structural engineer is recommended.

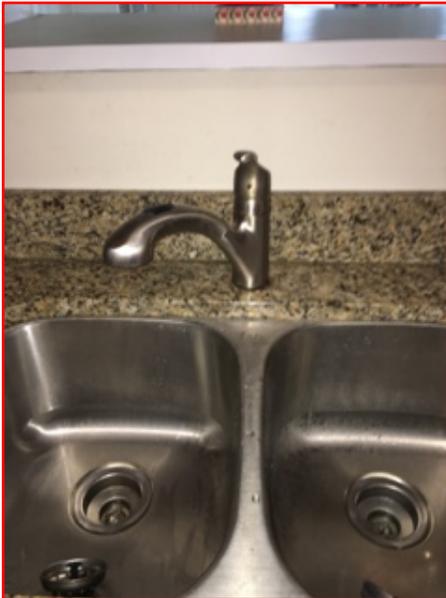
Figure 42-1

25) Hot water (right) and cold water (left) are switched.
