YOUR Inspection Report

443 Madison St.
Chicago, IL

RE: Report No. JHI17-000
443 Madison St.
Chicago, IL

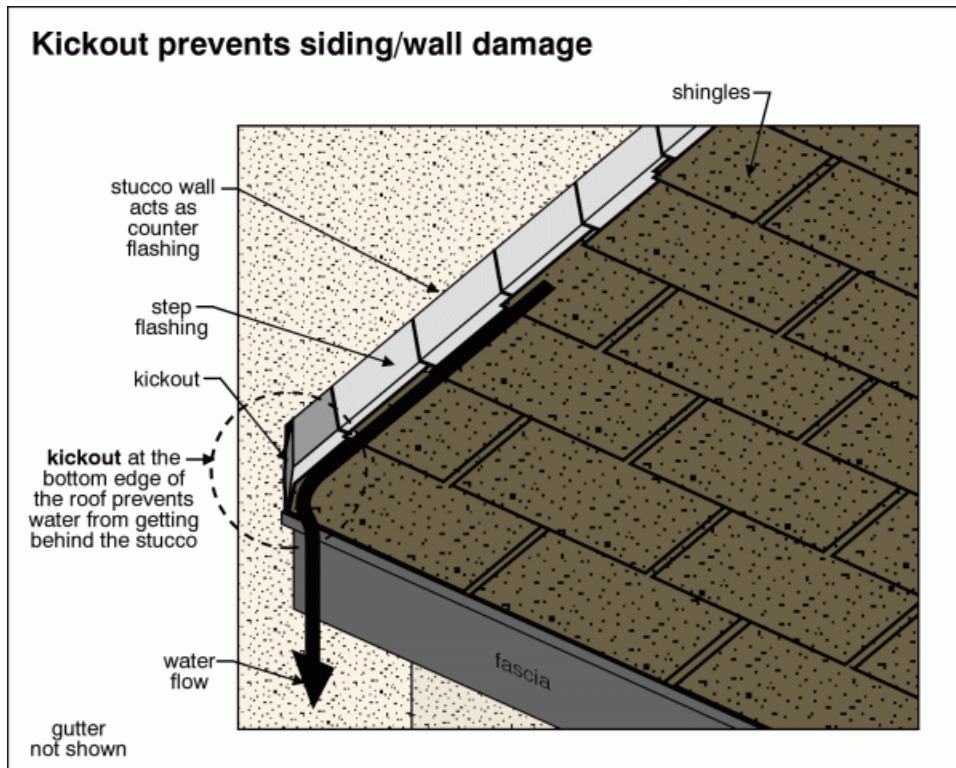
2. **Condition:** • [No kickout flashing](#)

Implication(s): Chance of water damage to contents, finishes and/or structure

Task: Improve

Time: Less than 1 year

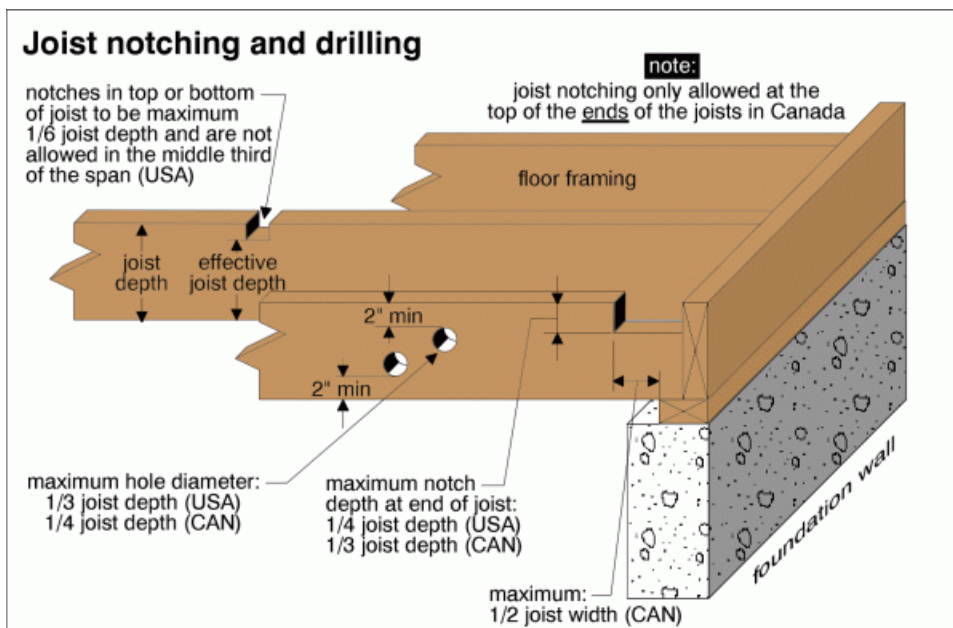
- 6. Condition:** • [Notches or holes](#)
- Implication(s):** Weakened structure
- Location:** West
- Task:** Repair
- Time:** Immediate
