Property Inspection Report

Inspection Report

11827 Moorcreek Dr Houston TX 77070

Date of Inspection: 12/15/2023

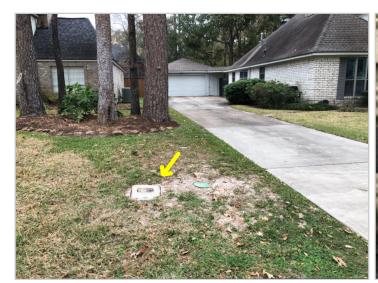
Water meter and shutoff

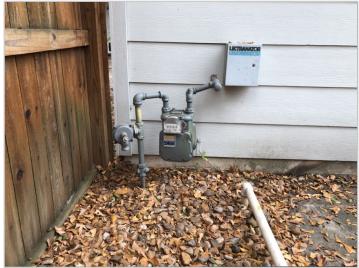
Gas meter and shutoff valve
	F. Other
	Materials: Comments:
	V. APPLIANCES
	A. Dishwashers
	Comments:
	I did not run dishwasher because dishes were present.
	Drain hose was not attached to counter top to form a high loop. This is to prevent drain waste from entering the dishwasher.
X	B. Food Waste Disposers
	Comments:
	The garbage disposal is inspected for proper operation, physical condition, rust, vibration, mounting, leakage and damage to components. No deficiencies observed at the time of inspection.
$X \square \square$	C. Range Hood and Exhaust Systems
	Comments:
	Vent hoods and exhaust systems are inspected for proper operation, mounting, and physical condition. The type, condition and termination point of the vent pipe

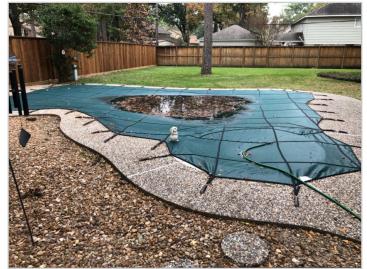
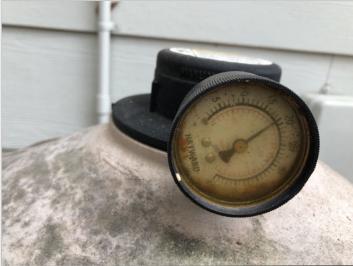
Pool pressure 18 psi Pool cover C. Outbuildings Materials: Comments: D. Private Water Wells (A coliform analysis is recommended) Type of Pump: Type of Storage Equipment: Comments: E. Private Sewage Disposal Systems Type of System: Location of Drain Field: Comments: F. Other Built-in Appliances Comments: G. Other Comments:
