Inspection Report

955 Johndoe Street, Johndoe, California 95453

Inspection Date December 17, 2017
Client Henry Home Inspections
Inspector Keith Henry
707.354.4472
keithrhenry22@gmail.com

Henry Home Inspections

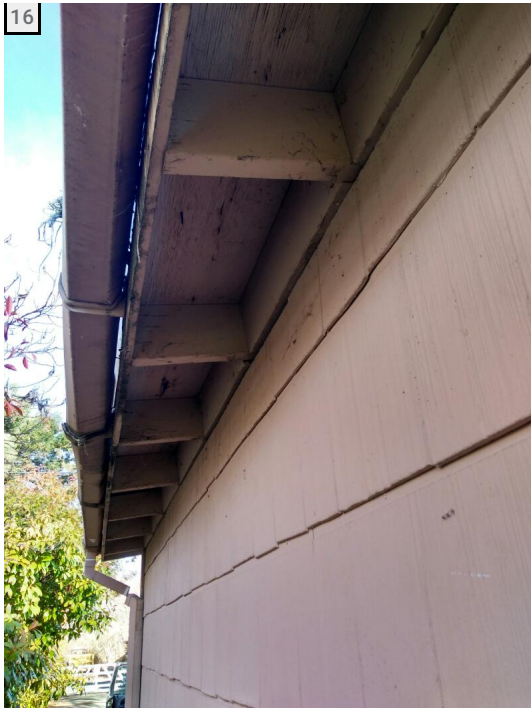
Fascia paint is chipped, faded or worn

Location	Exterior: Ground View
Impact	May cause rot
Suggested Action	Repaint

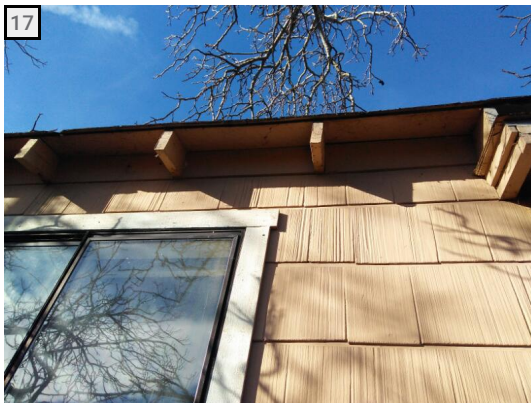
Wood fascia is missing

Location Exterior: Ground View

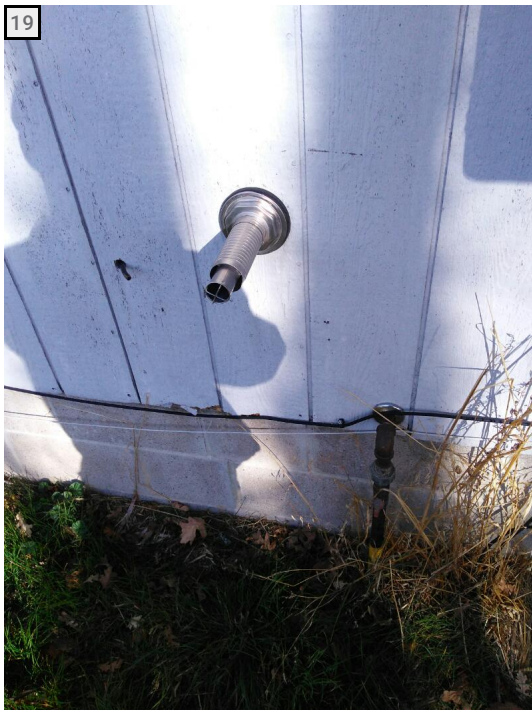
Located within 3 feet of a window, door or other vent

Location	Exterior: Ground View
Impact	When a vent is too close to a windows, exhaust gas could re-enter the home
Suggested Action	Relocate the exhaust vent to be further than 3 feet from any window, door or other vent

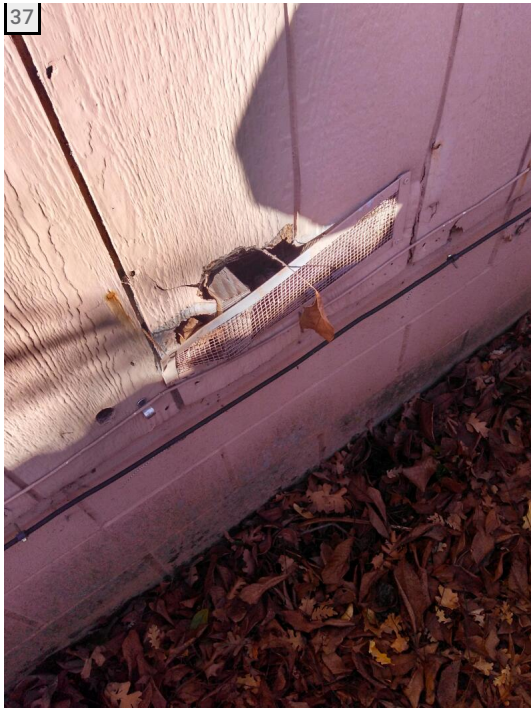
There is a 2x4 pushing on the vent

Location	Exterior: Ground View
Impact	Can allow critters into crawlspace
Suggested Action	Have repaired by a professional carpenter

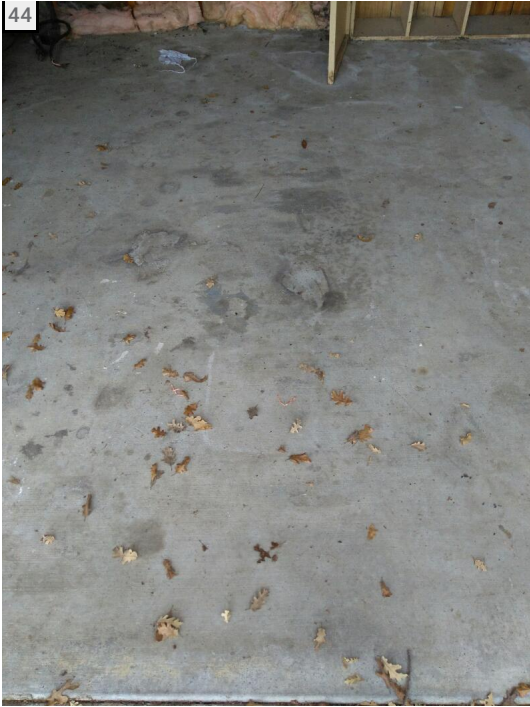
Exhibits hairline cracking

Location	Exterior: Ground View (Garage slab)
Impact	Recommend monitoring this area for future change. Should change occur, contact a structural engineer to inspect the entire foundation system

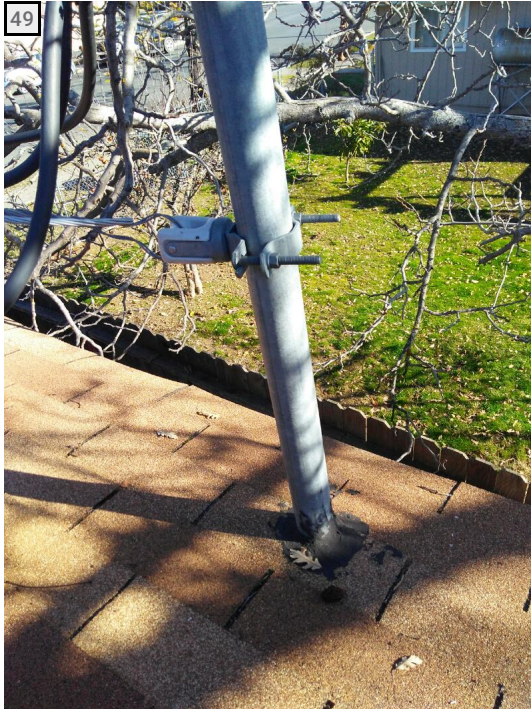
Flashing is missing

Location	Exterior: Roof View
Impact	Roof leak
Suggested Action	Have repaired or replaced by a qualified professional

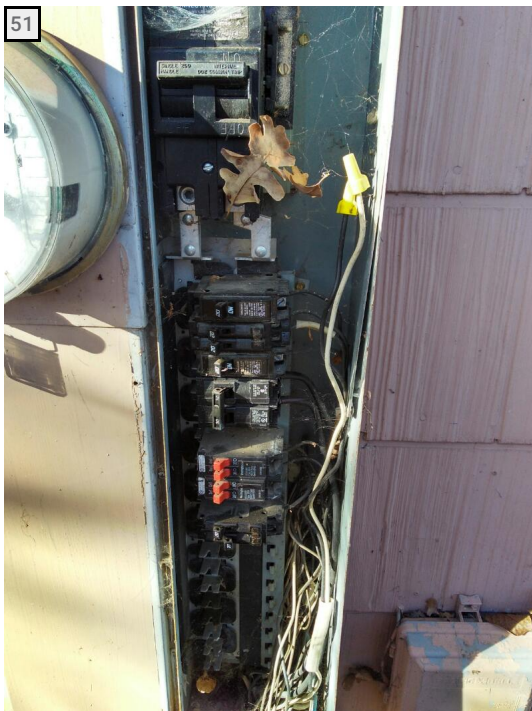
There does not appear to be enough breakers for the house.

Location	Exterior: Ground View
Impact	Breakers may be overloaded.
Suggested Action	This should be evaluated by a professional electrician.

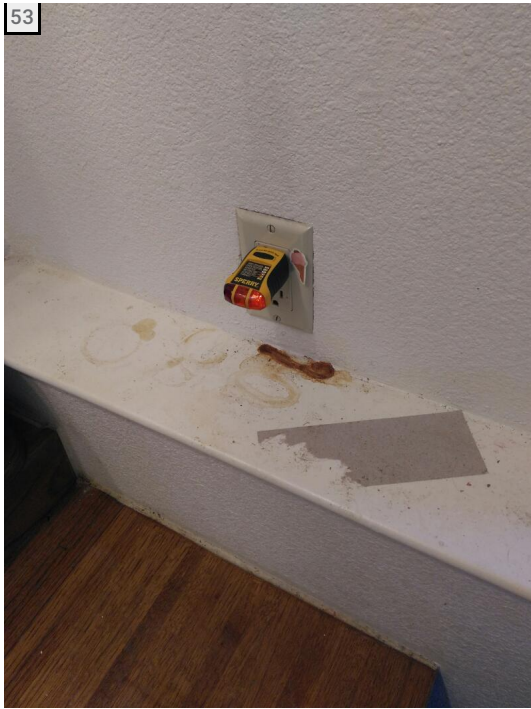
Tester shows open neutral

Location	1st Bathroom (Between bonus room and second bedroom bathroom)
Impact	An open neutral outlet can cause an electrical shock through an appliance
Suggested Action	Have repaired by a licensed electrical technician

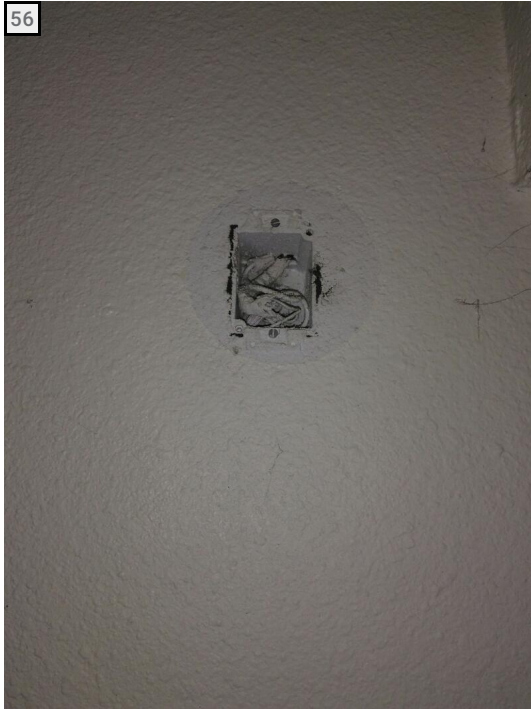
Safety Concern**Cover plate is missing**

Location	Living Room (Front Room living room)
Impact	Without a cover plate, electrical shock may result if touched
Suggested Action	Install a cover

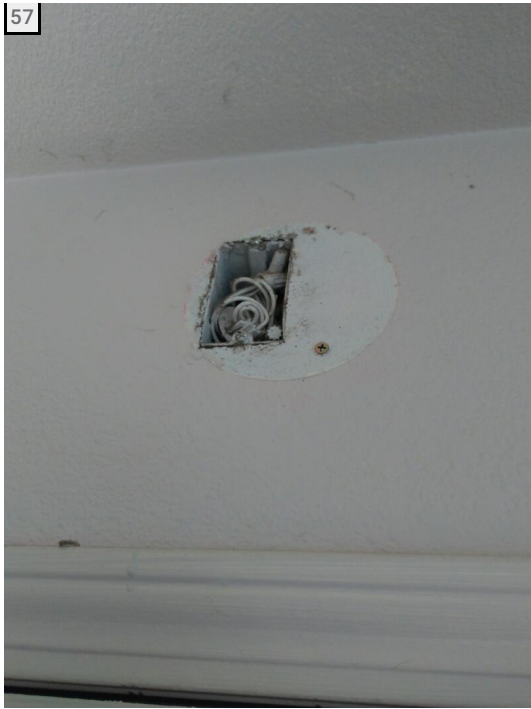
**Safety Concern****Has open wires**

Location	2nd Bedroom (Rear of house bedroom)
Impact	Exposed energized wiring can be hazardous to touch
Suggested Action	Have repaired by a licensed electrician

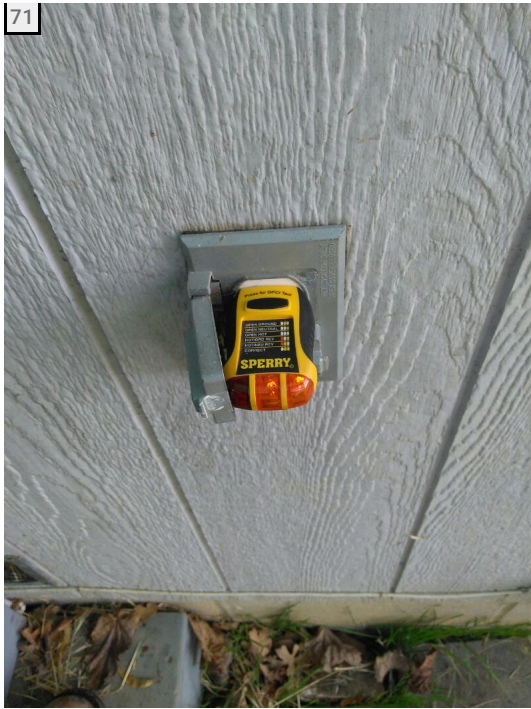
**Minor Concern****Wired correctly but not GFCI protected**

Location	Attached Garage, Exterior: Ground View
Impact	Electrical hazard if moisture enters
Suggested Action	Have repaired by qualified electrician

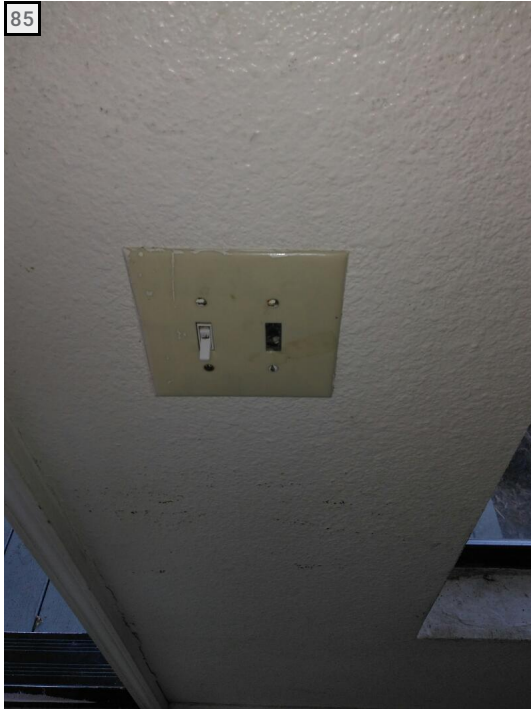
Minor Concern**One switch is missing**

Location	Living Room (Front Room living room)
Impact	Possibility of electrocution
Suggested Action	Change switch plate

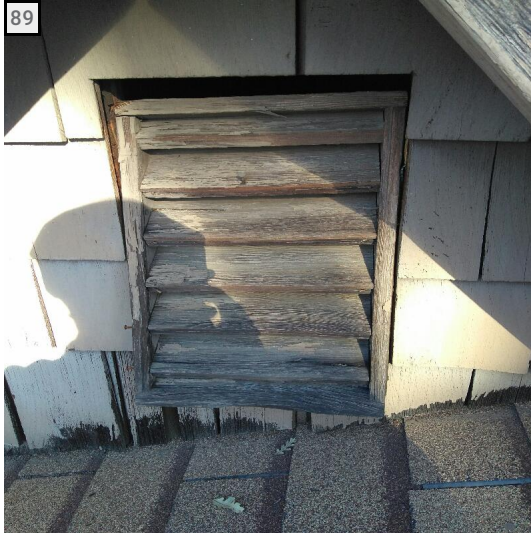
Paint is old and worn

Location	Attic
Impact	Wood decay
Suggested Action	Caulk and paint

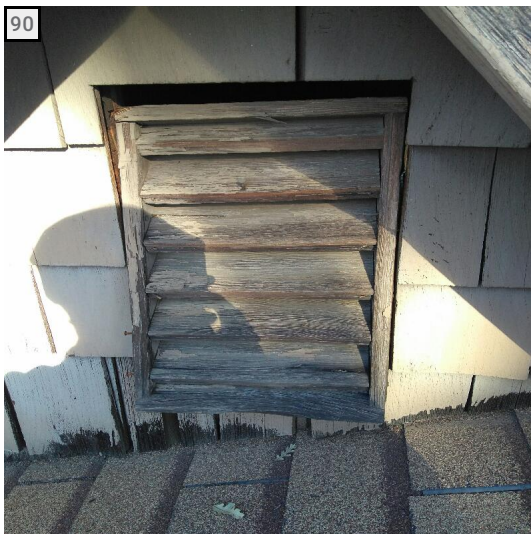
Minor Concern

Vent is not secured well

Location	Attic
Suggested Action	Have repaired by professional

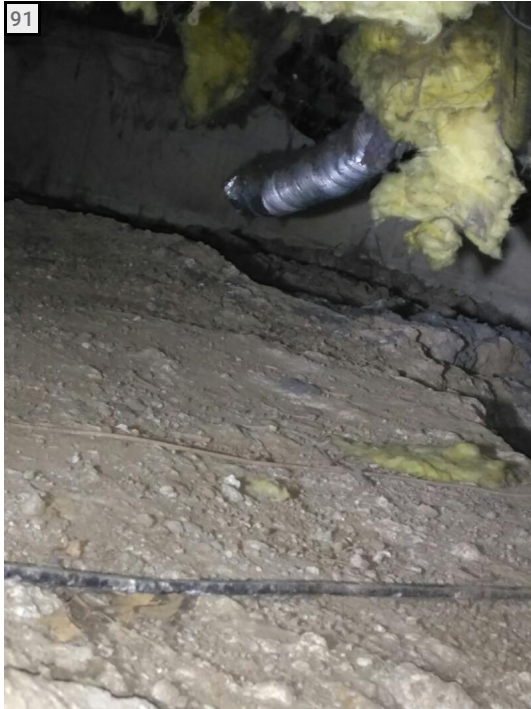
Minor Concern

Dryer vent doesn't terminate outside

Location	Crawl Space
Impact	Add moisture to crawlspace, build up of lint could be fire hazard
Suggested Action	Have professional reinstall vent

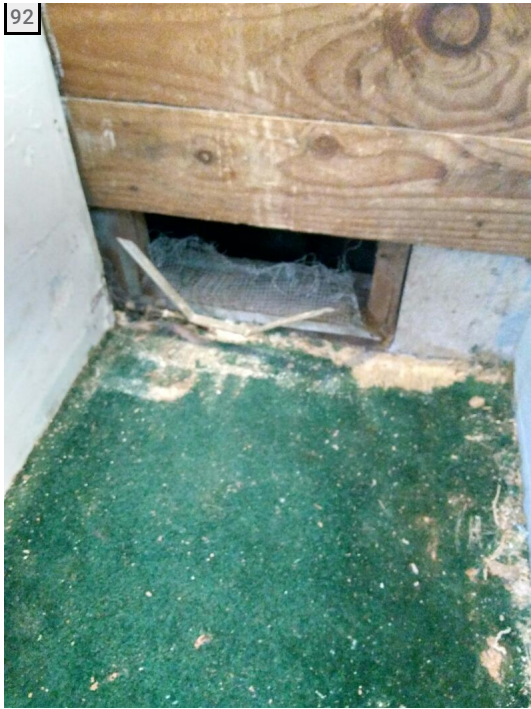
Minor Concern

Vent is open

Location	Hallway and Stairs (Between kitchen and second bonus room hallway and stairs)
Impact	Allows animals to enter house
Suggested Action	Have professional reinstall vent

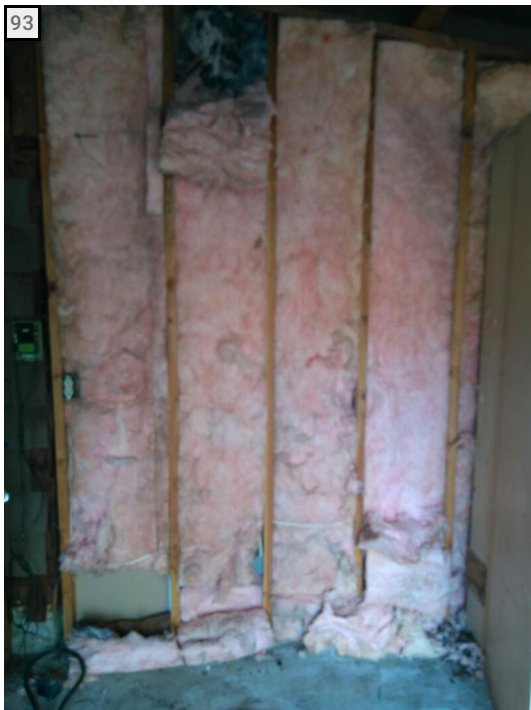
Minor Concern

Some insulation needs reinstalled

Location	Attached Garage
Impact	Heat loss
Suggested Action	Reinstall insulation and secure it

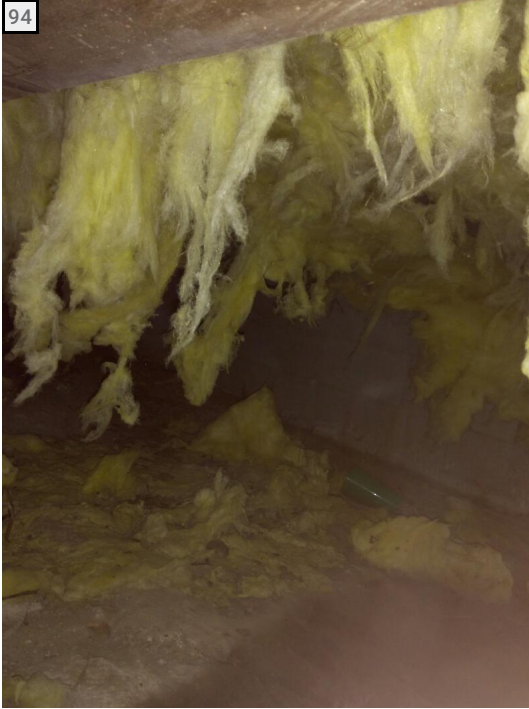
Minor Concern

Torn by animals

Location	Crawl Space
Impact	Heat loss
Suggested Action	Have reinstalled by professional

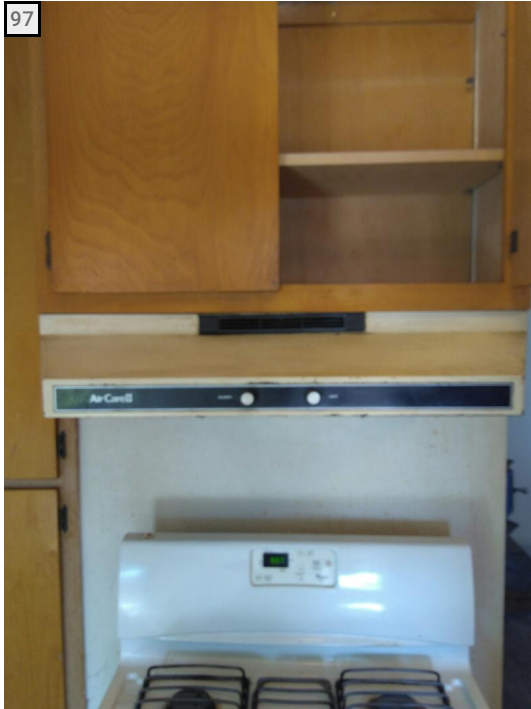
Does not exhaust to exterior

Location	Kitchen
Impact	When exhausting to the interior, humidity or other particulates are not expelled from the home increasing health risks
Suggested Action	Re-route the exhaust to exit to the exterior using an exterior wall or roof vent

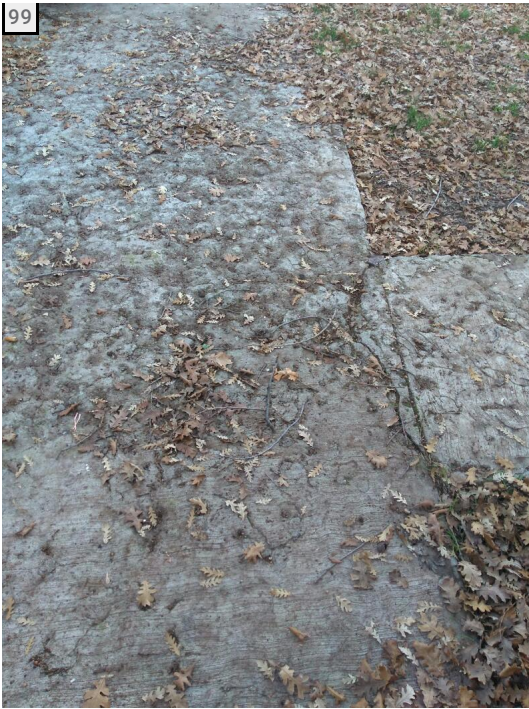
Concrete is spalling

Location	Exterior: Ground View
Impact	If left unrepaired, spalls can accelerate pavement deterioration
Suggested Action	Repair either the damaged portion or entire driveway depending on your asthetic preferences
Other Information	Spalling appears as circular or oval depressions on surfaces or as elongated cavities along joints

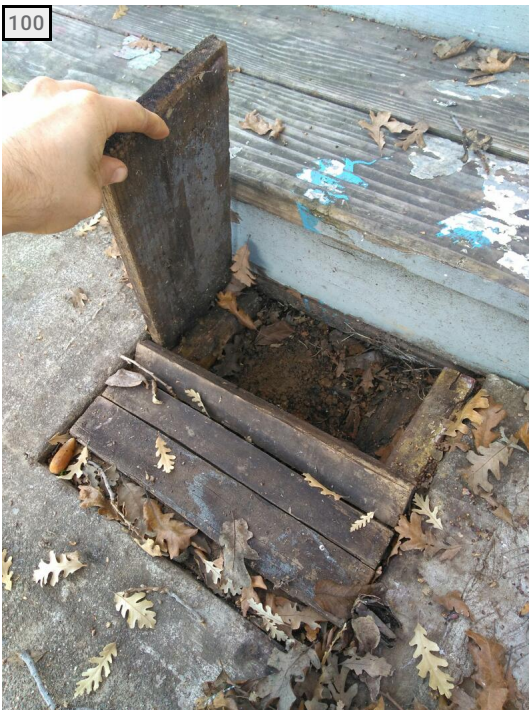
! Patio and walkway

Safety Concern

Hole in concrete covered with boards

Location	Exterior: Ground View
Impact	Fall hazard
Suggested Action	Have repaired by professional contractor

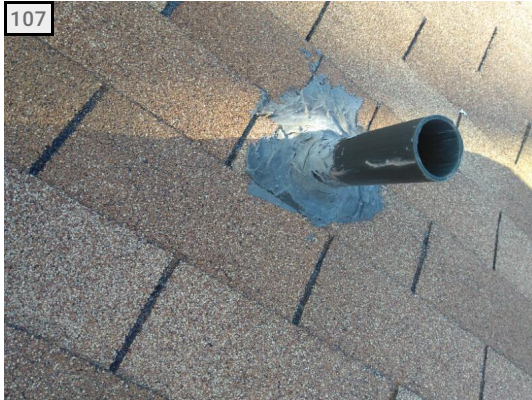
⊖ Plumbing Vent

Moderate Concern

Flashing is missing

Location	Exterior: Roof View
Impact	Roof leak
Suggested Action	Have a qualified technician replace the flashing

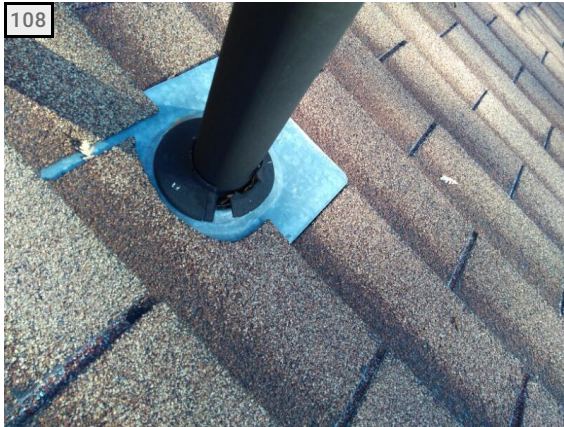
Moderate Concern

Rubber boot flashing is damaged

Location	Exterior: Roof View
Impact	The damage may cause the vent to leak
Suggested Action	Replace the flashing

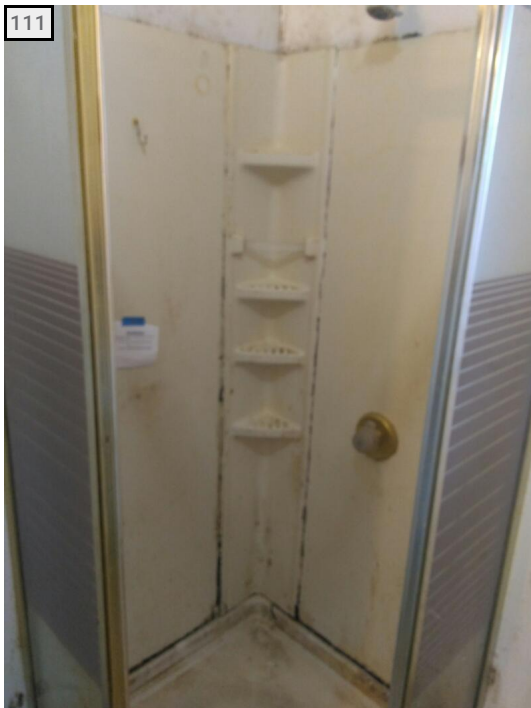
Caulking is deteriorated

Impact Without the seal that caulk provides, moisture may leak into surrounding areas causing damage to floors and walls

Suggested Action Clean out the existing caulk and re-caulk the seams

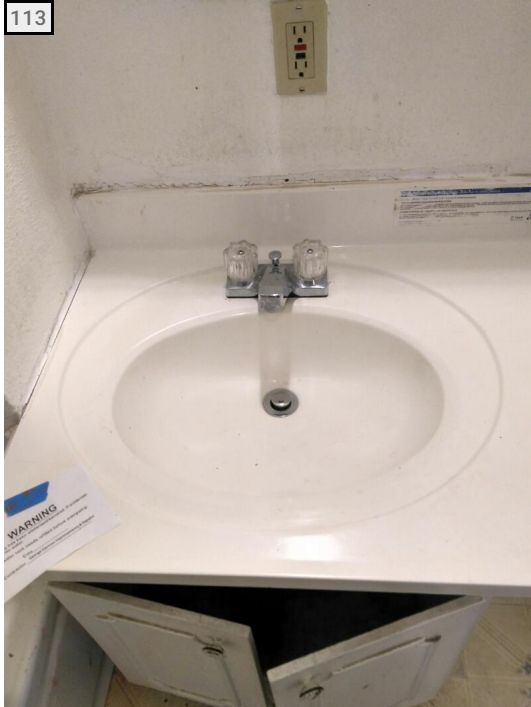
Minor Concern

Caulking is deteriorated

Location 2nd Bathroom (west of living room bathroom)
Impact Leak
Suggested Action Repair caulking

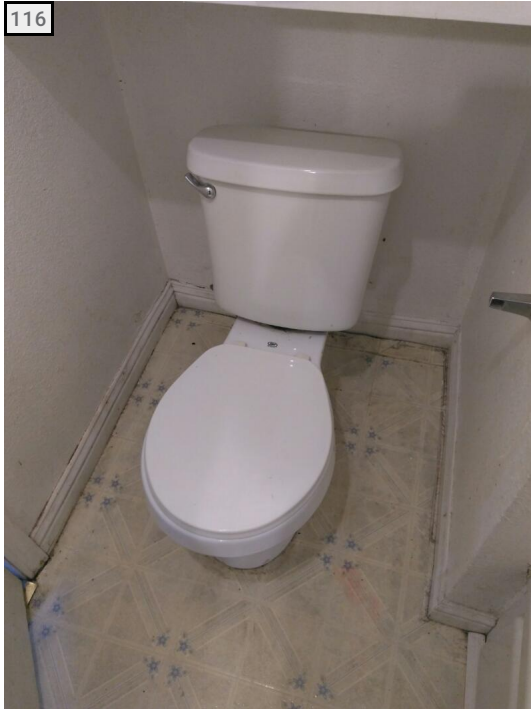
Moderate Concern**Loose**

Location	2nd Bathroom (west of living room bathroom)
Impact	A loose toilet may damage the wax ring that prevents leaking
Suggested Action	Remove and reinstall the toilet, including replace the wax ring

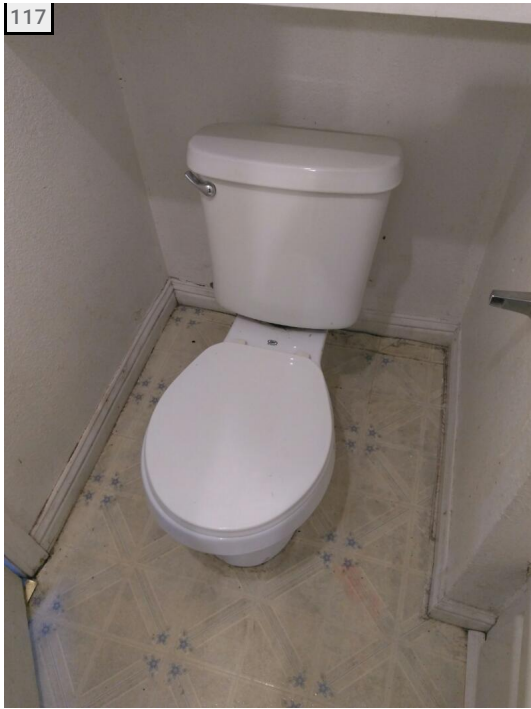
**Minor Concern****Bowl is loose**

Location	2nd Bathroom (west of living room bathroom)
Suggested Action	Tighten the bowl

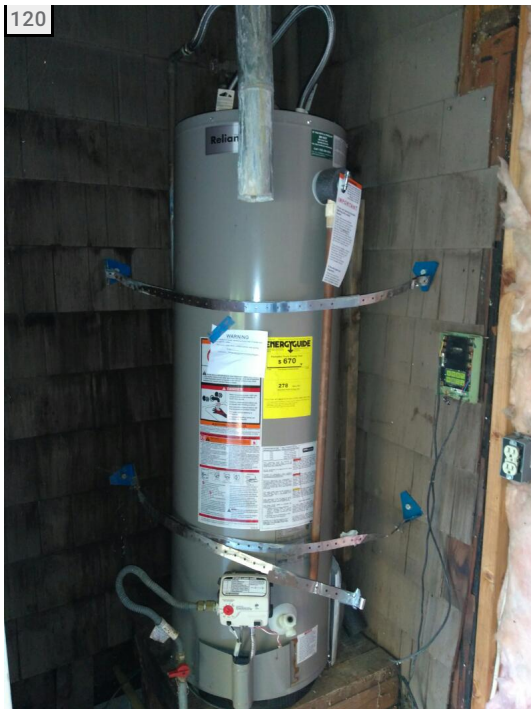
Exhaust vent is disconnected

Location	Attached Garage
Impact	Fumes will build up into garage and possibly enter living area
Suggested Action	Reconnect vent

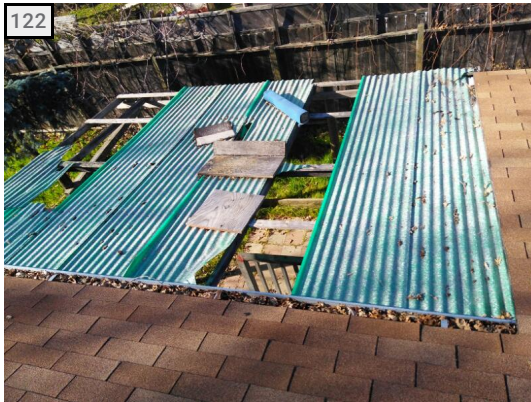
This patio roof is in disrepair

Location	Exterior: Roof View
Suggested Action	Should be rebuilt or removed

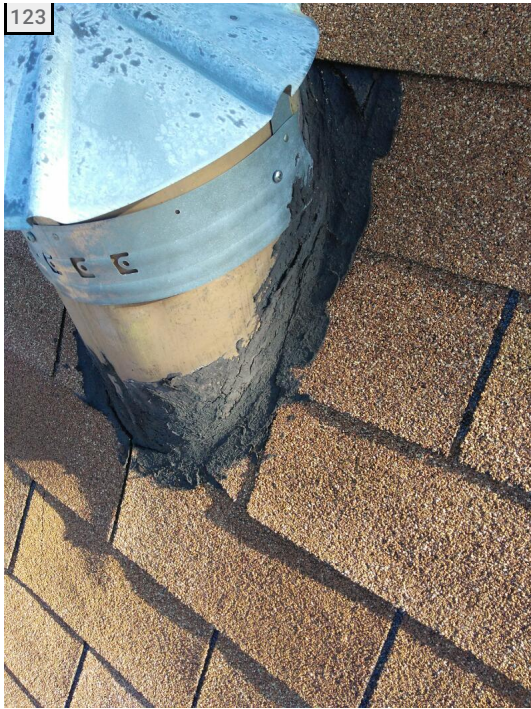
Moderate Concern

Flashing is missing

Location	Exterior: Roof View
Impact	Roof leak
Suggested Action	Have repaired by qualified professional

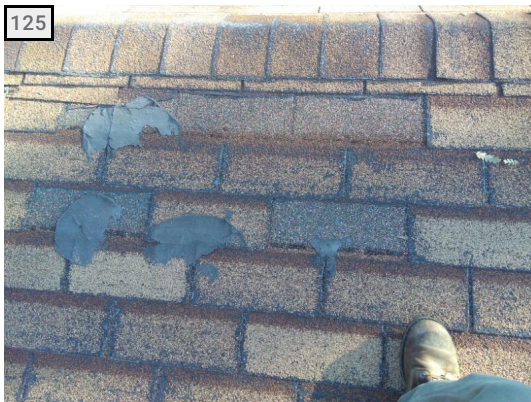
Roof is spongy to walk on in multiple areas

Location	Exterior: Roof View
Impact	Roof sheathing is rotting and will need replaced
Suggested Action	Have repaired by a qualified roofing contractor

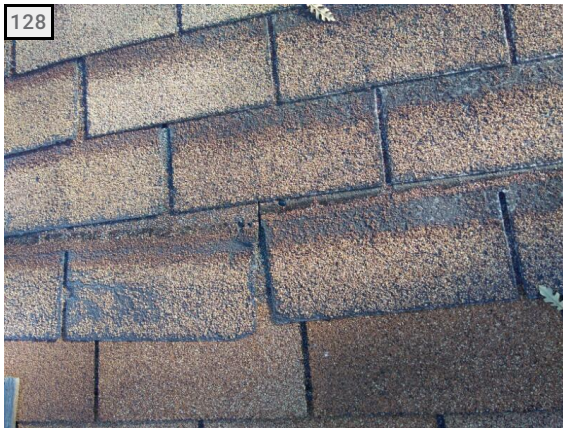
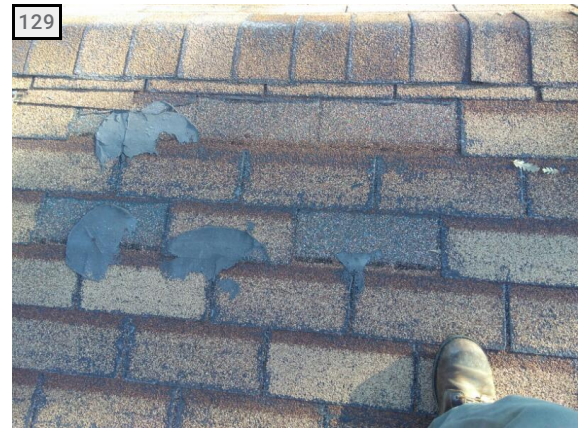
Major Concern

Shows signs of excessive wear

Location	Exterior: Roof View
Impact	The condition of the roof will further deteriorate and water could infiltrate causing interior damage
Suggested Action	Budget for a new roof. In the interim, a higher level of maintenance can be expected
Other Information	Excessive wear is a sign that the roof is nearing the end of its useful life

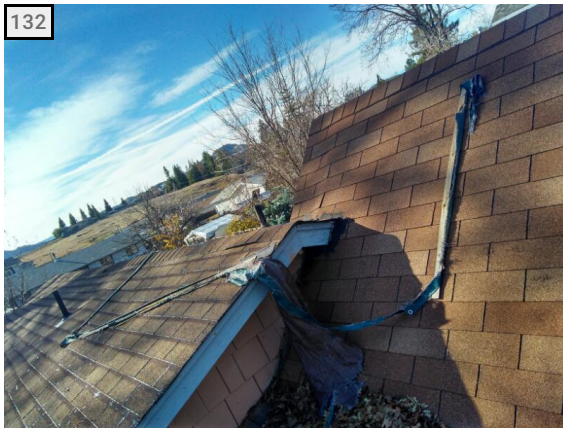
Major Concern

Tarp was screwed into roof creating new holes

Location	Exterior: Roof View
Impact	Roof leak
Suggested Action	Have repaired by a qualified roofing contractor

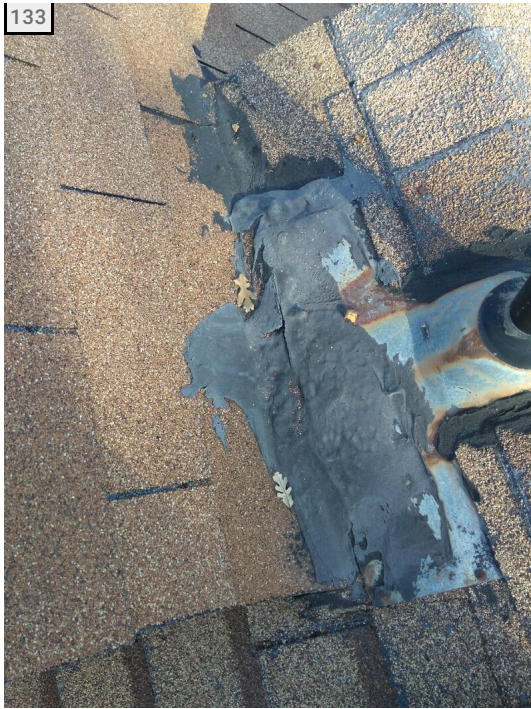
Moderate Concern

Repair was done improperly

Location	Exterior: Roof View
Impact	Because the roof material was installed incorrectly and lack proper stability and protection
Suggested Action	Have repaired by a qualified roofing contractor

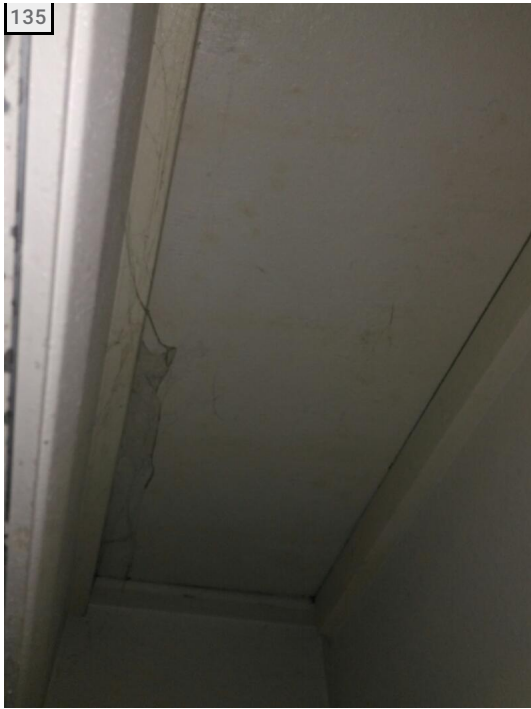
Satisfactory

Location 1st Bedroom (Front of house bedroom)

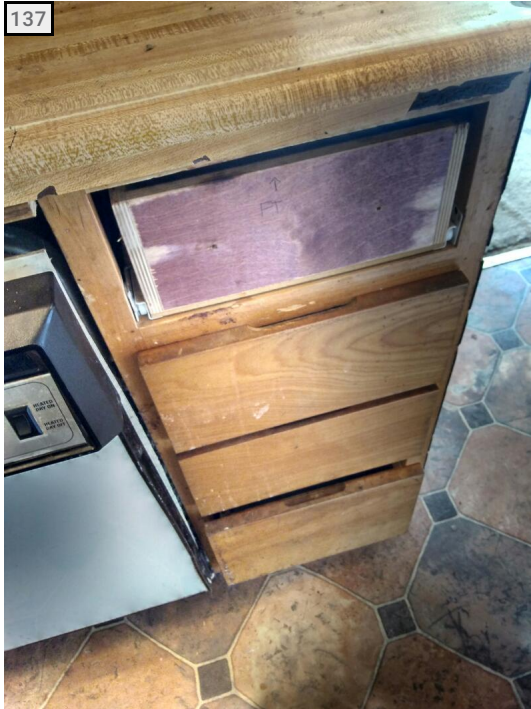
Drawer front is missing

Location	Kitchen
Impact	The missing front renders the cabinet drawer unusable
Suggested Action	Install a drawer front

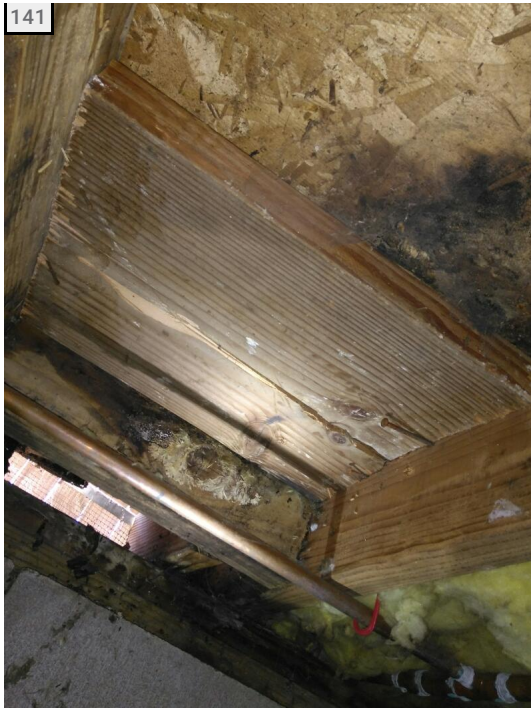
Subfloor rotted and improperly repaired

Location	Crawl Space
Impact	Result in hole in floor
Suggested Action	Have repaired by a qualified contractor

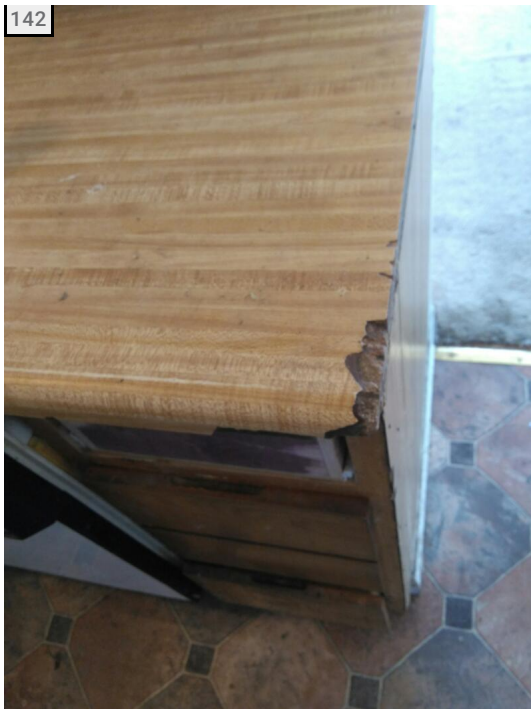
Excessively worn and/or damaged

Location	Kitchen
Impact	While still functional, it lacks aesthetics
Suggested Action	Consider replacing the countertops

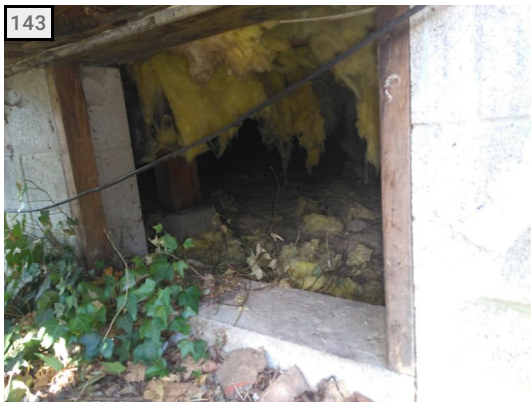
Minor Concern

Door to entrance is missing

Location	Crawl Space
Impact	Animals can enter
Suggested Action	Have professional add door

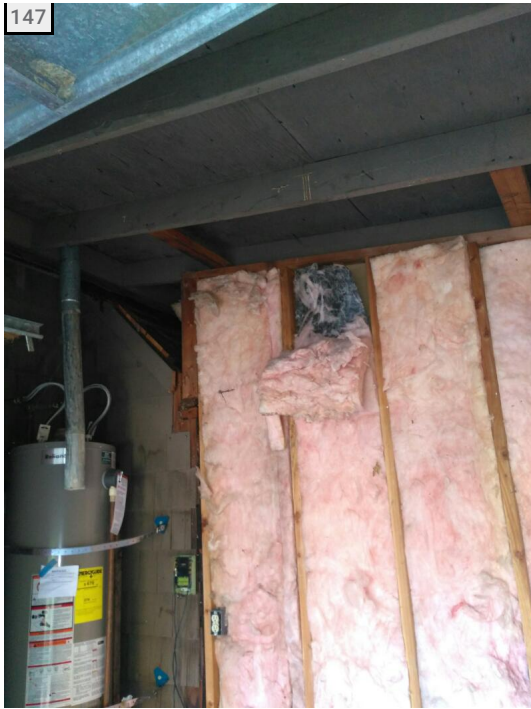
Does not exist

Location	Attached Garage
Impact	Should a fire ignite in the garage, the fire will spread more quickly to the living areas of the home
Suggested Action	Install fire-resistant material, such as drywall, between the garage and the living space
Other Information	The firewall is intended to slow the spread of fire from the garage to the living space

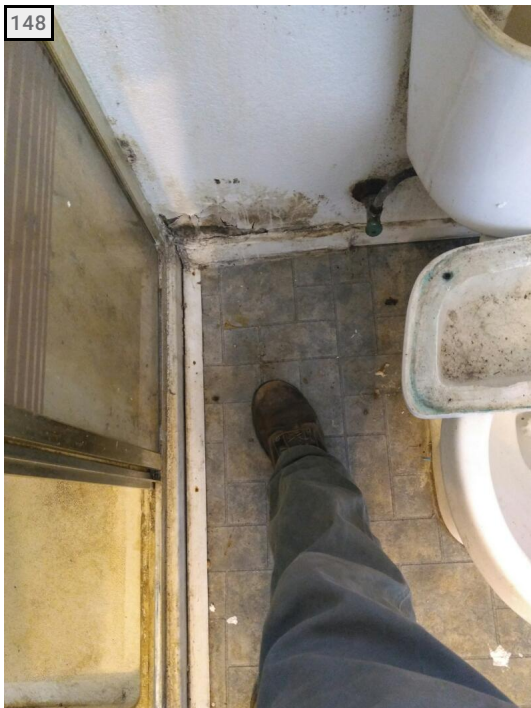
Moderate Concern

Rotted

Location	1st Bathroom (Between bonus room and second bedroom bathroom)
Impact	A rotted floor could worsen creating a more expensive repair
Suggested Action	After repairs are made to eliminate the moisture intrusion, have the affected flooring repaired by a wood flooring professional
Other Information	A rotted floor could worsen creating a more expensive repair

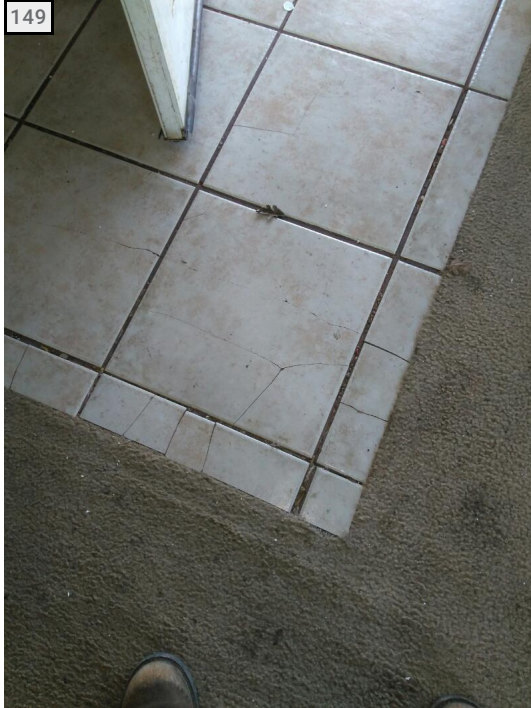
Moderate Concern**Tile is cracked**

Location	Living Room (Front Room living room)
Impact	The tiles could come loose and cause either a trip or a sharp edge cutting hazard
Suggested Action	Replace the broken tiles

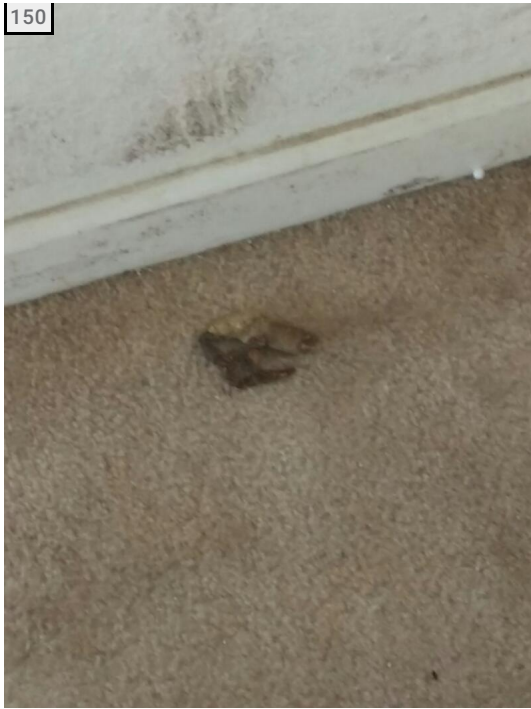
**Minor Concern****Droppings on floor**

Location	Living Room (Front Room living room)
Impact	Health hazard
Suggested Action	Should be cleaned

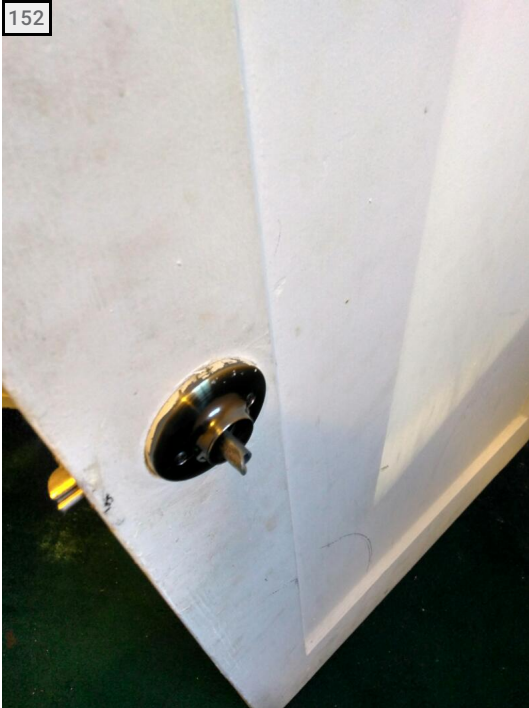
Handle is missing or broken

Location Bonus Room 2
Suggested Action Replace the door handle assembly

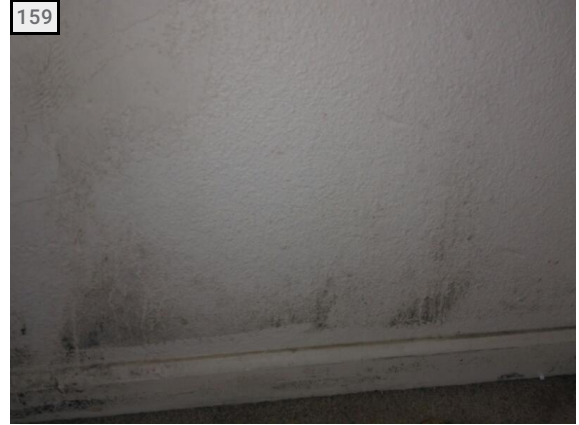
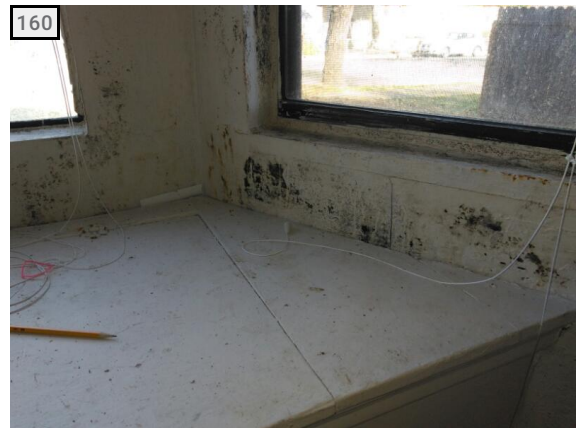
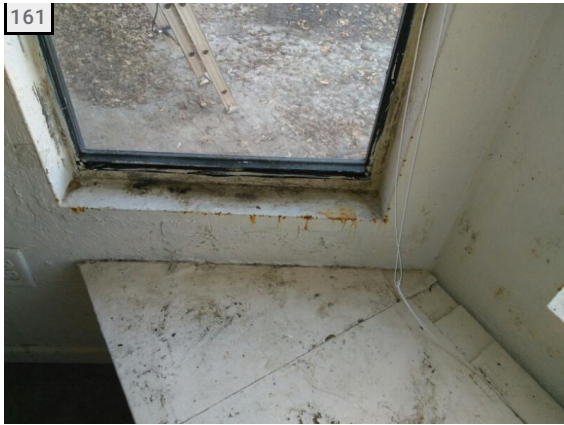
Impact Indicates leak and it is a health hazard to live with mold

Suggested Action Have repaired by a qualified contractor

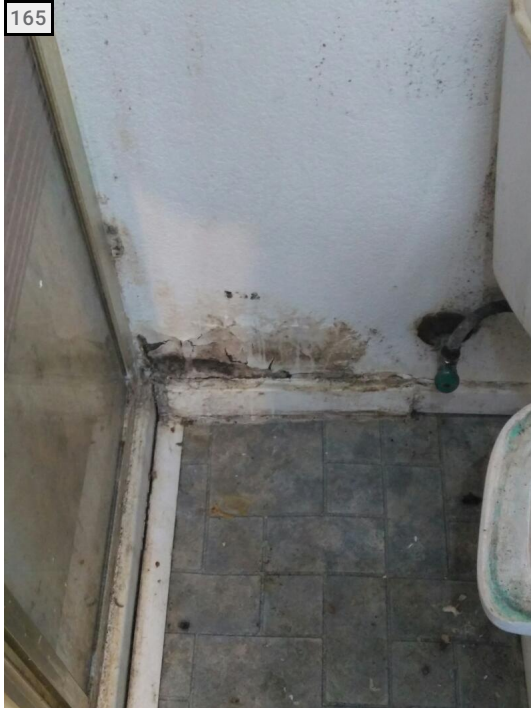
Moderate Concern**Wall has water damage**

Location	1st Bathroom (Between bonus room and second bedroom bathroom)
Impact	If the leak is still active, it will further damage drywall and the support structure
Suggested Action	After repairing the leak, repair or replace the damaged area
Other Information	This is likely a result of moisture intrusion potentially by a leak in the roof, plumbing, appliance, etc,... elsewhere in the home

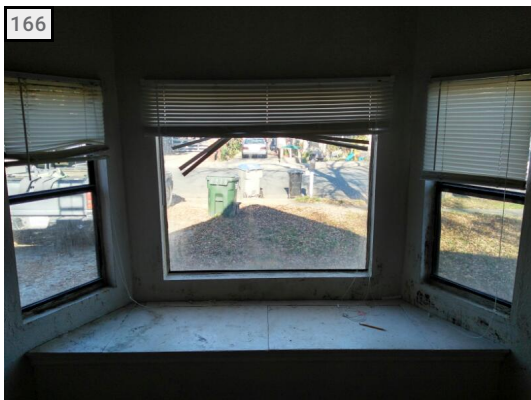
**! Window****Safety Concern****Single hung windows on either side of casement window do not lock**

Location	1st Bedroom (Front of house bedroom)
Impact	Unwanted entry
Suggested Action	Have professional install locks

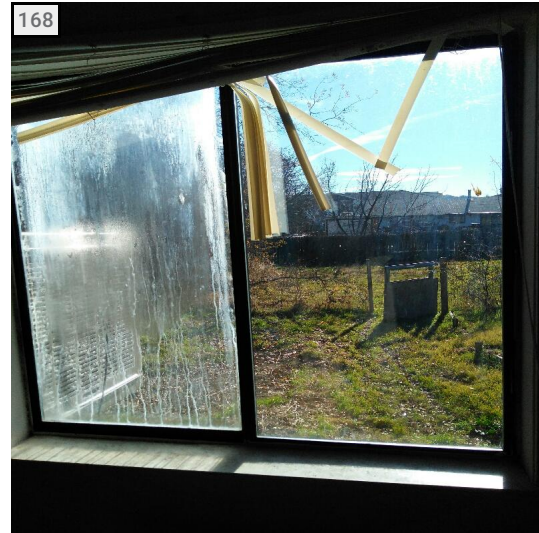
Minor Concern

Blinds are damaged

Location Family Room, 2nd Bedroom (Rear of house bedroom)
Suggested Action Repair or replace
